Artikel: Stress measurement and repair of a fatigue cracked box girder bridge
Autor: Yamada, Kentaro / Ojio, Tatsuya / Kainuma, Shigenobu
DOI: <https://doi.org/10.5169/seals-57469>

Stress Measurement and Repair of a Fatigue Cracked Box Girder Bridge

A three span continuous box girder bridge in Nagoya was subjected to very heavy traffic, amounting to over 55,000 vehicles per day on three lanes and with about 50 percent trucks. In 1988 fatigue cracks were observed at diaphragm corners after 20 years of service. The fatigue damaged diaphragm corners were repaired by high strength bolted splices. Truss members were also added to stiffen the diaphragms and the cross beams. In the summer and the fall of 1996 stress measurements were carried out to investigate a method for measuring truck axle weights and to carry out a fatigue assessment of the orthotropic steel decks and diaphragm corners. In this paper the case history of the box girder bridge is summarized and the preliminary results of stress measurement are presented.

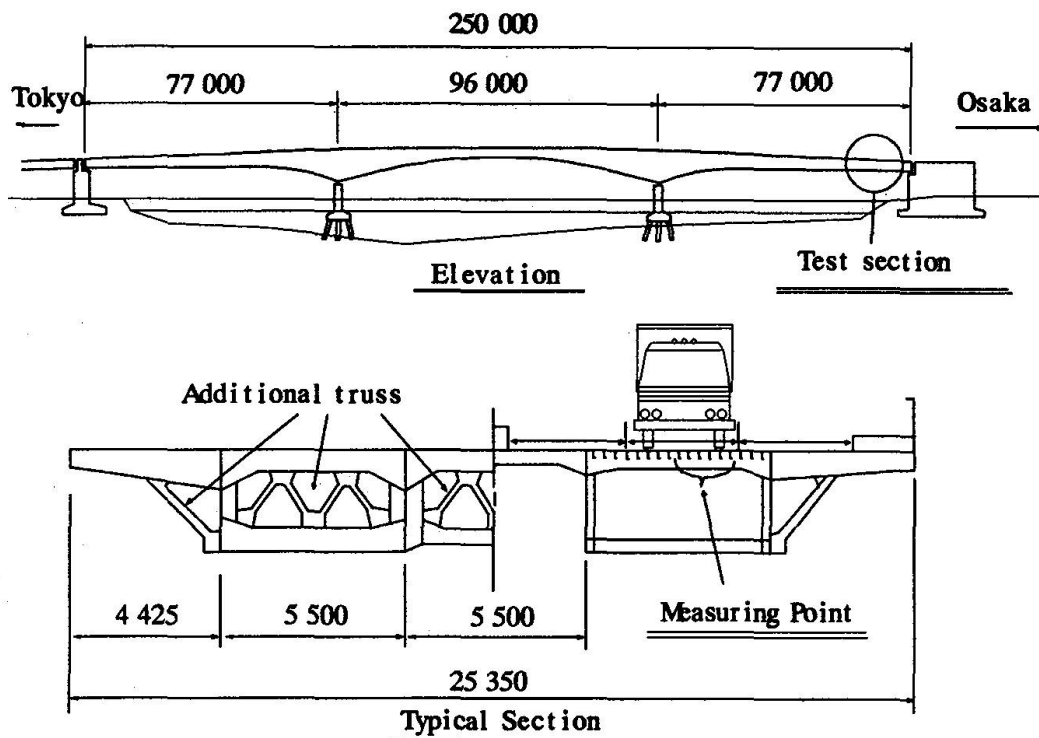
Fig. 1 Orthotropic steel deck bridge

After about 25 years in service, fatigue cracks were found at corners of diaphragms and at sole plates of supports. A committee (Chairman; Prof. Nishino) was formed to investigate the extent of the damage, causes of the cracks and ways to retrofit the bridge. Intensive investigations, such as stress and vibration measurements and structural analysis by the finite element method, were carried out to find the best possible ways to retrofit the bridge. Based on such investigations the cracked parts were strengthened by high strength bolted splices, and truss members were added

to stiffen all diaphragms and every other cross ribs. The rehabilitation scheme seemed successful, and no further fatigue damages were observed at these stiffened parts. However, recent inspection revealed that a few additional cracks were found at the diaphragm corners which were not retrofitted eight years ago, because no fatigue cracks were observed at that time.
