Stress measurement and repair of a fatigue cracked box girder bridge

Stress Measurement and Repair of a Fatigue Cracked Box Girder Bridge

A three span continuous box girder bridge in Nagoya was subjected to very heavy traffic, amounting to over 55,000 vehicles per day on three lanes and with about 50 percent trucks. In 1988 fatigue cracks were observed at diaphragm corners after 20 years of service. The fatigue damaged diaphragm corners were repaired by high strength bolted splices. Truss members were also added to stiffen the diaphragms and the cross beams. In the summer and the fall of 1996 stress measurements were carried out to investigate a method for measuring truck axle weights and to carry out a fatigue assessment of the orthotropic steel decks and diaphragm corners. In this paper the case history of the box girder bridge is summarized and the preliminary results of stress measurement are presented.

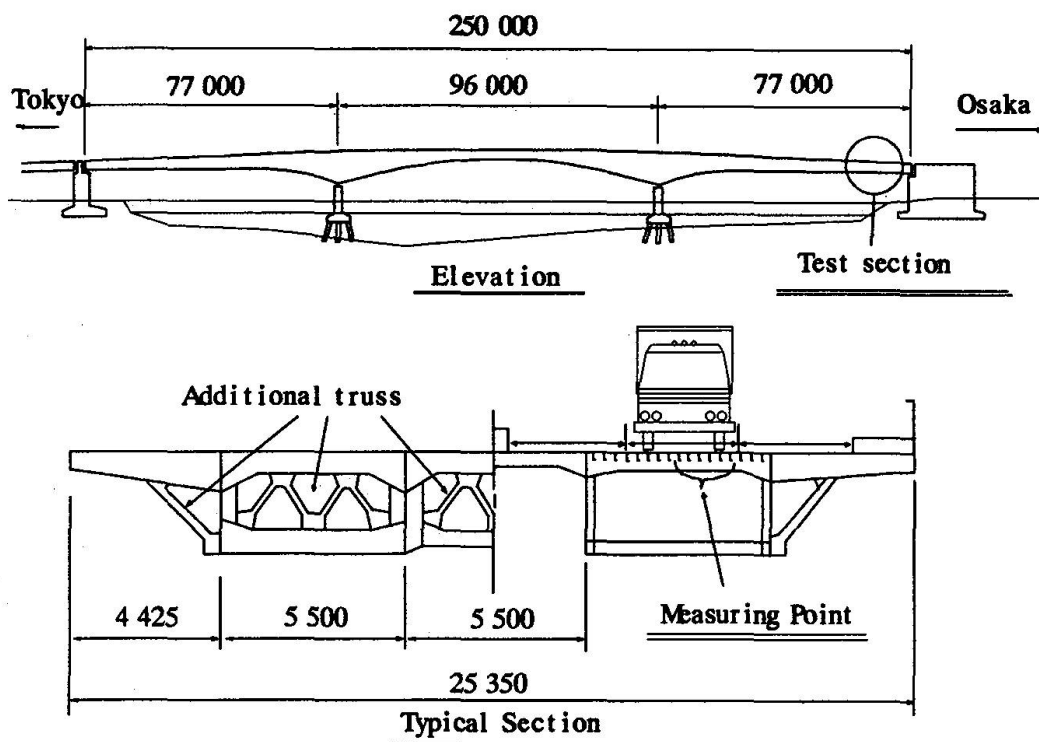
Fig. 1 Orthotropic steel deck bridge

After about 25 years in service, fatigue cracks were found at corners of diaphragms and at sole plates of supports. A committee (Chairman; Prof. Nishino) was formed to investigate the extent of the damage, causes of the cracks and ways to retrofit the bridge. Intensive investigations, such as stress and vibration measurements and structural analysis by the finite element method, were carried out to find the best possible ways to retrofit the bridge. Based on such investigations the cracked parts were strengthened by high strength bolted splices, and truss members were added

to stiffen all diaphragms and every other cross ribs. The rehabilitation scheme seemed successful, and no further fatigue damages were observed at these stiffened parts. However, recent inspection revealed that a few additional cracks were found at the diaphragm corners which were not retrofitted eight years ago, because no fatigue cracks were observed at that time.

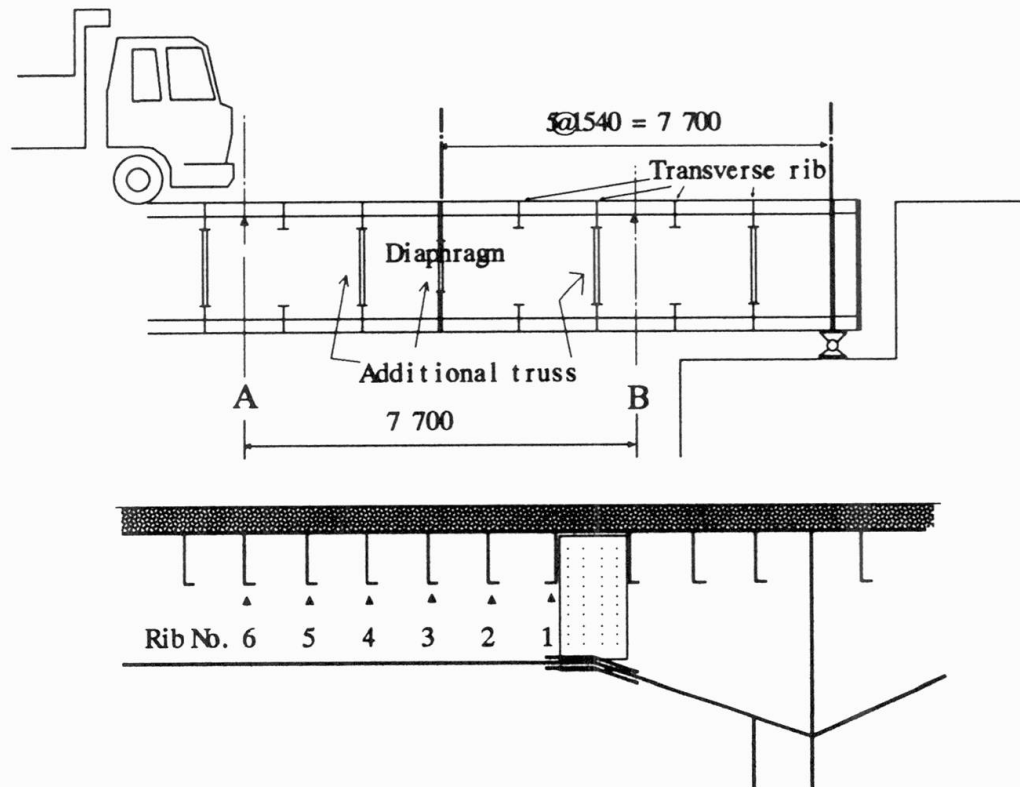
Fig. 2 Orthotropic steel deck of test bridge

The orthotropic steel deck of the box girder bridge is schematically shown in Figure 2. It has a 12 mm thick deck plate, stiffened longitudinally at every 300 mm with bulb plates (open ribs) of 180 mm wide and 9.5 mm thick. About 80 mm thick asphalt pavement is placed over the deck plate. Diaphragms are placed at every 7.7 m with four cross beams of which are 1.54 m apart between the diaphragms. As mentioned previously, the truss members were added to all diaphragms and every other cross ribs in order to stiffen them in 1988/89 retrofitting.

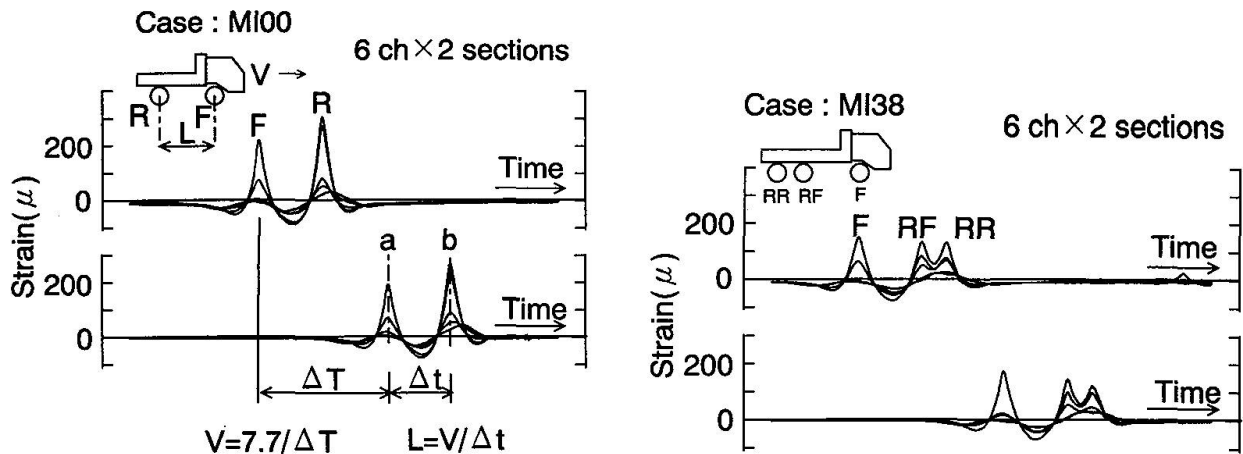
Fig. 3 Strain histories due to running of test trucks

- FEM analysis** : The finite element analysis was carried out for the orthotropic steel deck of interest to determine influence surfaces for all locations of strain gages, that were placed at the mid-span of the longitudinal ribs.
- Effect of tire loading** : Wheels with single tire and double tires with an unit weight were placed at different positions to calculate stress waves of the longitudinal ribs. Loading areas of the tires were determined according to JRA Specifications. Through such analysis it was determined to use six strain gages at two sections, A and B, near the supports, which were 7.7 m apart, as shown in Figure 2.
- Strain measurements** : Strain histories were recorded dynamically using Digital Data Recorder, and the data was transferred to a personal computer for further analyses. Typical strain recordings for 2-axle truck and 3-axle truck are shown in Figure 3.

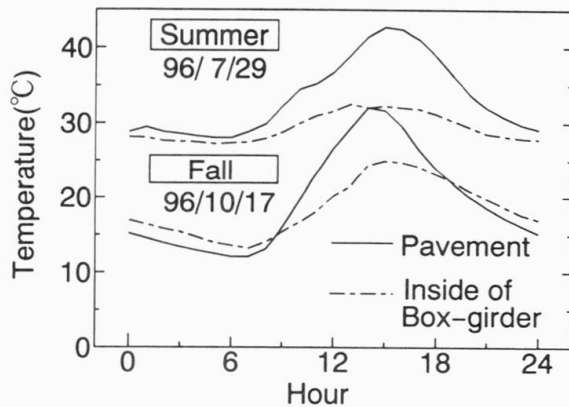
Fig. 5 Temperature of asphalt pavement

The first measurement was carried out in the end of July, 1996. It was the mid-summer in Nagoya and the temperature at the bottom of the asphalt pavement of the orthotropic deck was between 27 and 49, as shown in Figure 5. Two test trucks were used, as shown in Table 1. They were a 2-axle dump truck of 220 kN gross vehicle weight (GVW), and a 3-axle dump truck of 223 kN GVW. Drivers of the test trucks were asked to drive the trucks intentionally in the left, the center and the right sides of the mid-lane at different velocity. The test trucks ran with speed between 22 and 58 km/h over the test sections.

The measurement was once more carried out in the mid-October, 1996, when the temperature of the asphalt pavement was ranging between 12 and 32, as shown in Figure 5. A 3-axle truck of 199 kN, which ran over the test sections 12 times, was used to calibrate the results. The wheel loads of the test trucks were estimated using the same technique used in the summer experiments. The results are plotted in Figure 9. The average estimated wheel loads were about 5 percent more than the actual wheel loads

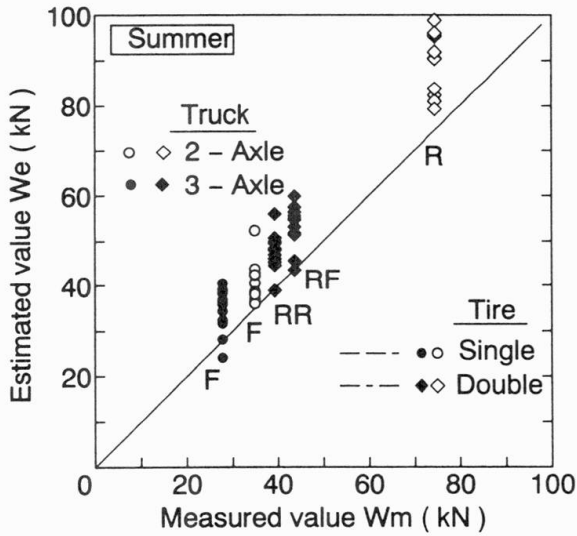
Fig. 6 Comparison of measured and estimated wheel loads of test trucks

From the recorded strains the wheel loads were estimated. The estimated wheel loads, W_e , are plotted against actual wheel loads, W_a , measured statically at a weigh station in Figure 6. It was found that W_e for the front and rear wheels were about 20 percent higher in average than W_a . The scatter of the estimated wheel loads was also observed owing to the scatter in the measured strain recording, which probably came from the vibration of the truck during the passage over the test sections.

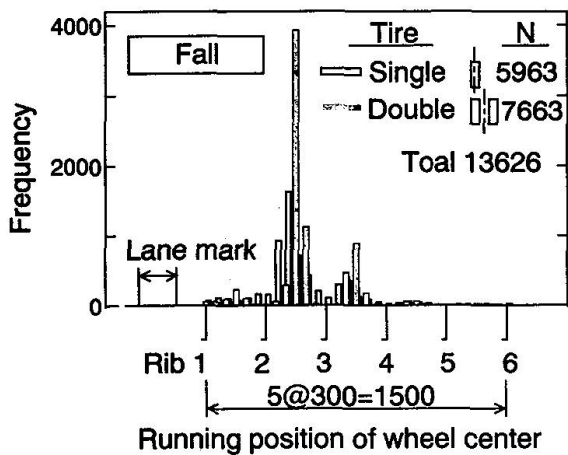
Fig. 11 Frequency of estimated wheel position

The running position of all wheels are plotted in Figure 11. The majority of the wheels passed between ribs 2 and 3, and some passed between ribs 3 and 4. In these areas ruts were observed, and the trucks seemed to run along such ruts.

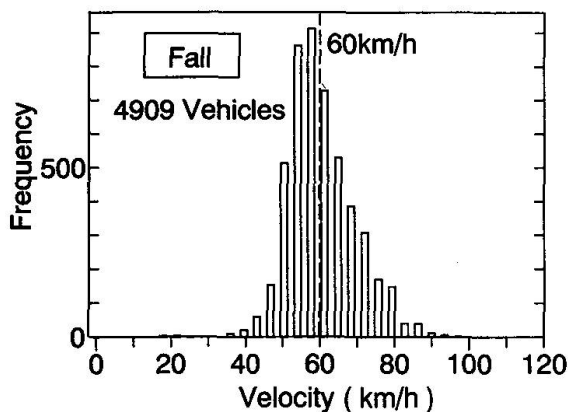
Fig.12 Frequency of vehicle velocity

The velocity of each truck in service was also computed. The distribution of the velocity is plotted in Figure 12. The average speed was about 57 km/h. Approximately 50 percent of the trucks ran with speeds over 60 km/h, while speed limit of this road was 60 km/h.

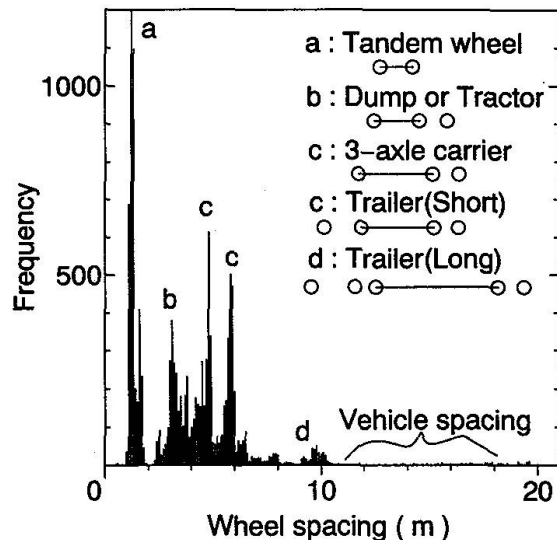
Fig.13 Frequency of estimated wheel spacing

Once the speed of each truck was known, one can compute the wheel spacing. The distribution of the computed wheel spacing is shown in Figure 13. There are several groups of wheel spacing. Compared with the configuration of the trucks currently used in Japan, the wheel spacing seems to correspond to (a) tandem wheels (about 1.3 m), (b) main spacing of dump trucks or tractors, (c) main spacing of 3-axle trucks or short trailer trucks, and (d) main spacing of long trailer trucks.
