Zeitschrift: IABSE reports = Rapports AIPC = IVBH Berichte
Band: 76 (1997)

Artikel: Stress measurement and repair of a fatigue cracked box girder bridge
Autor: Yamada, Kentaro / Ojio, Tatsuya / Kainuma, Shigenobu
DOI: <https://doi.org/10.5169/seals-57469>

Stress Measurement and Repair of a Fatigue Cracked Box Girder Bridge

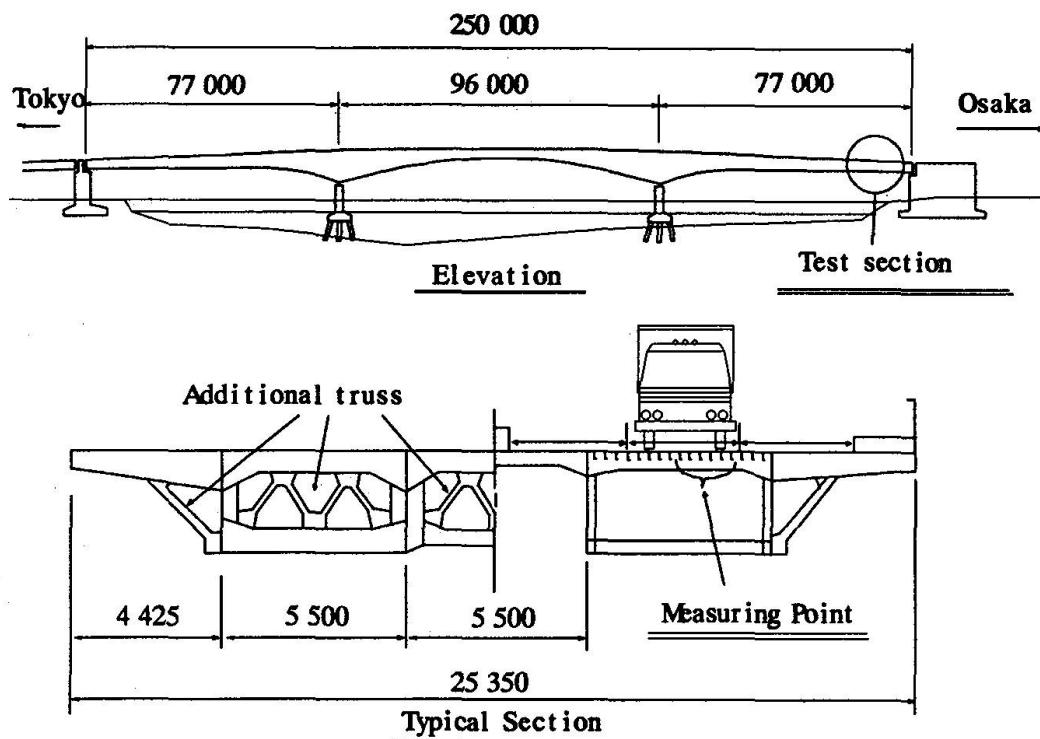
Fig. 1 Orthotropic steel deck bridge

After about 25 years in service, fatigue cracks were found at corners of diaphragms and at sole plates of supports. A committee (Chairman; Prof. Nishino) was formed to investigate the extent of the damage, causes of the cracks and ways to retrofit the bridge. Intensive investigations, such as stress and vibration measurements and structural analysis by the finite element method, were carried out to find the best possible ways to retrofit the bridge. Based on such investigations the cracked parts were strengthened by high strength bolted splices, and truss members were added

to stiffen all diaphragms and every other cross ribs. The rehabilitation scheme seemed successful, and no further fatigue damages was observed at these stiffened parts. However, recent inspection revealed that a few additional cracks were found at the diaphragm corners which were not retrofitted eight years ago, because no fatigue cracks were observed at that time.

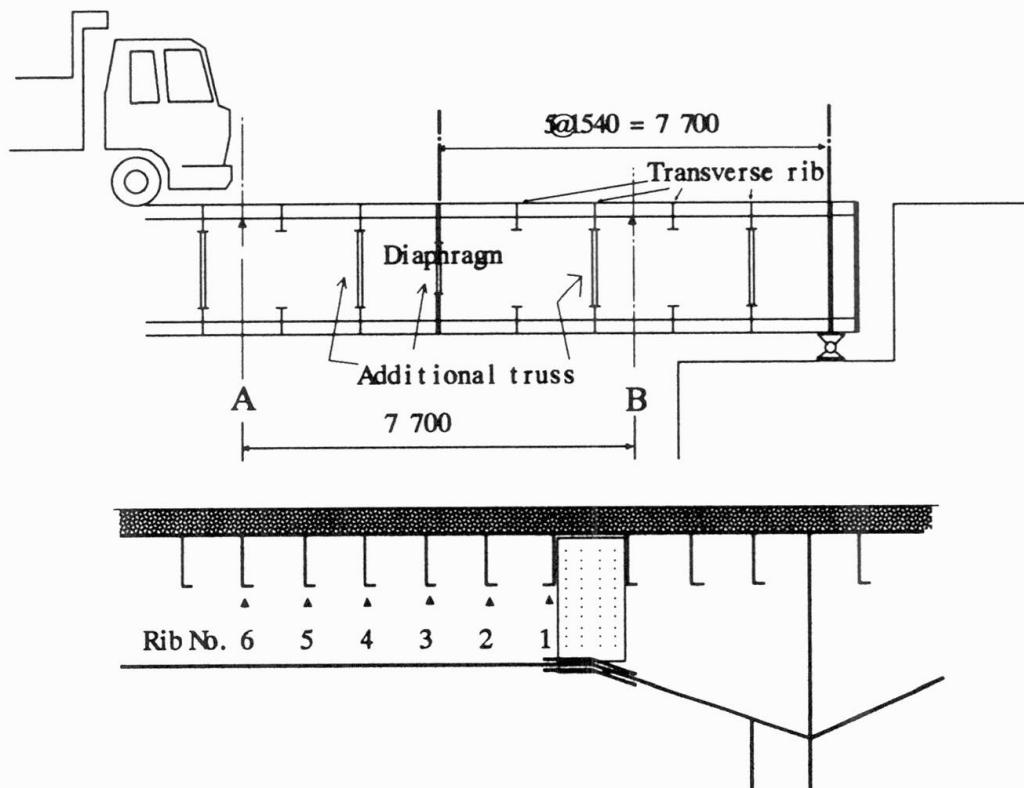
Fig. 2 Orthotropic steel deck of test bridge

The orthotropic steel deck of the box girder bridge is schematically shown in Figure 2. It has a 12 mm thick deck plate, stiffened longitudinally at every 300 mm with bulb plates (open ribs) of 180 mm wide and 9.5 mm thick. About 80 mm thick asphalt pavement is placed over the deck plate. Diaphragms are placed at every 7.7 m with four cross beams of which are 1.54 m apart between the diaphragms. As mentioned previously, the truss members were added to all diaphragms and every other cross ribs in order to stiffen them in 1988/89 retrofitting.

b) **Effect of tire loading** : Wheels with single tire and double tires with an unit weight were placed at different positions to calculate stress waves of the longitudinal ribs. Loading areas of the tires were determined according to JRA Specifications. Through such analysis it was determined to use six strain gages at two sections, A and B, near the supports, which were 7.7 m apart, as shown in Figure 2.

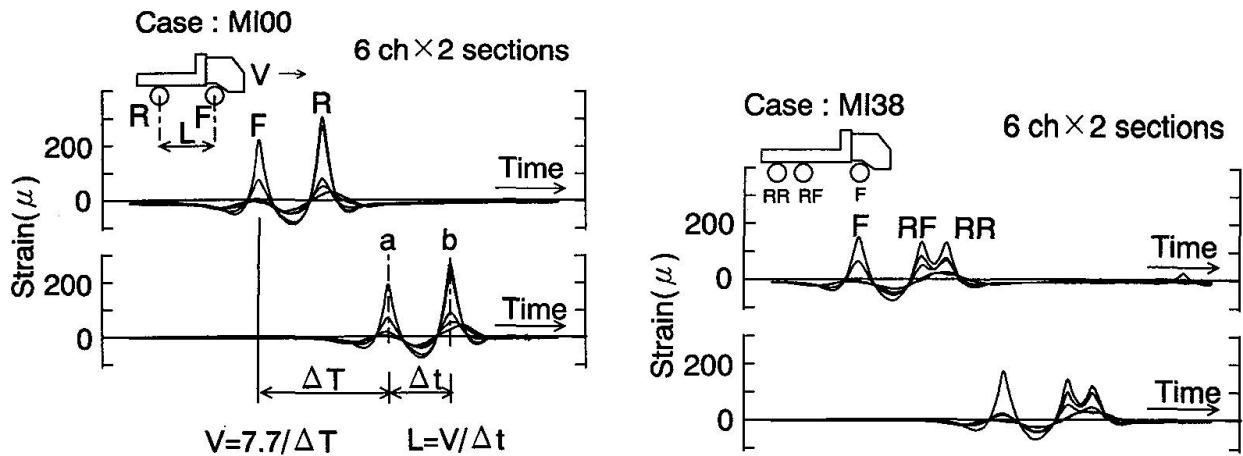
Fig. 3 Strain histories due to running of test trucks

c) **Strain measurements** : Strain histories were recorded dynamically using Digital Data Recorder, and the data was transferred to a personal computer for further analyses. Typical strain recordings for 2-axle truck and 3-axle truck are shown in Figure 3.

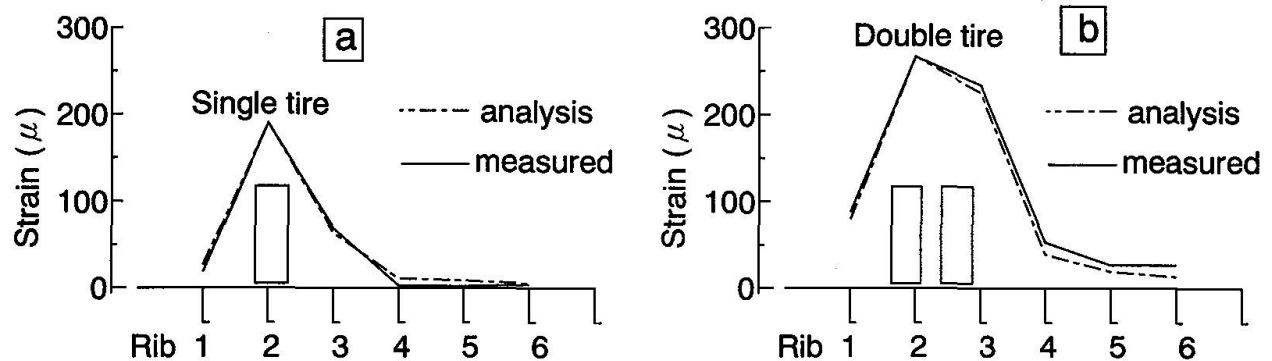
Fig. 4 Stress distribution of six ribs at a and b

d) **Tire types and their positions** : From six strain recordings peak strains corresponding to wheels passing on the mid-span of the ribs were determined first. Then, three largest strain recordings were picked up, and tire position was determined. Single or double tires was also clarified from the shape of the strain waves, as shown in Figure 4.

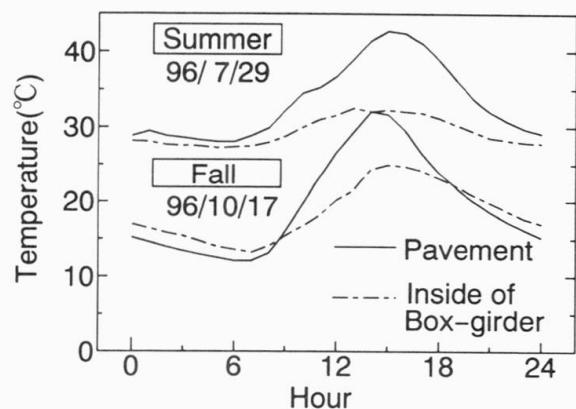
Fig. 5 Temperature of asphalt pavement

The first measurement was carried out in the end of July, 1996. It was the mid-summer in Nagoya and the temperature at the bottom of the asphalt pavement of the orthotropic deck was between 27 and 49, as shown in Figure 5. Two test trucks were used, as shown in Table 1. They were a 2-axle dump truck of 220 kN gross vehicle weight (GVW), and a 3-axle dump truck of 223 kN GVW. Drivers of the test trucks were asked to drive the trucks intentionally in the left, the center and the right sides of the mid-lane at different velocity. The test trucks ran with speed between 22 and 58 km/h over the test sections.

The measurement was once more carried out in the mid-October, 1996, when the temperature of the asphalt pavement was ranging between 12 and 32, as shown in Figure 5. A 3-axle truck of 199 kN, which ran over the test sections 12 times, was used to calibrate the results. The wheel loads of the test trucks were estimated using the same technique used in the summer experiments. The results are plotted in Figure 9. The average estimated wheel loads were about 5 percent more than the actual wheel loads

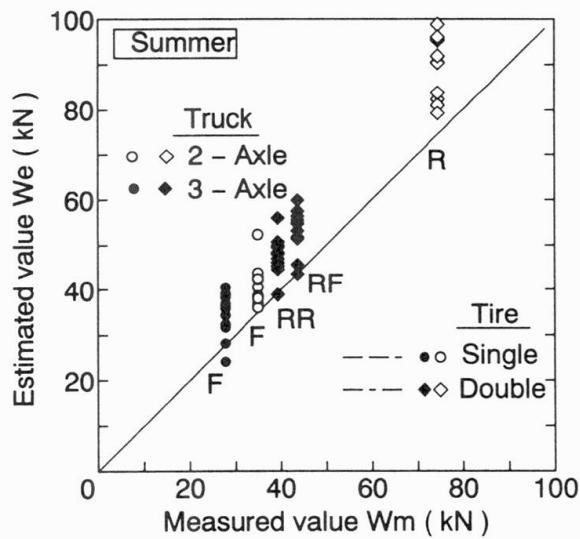
Fig. 6 Comparison of measured and estimated wheel loads of test trucks

From the recorded strains the wheel loads were estimated. The estimated wheel loads, We , are plotted against actual wheel loads, We , measured statically at a weigh station in Figure 6. It was found that We for the front and rear wheels were about 20 percent higher in average than We . The scatter of the estimated wheel loads was also observed owing to the scatter in the measured strain recording, which probably came from the vibration of the truck during the passage over the test sections.

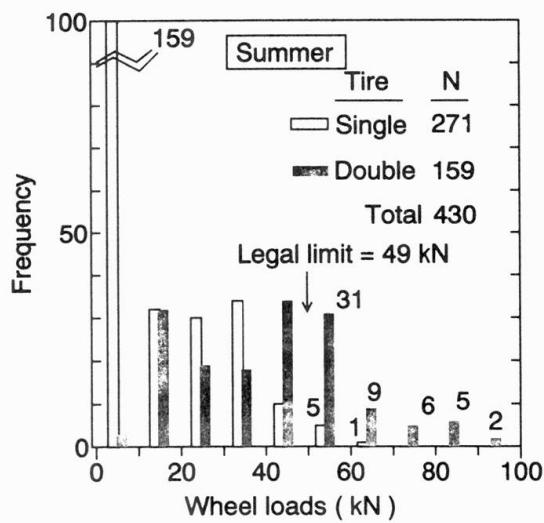
Fig. 7 Frequency of estimated wheel load position

The wheel loads of the passing trucks of various types were also estimated. The result is plotted in Figure 7. The wheel loads of these trucks were not known, but the estimated wheel loads for the front wheel (single tire) are ranging from 4.9 kN to 64 kN. The maximum wheel loads showed scatter from 4.9 kN to 98 kN. The legal limit of the wheel loads was 49 kN in Japan. From the measured strain the wheel positions were also determined through the analysis and plotted in Figure 8. For 312 wheel loads heavier than 4.9 kN the wheel positions were between the ribs 1 and 5, which were 1.2 m apart. The majority of the wheels passed between the ribs 2 and 3.

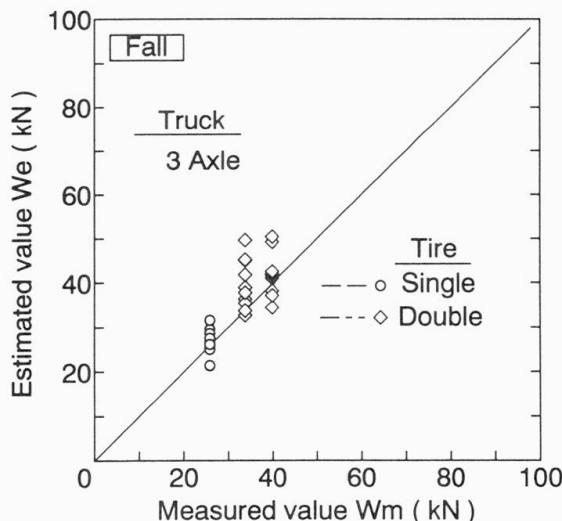
Fig. 9 The comparison of measured and estimated wheel loads of test trucks

The difference in the ratio of the average estimated wheel loads to the statically measured ones between the summer and the fall experiments was about 15 points. In this period supports near the section B was temporarily jacked up for replacement works from metal shoes to rubber ones. The effect of such change in structural details on the test results is unknown at this moment. The increase in the stiffness of the asphalt pavement above the orthotropic deck may also attribute to the

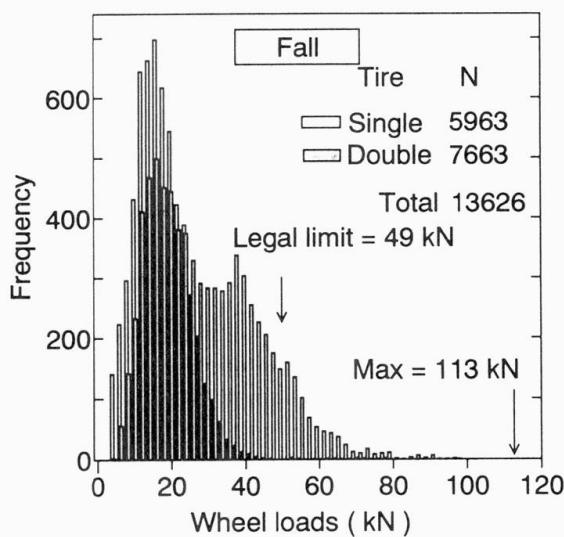
Fig. 10 Frequency of estimated wheel load

The estimated wheel loads, W_e , are summarized in Figure 10. Note that these wheel loads are for the trucks in which one of the strain recordings exceeded the trigger level of 50 micro-strain. The maximum wheel load observed during the 12-hr measurement was 113 kN. The frequency distribution of wheels with double tires shows two peaks, one around 39 kN, and the other at about 15 kN. The latter seemed the wheel loads when the truck were not loaded.

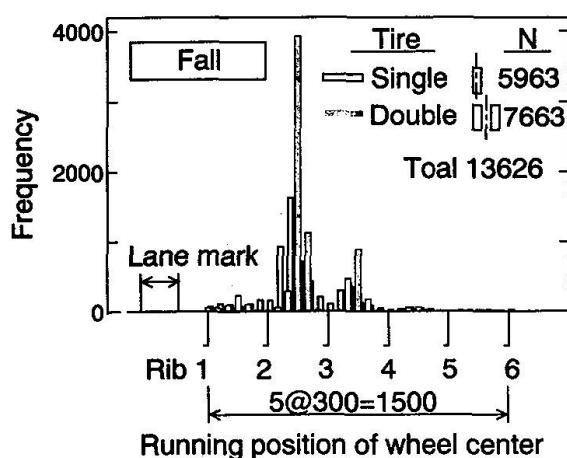
Fig. 11 Frequency of estimated wheel position

The running position of all wheels are plotted in Figure 11. The majority of the wheels passed between ribs 2 and 3, and some passed between ribs 3 and 4. In these areas ruts were observed, and the trucks seemed to run along such ruts.

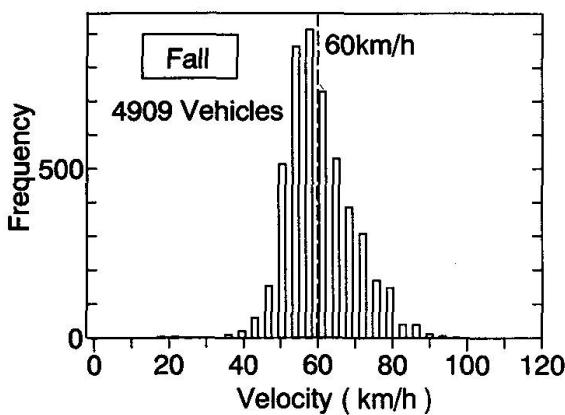
Fig.12 Frequency of vehicle velocity

The velocity of each truck in service was also computed. The distribution of the velocity is plotted in Figure 12. The average speed was about 57 km/h. Approximately 50 percent of the trucks ran with speeds over 60 km/h, while speed limit of this road was 60 km/h.

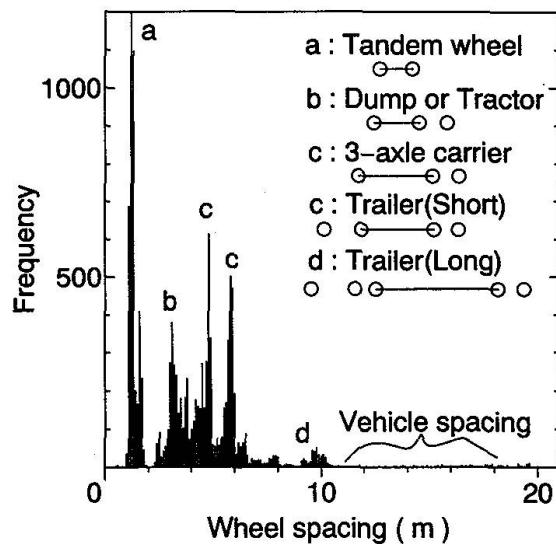
Fig.13 Frequency of estimated wheel spacing

Once the speed of each truck was known, one can compute the wheel spacing. The distribution of the computed wheel spacing is shown in Figure 13. There are several groups of wheel spacing. Compared with the configuration of the trucks currently used in Japan, the wheel spacing seems to correspond to (a) tandem wheels (about 1.3 m), (b) main spacing of dump trucks or tractors, (c) main spacing of 3-axle trucks or short trailer trucks, and (d) main spacing of long trailer trucks.
