Artikel: Stress measurement and repair of a fatigue cracked box girder bridge

Stress Measurement and Repair of a Fatigue Cracked Box Girder Bridge

A three span continuous box girder bridge in Nagoya was subjected to very heavy traffic, amounting to over 55,000 vehicles per day on three lanes and with about 50 percent trucks. In 1988 fatigue cracks were observed at diaphragm corners after 20 years of service. The fatigue damaged diaphragm corners were repaired by high strength bolted splices. Truss members were also added to stiffen the diaphragms and the cross beams. In the summer and the fall of 1996 stress measurements were carried out to investigate a method for measuring truck axle weights and to carry out a fatigue assessment of the orthotropic steel decks and diaphragm corners. In this paper the case history of the box girder bridge is summarized and the preliminary results of stress measurement are presented.

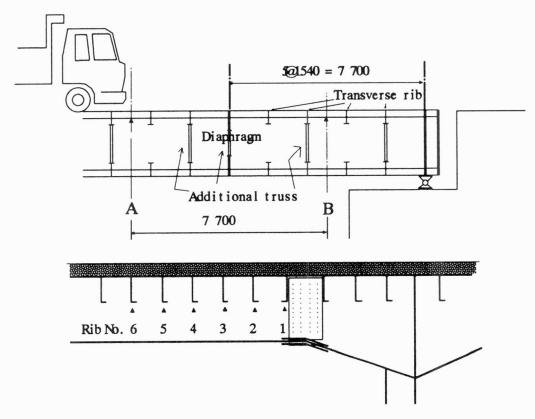
Fig. 2 Orthotropic steel deck of test bridge

The orthotropic steel deck of the box girder bridge is schematically shown in Figure 2. It has a 12 mm thick deck plate, stiffened longitudinally at every 300 mm with bulb plates (open ribs) of 180 mm wide and 9.5 mm thick. About 80 mm thick asphalt pavement is placed over the deck plate. Diaphragms are placed at every 7.7 m with four cross beams of which are 1.54 m apart between the diaphragms. As mentioned previously, the truss members were added to all diaphragms and every other cross ribs in order to stiffen them in 1988/89 retrofitting.

- b) **Effect of tire loading**: Wheels with single tire and double tires with an unit weight were placed at different positions to calculate stress waves of the longitudinal ribs. Loading areas of the tires were determined according to JRA Specifications. Through such analysis it was determined to use six strain gages at two sections, A and B, near the supports, which were 7.7 m apart, as shown in Figure 2.

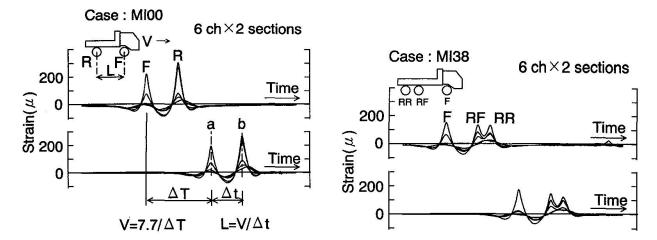
Fig. 3 Strain histories due to running of test trucks

- c) **Strain measurements**: Strain histories were recorded dynamically using Digital Data Recorder, and the data was transferred to a personal computer for further analyses. Typical strain recordings for 2-axle truck and 3-axle truck are shown in Figure 3.

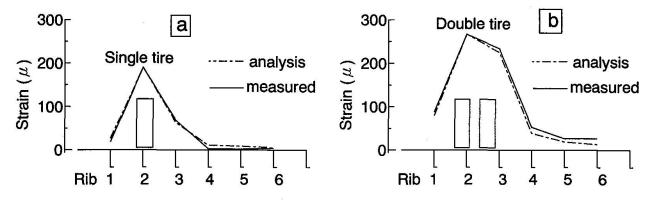
Fig. 4 Stress distribution of six ribs at a and b

d) Tire types and their positions: From six strain recordings peak strains corresponding to wheels passing on the mid-span of the ribs were determined first. Then, three largest strain recordings were picked up, and tire position was determined. Single or double tires was also clarified from the shape of the strain waves, as shown in Figure 4.

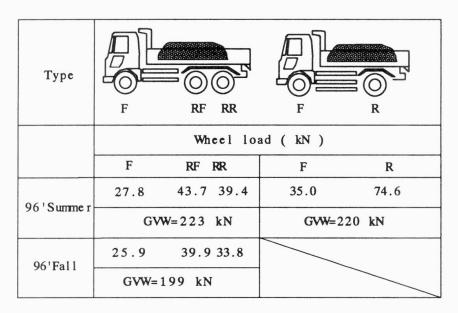
Table 1 Wheel loads of test trucks

The first measurement was carried out in the end of July, 1996. It was the mid-summer in Nagoya and the temperature at the bottom of the asphalt pavement of the orthotropic deck was between 27 and 49, as shown in Figure 5. Two test trucks were used, as shown in Table 1. They were a 2-axle dump truck of 220 kN gross vehicle weight (GVW), and a 3-axle dump truck of 223 kN GVW. Drivers of the test trucks were asked to drive the trucks intentionally in the left, the center and the right sides of the mid-lane at different velocity. The test trucks ran with speed between 22 and 58 km/h over the test sections.

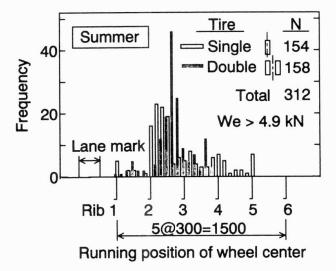
Fig. 8 Frequency of estimated wheel

The wheel loads of the passing trucks of various types were also estimated. The result is plotted in Figure 7. The wheel loads of these trucks were not known, but the estimated wheel loads for the front wheel (single tire) are ranging from 4.9 kN to 64 kN. The maximum wheel loads showed scatter from 4.9 kN to 98 kN. The legal limit of the wheel loads was 49 kN in Japan. From the measured strain the wheel positions were also determined through the analysis and plotted in Figure 8. For 312 wheel loads heavier than 4.9kN the wheel positions were between the ribs 1 and 5, which were 1.2 m apart. The majority of the wheels passed between the ribs 2 and 3.
