Artikel: Stress measurement and repair of a fatigue cracked box girder bridge
Autor: Yamada, Kentaro / Ojio, Tatsuya / Kainuma, Shigenobu
DOI: <https://doi.org/10.5169/seals-57469>

Stress Measurement and Repair of a Fatigue Cracked Box Girder Bridge

A three span continuous box girder bridge in Nagoya was subjected to very heavy traffic, amounting to over 55,000 vehicles per day on three lanes and with about 50 percent trucks. In 1988 fatigue cracks were observed at diaphragm corners after 20 years of service. The fatigue damaged diaphragm corners were repaired by high strength bolted splices. Truss members were also added to stiffen the diaphragms and the cross beams. In the summer and the fall of 1996 stress measurements were carried out to investigate a method for measuring truck axle weights and to carry out a fatigue assessment of the orthotropic steel decks and diaphragm corners. In this paper the case history of the box girder bridge is summarized and the preliminary results of stress measurement are presented.

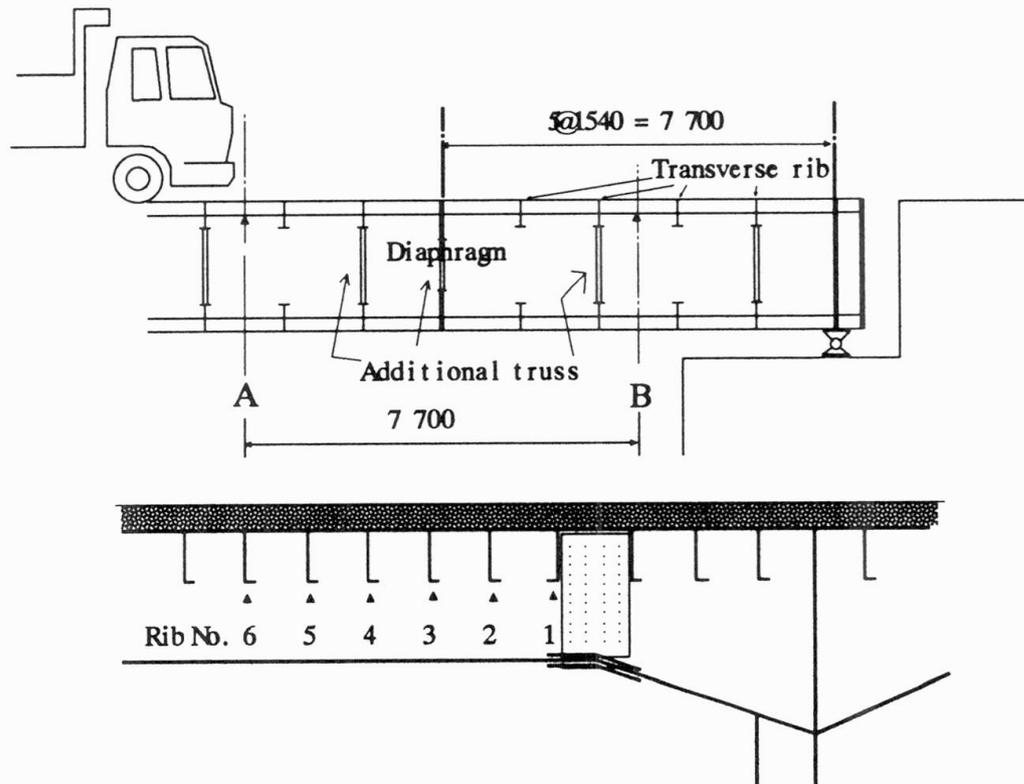
Fig. 2 Orthotropic steel deck of test bridge

The orthotropic steel deck of the box girder bridge is schematically shown in Figure 2. It has a 12 mm thick deck plate, stiffened longitudinally at every 300 mm with bulb plates (open ribs) of 180 mm wide and 9.5 mm thick. About 80 mm thick asphalt pavement is placed over the deck plate. Diaphragms are placed at every 7.7 m with four cross beams of which are 1.54 m apart between the diaphragms. As mentioned previously, the truss members were added to all diaphragms and every other cross ribs in order to stiffen them in 1988/89 retrofitting.

- b) **Effect of tire loading** : Wheels with single tire and double tires with an unit weight were placed at different positions to calculate stress waves of the longitudinal ribs. Loading areas of the tires were determined according to JRA Specifications. Through such analysis it was determined to use six strain gages at two sections, A and B, near the supports, which were 7.7 m apart, as shown in Figure 2.

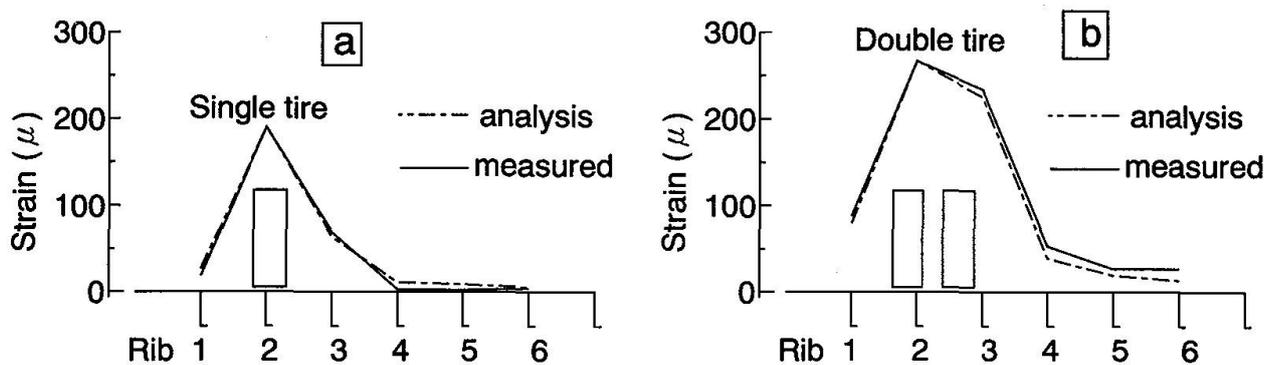
Fig. 4 Stress distribution of six ribs at a and b

d) **Tire types and their positions** : From six strain recordings peak strains corresponding to wheels passing on the mid-span of the ribs were determined first. Then, three largest strain recordings were picked up, and tire position was determined. Single or double tires was also clarified from the shape of the strain waves, as shown in Figure 4.

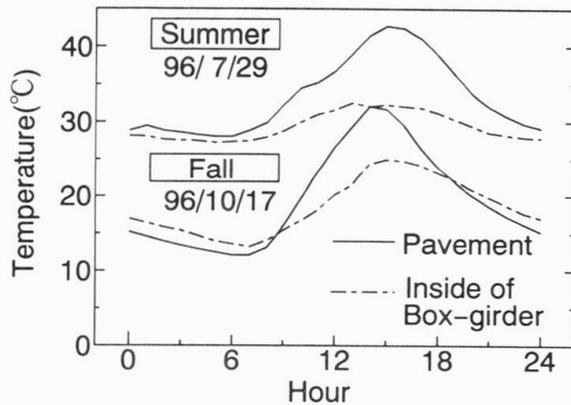
Fig. 5 Temperature of asphalt pavement

The first measurement was carried out in the end of July, 1996. It was the mid-summer in Nagoya and the temperature at the bottom of the asphalt pavement of the orthotropic deck was between 27 and 49, as shown in Figure 5. Two test trucks were used, as shown in Table 1. They were a 2-axle dump truck of 220 kN gross vehicle weight (GVW), and a 3-axle dump truck of 223 kN GVW. Drivers of the test trucks were asked to drive the trucks intentionally in the left, the center and the right sides of the mid-lane at different velocity. The test trucks ran with speed between 22 and 58 km/h over the test sections.

The measurement was once more carried out in the mid-October, 1996, when the temperature of the asphalt pavement was ranging between 12 and 32, as shown in Figure 5. A 3-axle truck of 199 kN, which ran over the test sections 12 times, was used to calibrate the results. The wheel loads of the test trucks were estimated using the same technique used in the summer experiments. The results are plotted in Figure 9. The average estimated wheel loads were about 5 percent more than the actual wheel loads

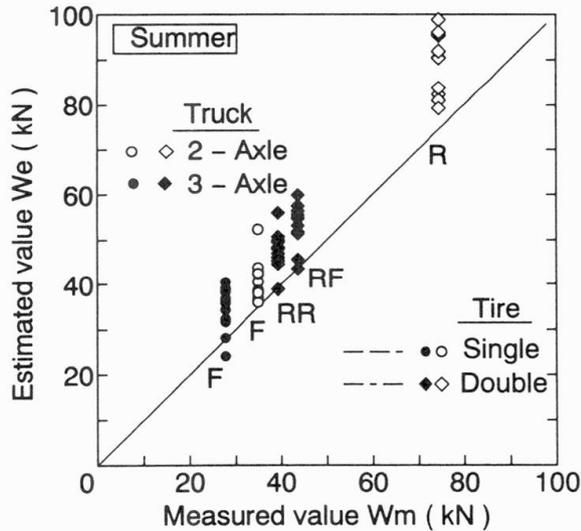
Fig. 6 Comparison of measured and estimated wheel loads of test trucks

From the recorded strains the wheel loads were estimated. The estimated wheel loads, W_e , are plotted against actual wheel loads, W_a , measured statically at a weigh station in Figure 6. It was found that W_e for the front and rear wheels were about 20 percent higher in average than W_a . The scatter of the estimated wheel loads was also observed owing to the scatter in the measured strain recording, which probably came from the vibration of the truck during the passage over the test sections.

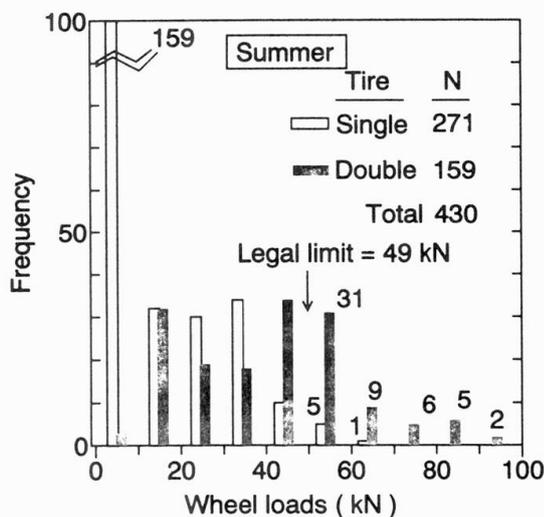
Fig. 7 Frequency of estimated wheel load position

The wheel loads of the passing trucks of various types were also estimated. The result is plotted in Figure 7. The wheel loads of these trucks were not known, but the estimated wheel loads for the front wheel (single tire) are ranging from 4.9 kN to 64 kN. The maximum wheel loads showed scatter from 4.9 kN to 98 kN. The legal limit of the wheel loads was 49 kN in Japan. From the measured strain the wheel positions were also determined through the analysis and plotted in Figure 8. For 312 wheel loads heavier than 4.9kN the wheel positions were between the ribs 1 and 5, which were 1.2 m apart. The majority of the wheels passed between the ribs 2 and 3.

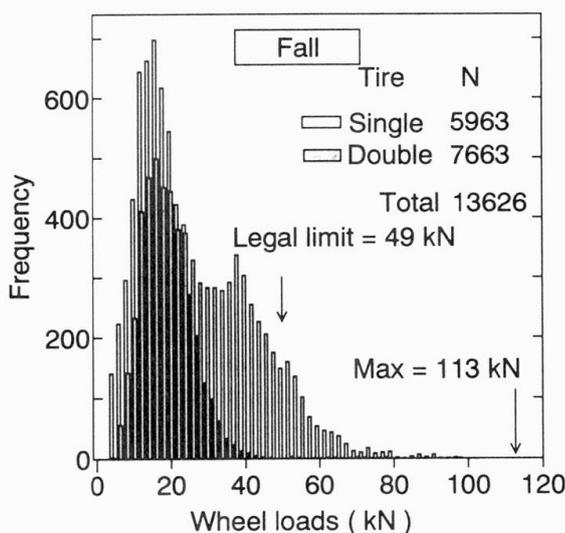
Fig. 10 Frequency of estimated wheel load

The estimated wheel loads, W_e , are summarized in Figure 10. Note that these wheel loads are for the trucks in which one of the strain recordings exceeded the trigger level of 50 micro-strain. The maximum wheel load observed during the 12-hr measurement was 113 kN. The frequency distribution of wheels with double tires shows two peaks, one around 39 kN, and the other at about 15 kN. The latter seemed the wheel loads when the truck were not loaded.

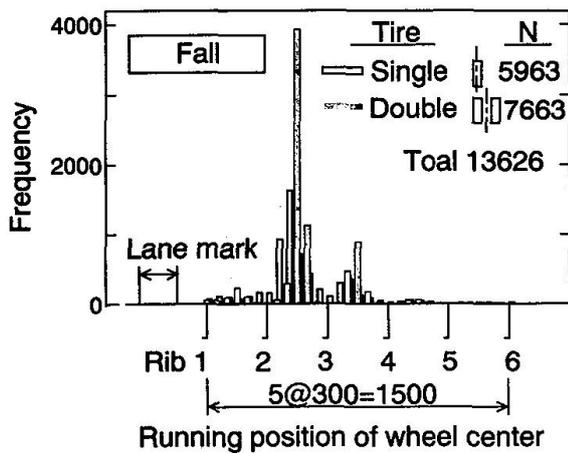
Fig. 11 Frequency of estimated wheel position

The running position of all wheels are plotted in Figure 11. The majority of the wheels passed between ribs 2 and 3, and some passed between ribs 3 and 4. In these areas ruts were observed, and the trucks seemed to run along such ruts.

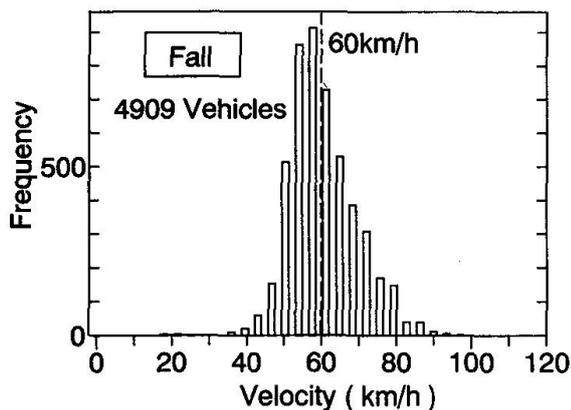
Fig.12 Frequency of vehicle velocity

The velocity of each truck in service was also computed. The distribution of the velocity is plotted in Figure 12. The average speed was about 57 km/h. Approximately 50 percent of the trucks ran with speeds over 60 km/h, while speed limit of this road was 60 km/h.

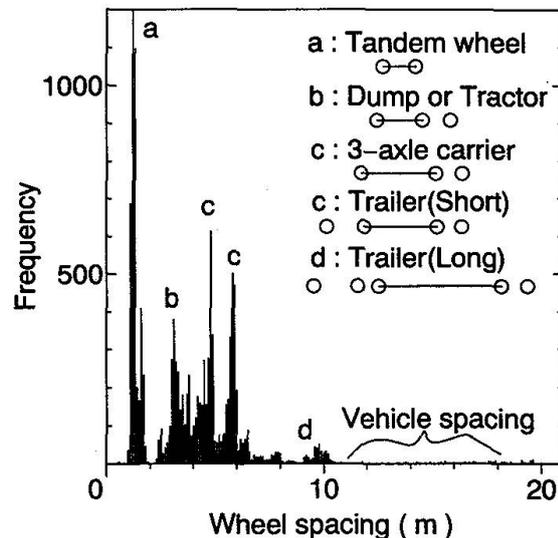
Fig.13 Frequency of estimated wheel spacing

Once the speed of each truck was known, one can compute the wheel spacing. The distribution of the computed wheel spacing is shown in Figure 13. There are several groups of wheel spacing. Compared with the configuration of the trucks currently used in Japan, the wheel spacing seems to correspond to (a) tandem wheels (about 1.3 m), (b) main spacing of dump trucks or tractors, (c) main spacing of 3-axle trucks or short trailer trucks, and (d) main spacing of long trailer trucks.
