# Theme E: Fatigue testing

Zeitschrift: **IABSE reports = Rapports AIPC = IVBH Berichte**

Band (Jahr): **76 (1997)**

## Repair Techniques for the Rehabilitation of Fatigue Cracked Orthotropic Steel Bridges

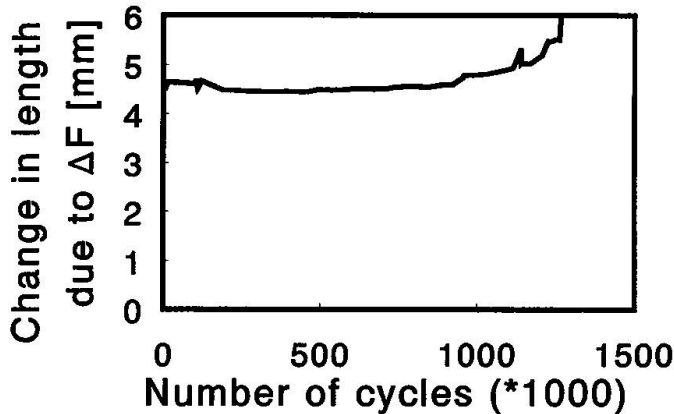
The recording of the change in distance between sockets as the test load cycled from the minimum to the maximum load indicated an increase in flexibility at the end of the test due to broken and pulled-out wires (see Figure 4). The theoretical change in length due to the loss of cable section is approximately 5 mm. This agrees well with the measured value of between 4.5 and 5.0 mm.

*Fig. 4 Change in length due to load range as a function of the number of cycles*

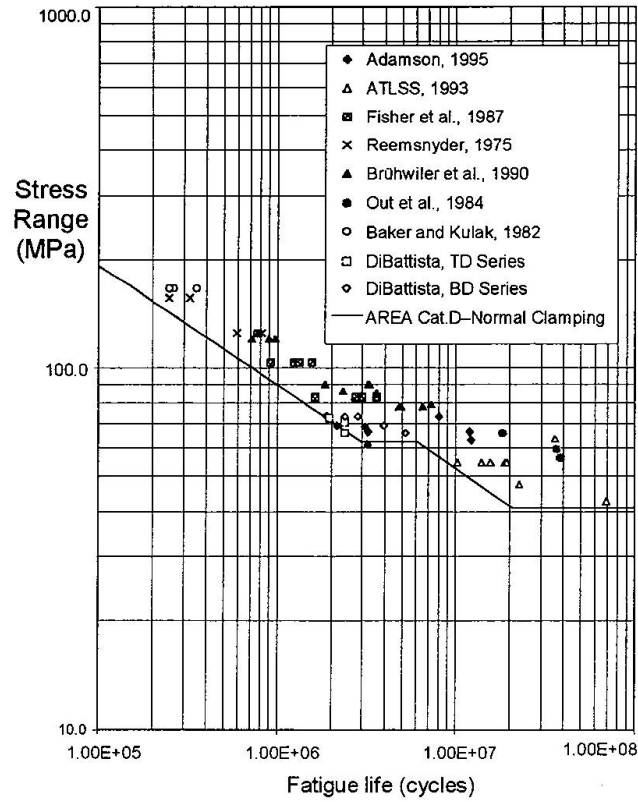
Fig. 5 Test Results + AREA, Normal Clamping
