Zeitschrift: IABSE reports = Rapports AIPC = IVBH Berichte
Band: 76 (1997)

Rubrik: Theme E: Fatigue testing

Fatigue Testing

Repair Techniques for the Rehabilitation of Fatigue Cracked Orthotropic Steel Bridges

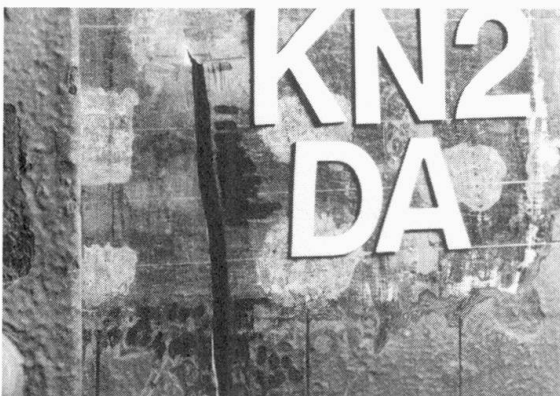
Fig. 4 Detail of crack tip in a web plate

In the **plate girder** test series (mild steel, 1906, Kn), all cracks initiated in the cover plate, sandwiched between angles and additional cover plates. Cracks were found after deflection and strains increased or when the crack was long enough to reach the edge of the sheet plate. When cracks reached the edge, they were only visible when the girder was loaded. All tests were continued to find out if crack growth became unstable. The result was plastification at the crack tip and crack dividing into two tips, but no unstable growth. In one of these tests the crack tip in the web plate had been cooled down to -30°C on both sides of the web plate. The crack tip detail is shown in Figure 4.
