Zeitschrift: IABSE reports = Rapports AIPC = IVBH Berichte
Band: 76 (1997)

Rubrik: Theme E: Fatigue testing

Repair Techniques for the Rehabilitation of Fatigue Cracked Orthotropic Steel Bridges

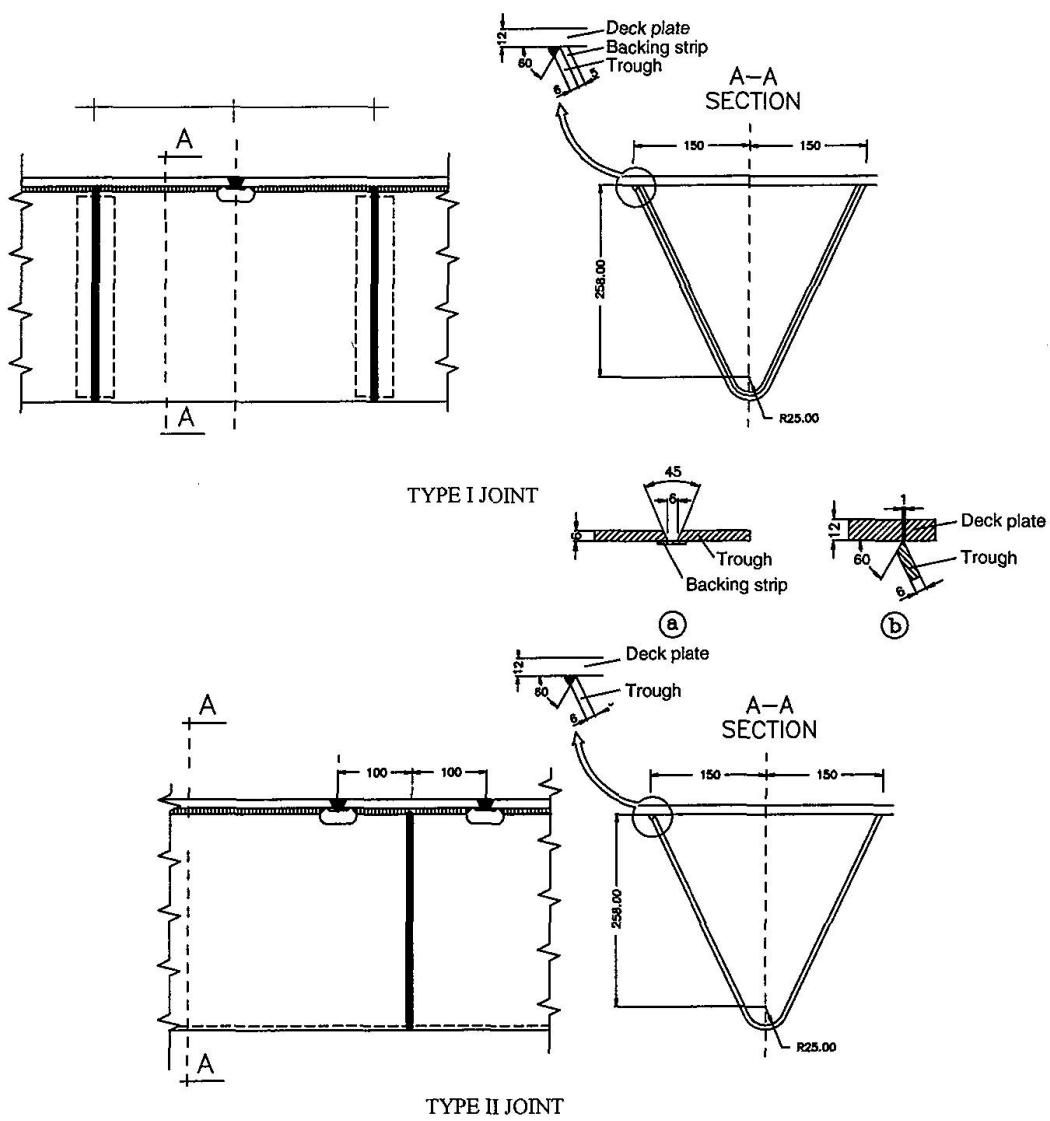
Fig. 1 Stiffener to stiffener connections

In the framework of the studies carried out on the virgin connections, the Authors [1], [2] have investigated two types of stiffener to stiffener welded connections, indicated as type I and type II joint in figure 1.

The R2 repair of fatigue cracks, which is especially conceived for strengthening of type I stiffener to stiffener connections (see fig. 1), can be carried out according the following sequence, in such a way that the final geometry shown in fig. 4 is obtained:

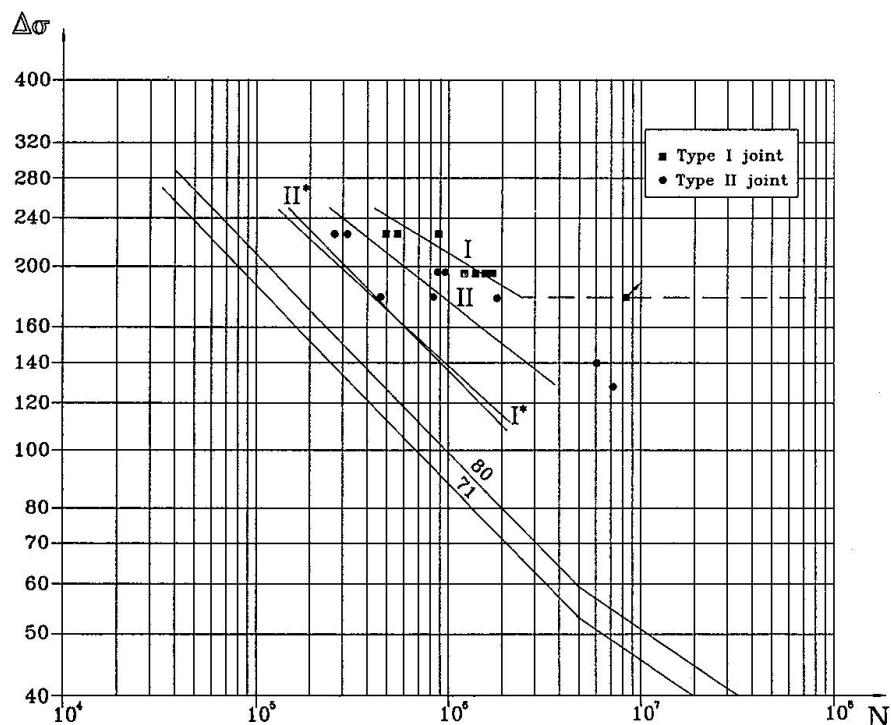
Fig. 2 Fatigue test results on stiffener to stiffener connections

The results of constant amplitude fatigue tests, carried out on real scale specimens on a three points bending scheme, are reported in table I and plotted in the S-N diagram of fig.2, in which are reported also the characteristic S-N curves for class 71 and class 80 details of EC3 and the mean S-N curves obtained on tensile specimens with butt welds on backing strip (I* curve) and full penetration welds (II* curve).

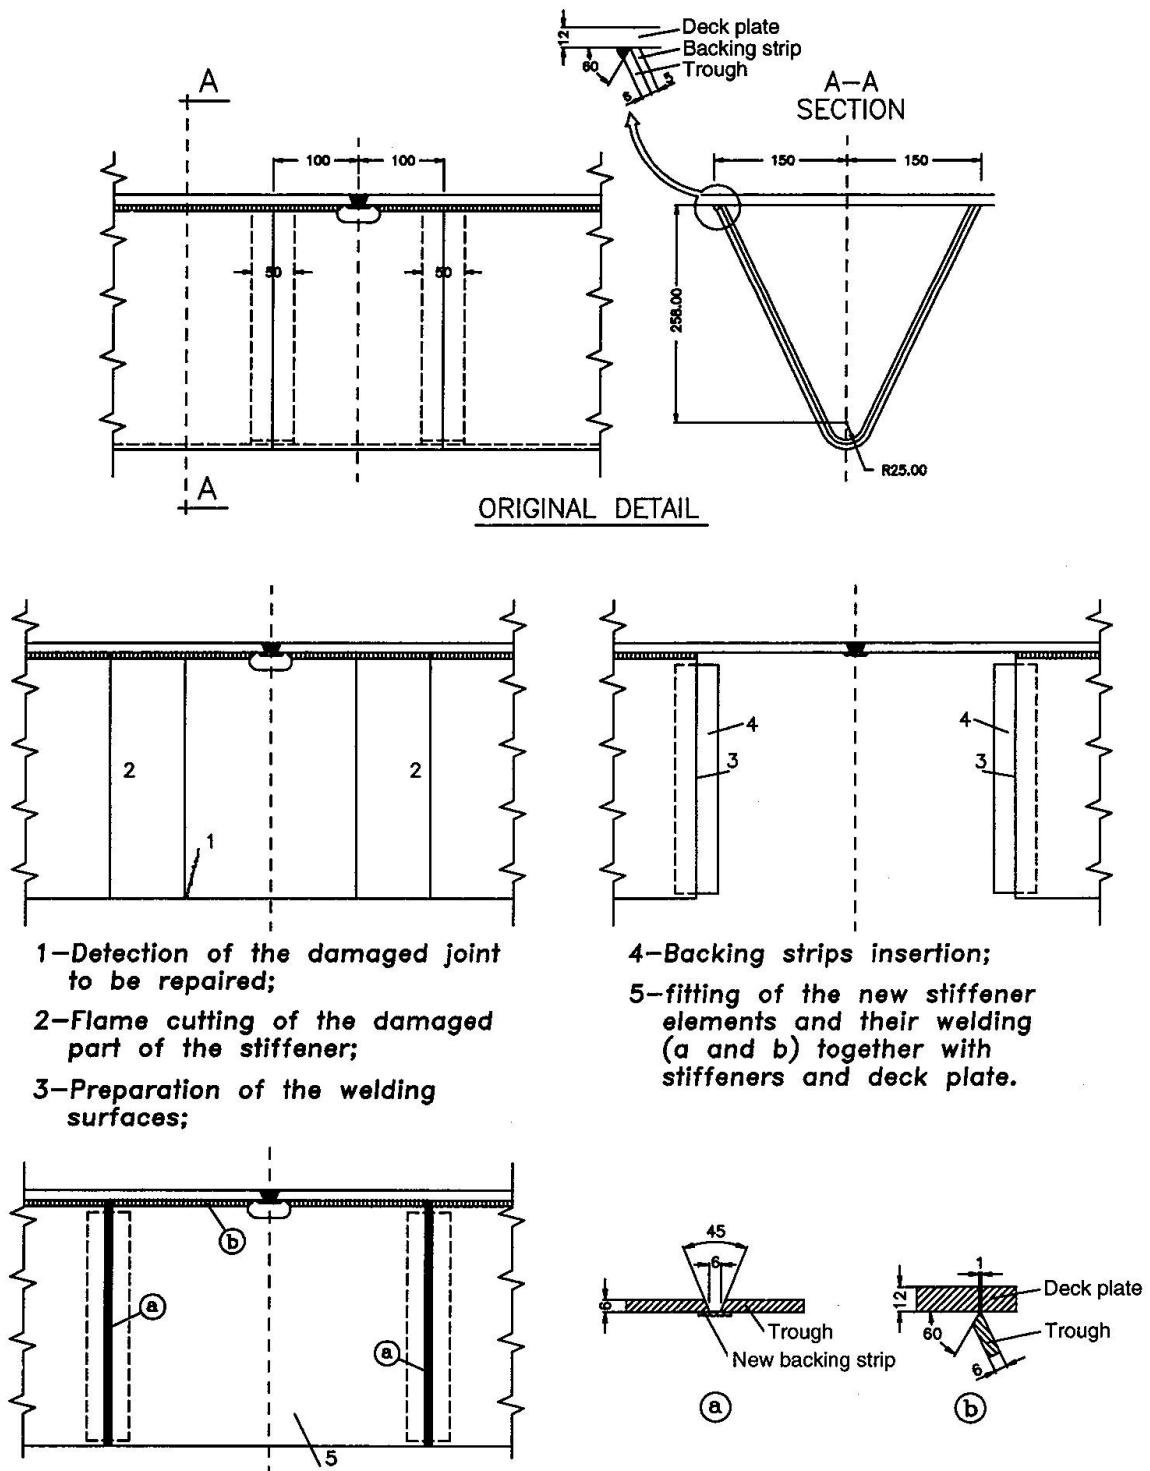
Fig. 3 R1 repair

The R1 repair of fatigue cracks in stiffener to stiffener connections can be applied to different joint types and requires the following operating sequence leading to a type I joint (fig. 3):

- 1) Detection of the damaged joints to be repaired.
- 2) Flame cutting of the damaged part of the stiffener.
- 3) Preparation of the welding surfaces (according to fig. 3).
- 4) Backing strips insertion.
- 5) Fitting of the new stiffener elements and completion, in overhead position, of the welds between the stiffeners and between the stiffeners and the deck plate. (The welders must satisfy the requirements of AWS welder qualification tests for overhead position).
- 6) Visual, liquid-penetrating and magnetic-particle inspections of the welds and, if necessary, their repair.

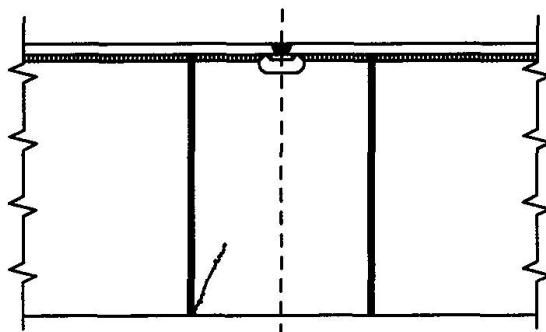
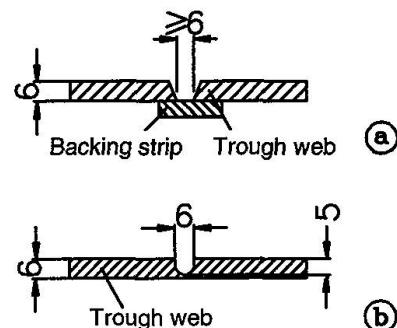
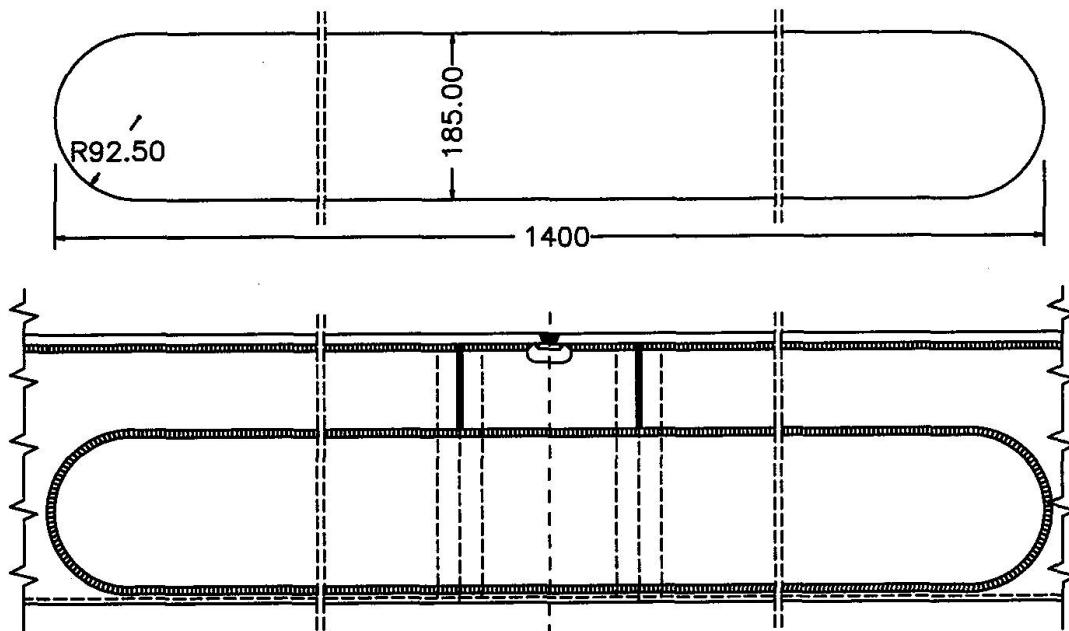
Fig. 4 R2 repair

1- Determination of crack extension and location in the whole joint by means of visual, liquid penetrating and magnetic particle inspections.

2- Crack milling. For the part of the crack located over the backing strip the depth of the milling must be equal to 6 mm in order to reach the backing strip; the minimum width must be equal to 6 mm, namely equal to the former root gap (a), while for the part of the crack located out of the backing strip the milling will be carried out in order to obtain an U-groove edge preparation, 6 mm wide and 5 mm deep (b).

3- Milling of the apex of the no-cracked welds.

7- Visual, liquid penetrating and magnetic-particle inspections of the welds and, if necessary, execution of the repair.

8- Preparation of the coverplates, 6 mm thick. The radius of the curved edges is equal to 92.5 cm while the coverplate dimensions are 1400x185 mm

9- Fillet welding of the coverplates to the webs of the stiffener: the fillet side is equal to 6 mm. The fillet runs continuously around the coverplate.

10- Fillet weld grinding of the curved edges.

11- Visual, liquid penetrating and magnetic-particle inspections of fillet welds and, if necessary, execution of new repairs.

2. Crack milling of the fatigue cracked welds: for the part of the crack located over the backing strip the minimum width of the milling must be equal to 6 mm, namely equal to the former root gap, with a depth of the 6 mm, in order to reach the backing strip (fig. 4); for the part of the crack located out of the backing strip, on the contrary, the result of the milling operation should be an U-groove edge preparation, 6 mm wide and 5 mm deep (fig. 4).

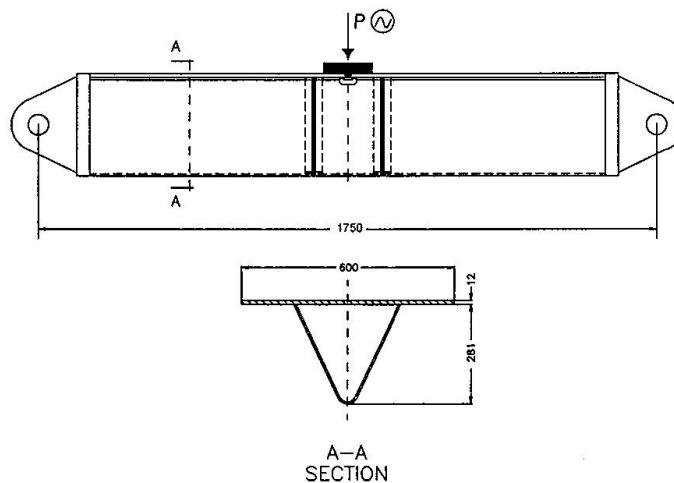
Fig. 5 Fatigue test scheme for repaired stiffener to stiffener connections

Constant amplitude fatigue tests on repaired stiffener to stiffener connections have been carried out on a three points bending scheme, with the pulsating load on the joint axis, located at the mid-span of the stiffener (Figure 5).

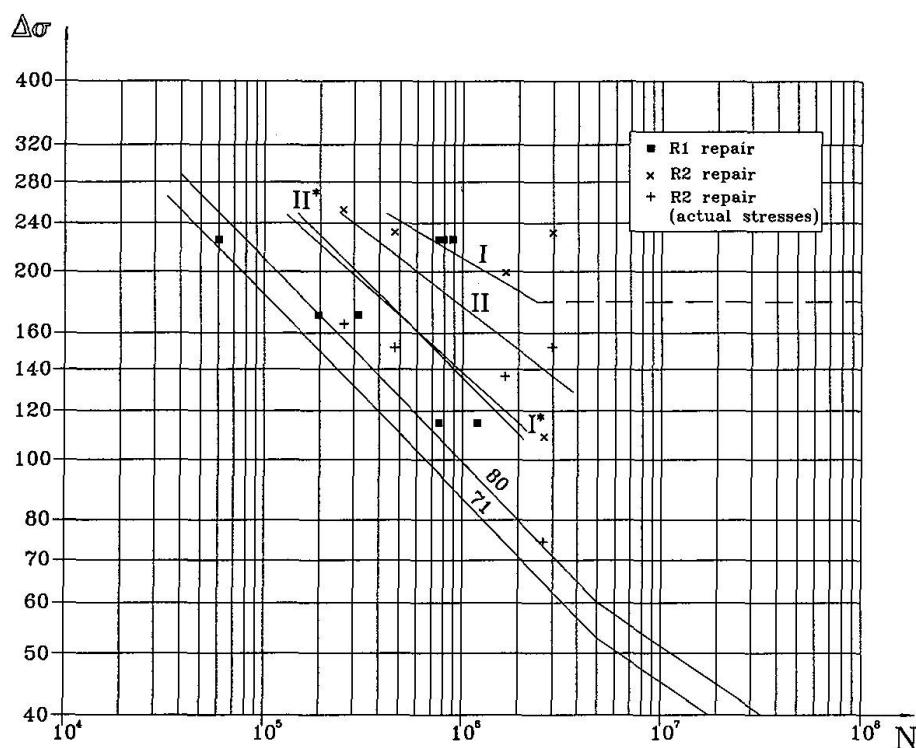
Fig. 6 Fatigue test results on repaired stiffener to stiffener connections

The fatigue test results are reported in table 2 and in the S-N diagram of figure 6, in which are also reported the characteristic S-N curves for class 71 and 80 details of EC3 and the relevant mean S-N curves already shown in fig. 1.

The test results on R2 repairs are reported in terms of nominal stresses, both taking into account the section modulus increase due to the presence of the cover plates (these stresses are indicated as *actual stresses*) or not, i.e. considering the stresses which should be obtained in the original cross section, disregarding the presence of the cover plates themselves. Obviously, for R1 repaired specimens are considered only nominal stresses.

Concerning the failure mode, it has been observed that in R1 repaired specimens cracks start always at the apex of the stiffener, in the weld, propagating in the weld itself; while in R2 repaired specimens n.1 and n. 10 cracks start at the apex of the stiffener, in the weld, propagating through the cover plates, and in R2 specimens n. 4, n. 5 and n. 6 the cracks start at the apex of the stiffener in correspondence of the tack weld of the baking strip, propagating through the cover plates.

- the fatigue strength is more scattered for repaired joints than for virgin ones;
- all test results are above the characteristic S-N curve for class EC3 71 detail;
- the original fatigue life is not completely restored with R1 repair;
- R2 repair gives, in terms of actual stresses, the same residual fatigue life as R1 repair;
- in terms of nominal stresses, i.e. with the same traffic loads, R2 repair gives a residual life appreciably higher than that assured by R1 repair and comparable with the fatigue life of type II virgin joints;
- R1 repair can be classified as 71;
- R2 repair can be classified as 71, in terms of actual stress;
- R2 repair can be classified as 100, in terms of nominal stress.

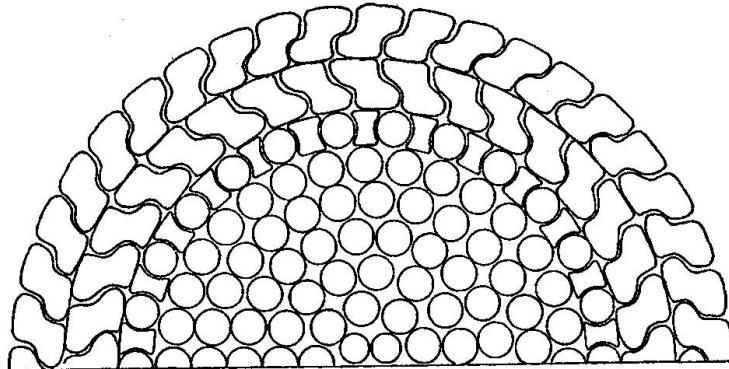
Fig. 1 Cross-section of steel wire rope

The specimen is a locked coil cable with both ends provided with end sockets. The free cable length between the sockets is 3.72 m. The cable has 9 layers of wires. The outer two layers were full lock Z shaped wires (see Figure 1). Further specifications were as follows:

Nominal diameter	$D = 101 \text{ mm}$
Cross-sectional area	$A = 6900 \text{ mm}^2$
Minimum breaking load	$F_f = 9030 \text{ kN}$
Aggregate breaking load	$F_a = 10076 \text{ kN}$
Apparent Young's modulus	$E_a = 150000 \text{ N/mm}^2$

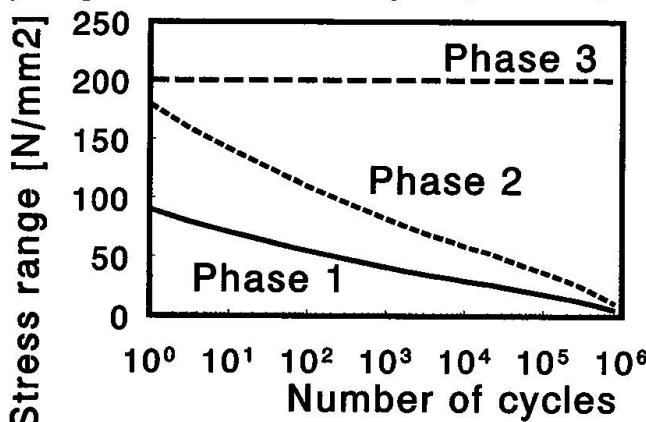
Fig. 2 Cumulative stress spectra

The fatigue loading on the cable during the first phase was based on strain measurements on the cables in the bridge in the year 1990 during 11 hours. Using traffic counting during a longer period the measurements were extrapolated to a year spectrum of 817898 cycles. The cumulative year spectrum of the stress ranges is given in Figure 2.

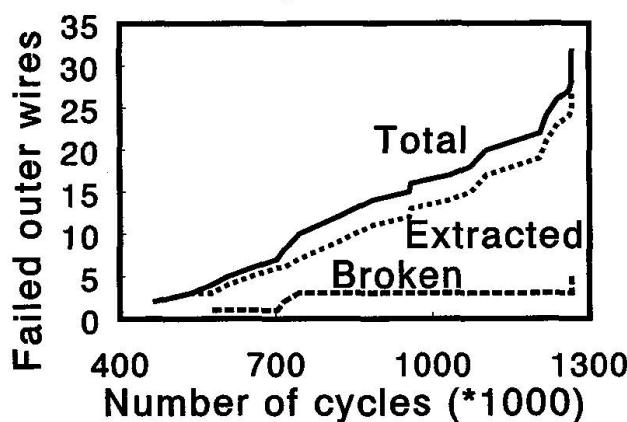
Fig. 3 Number of broken or pulled-out outer wires as a function of the number of cycles

During this phase a small number of wires were broken and a larger number of wires were pulled out from the sockets. Most of the failed wires were from the outer layer (layer number 9). The development of the number of broken or pulled-out wires of the outer layer is almost linearly proportional to the number of cycles (see Figure 3). The first wires to be pulled out (two) were found after 463000 cycles and at the end of the test at 1.266 million cycles a total of 32 outer wires were broken or pulled-out.

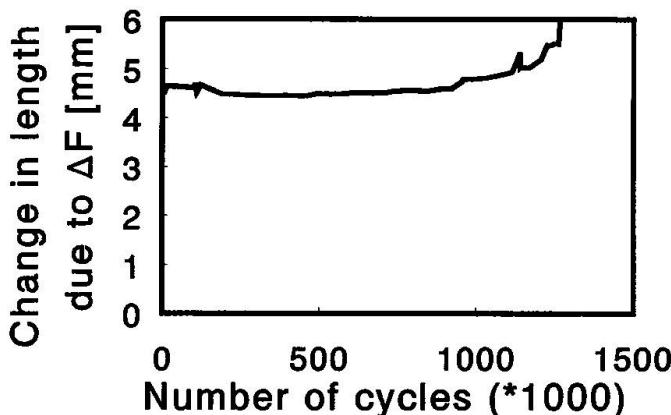
Fig. 4 Change in length due to load range as a function of the number of cycles

The recording of the change in distance between sockets as the test load cycled from the minimum to the maximum load indicated an increase in flexibility at the end of the test due to broken and pulled-out wires (see Figure 4). The theoretical change in length due to the loss of cable section is approximately 5 mm. This agrees well with the measured value of between 4.5 and 5.0 mm.

The loss in cross-section due to broken wires at the end of the test was approximately 20%. This means an increase in flexibility of 25%. The change in length at the end of the test was approximately 6 mm. These figures agree very well with each other.

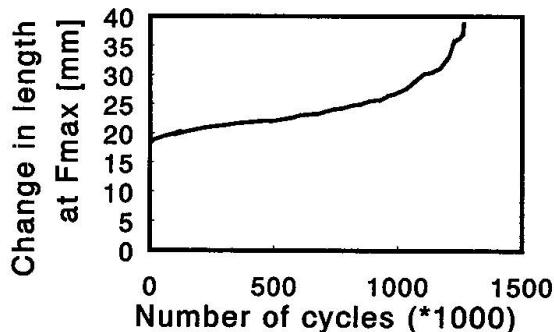
Fig. 5 Increase in length at maximum load as a function of the number of cycles

The increase in distance between the sockets at maximum load during the fatigue test is approximately 22 mm (see Figure 5). The displacement of the socket filler material is responsible for 5 mm of this displacement (see Figure 6). The loss of 32 outer wires means a loss in cross-section of 1650 mm^2 (6900 mm^2 to 5250 mm^2) and can be equated to an additional length at maximum load of 4 mm. The loss of the wires in the inner layers (7 broken wires) is responsible for 1 mm. The remaining increase in length of 12 mm can not be explained directly. Causes for this length increase can be an overall sliding of the wires in the socket filler material or relatively more sliding of the inner wires with regard to the outer wires.

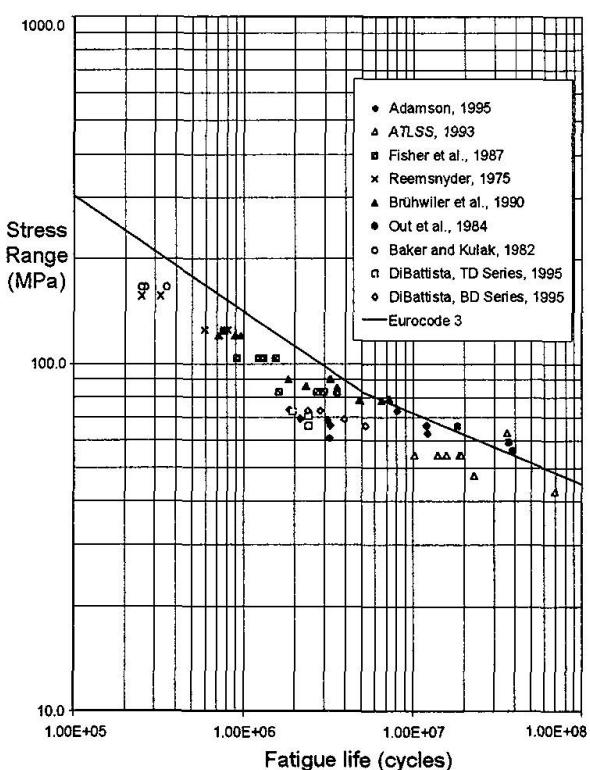
Fig. 1 Test Results + Eurocode 3

Eurocode 3 [2]— Riveted shear splices are not mentioned in this standard. If it is assumed that a riveted shear splice is the same as a splice that uses non-preloaded high-strength bolts, then Eurocode 3 prescribes the use of Detail Category 112. The slope of the fatigue life vs. number of cycles is taken as 3 until the constant amplitude fatigue limit is reached (which is at 5 million cycles). For Detail Category 112, this corresponds to a stress range of 83 MPa. A slope of 5 can then be used until the cutoff limit is reached (100 million cycles, 45 MPa). The Eurocode rule is plotted in Fig. 1, together with the test data that will be described later.

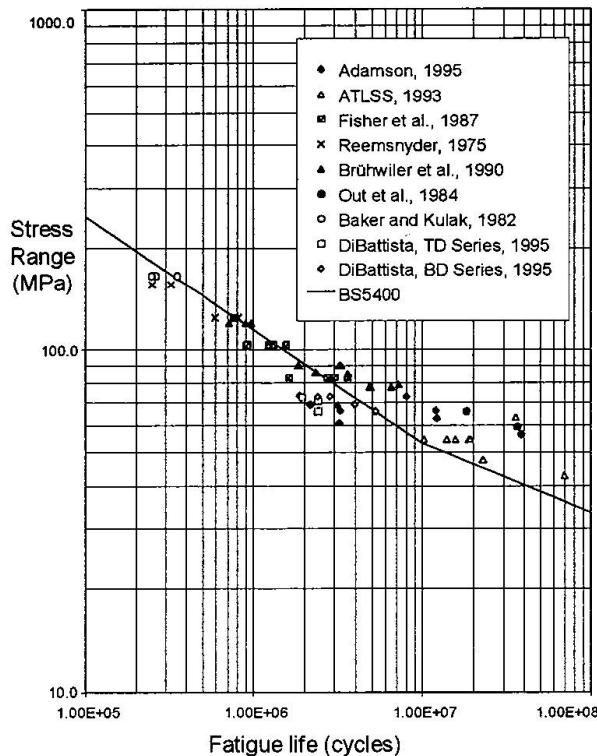
Fig. 2 Test Results + BS5400

British Standard (BS5400, Part 10) [3] — With the advent of the EUROCODES, development of national standards in Europe has ceased. However, riveted shear splices are specifically mentioned in BS5400, and it is likely that the information is still being used. The riveted shear splice detail is described in BS5400 as their Class D. A slope of 3 is used until the constant amplitude stress range of 53 MPa is reached at 10 million cycles. If variable amplitude cycles are present in this low stress range region (likely the case with a bridge), then a slope of 5 is used for all stress ranges less than 53 MPa. Figure 2 shows the permissible fatigue life rule and the test data.

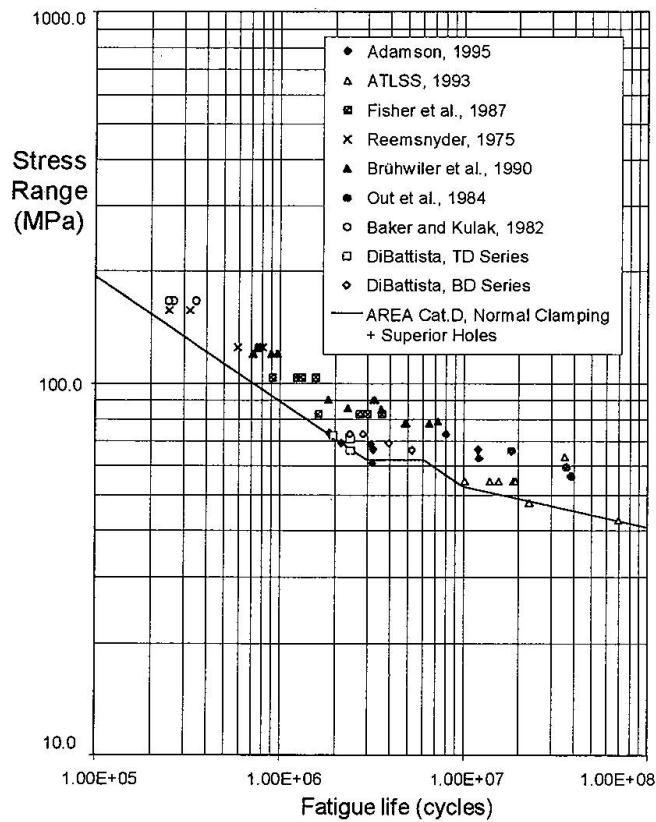
Fig. 6 Test Results + AREA, Normal Clamping, Superior Holes

It would be more common to evaluate the fatigue life on the assumption that the level of clamping force in the rivets can be taken as "normal." In this option, the AREA rules provide two categories. When the holes might have been punched, the fatigue life is that of Category D (71 MPa permissible stress range at 2 million cycles) for any stress range above 62 MPa. For stress ranges just below 62 MPa, the fatigue life line is then shifted laterally until it hits the Category C line, after which it moves downward on that line until the variable amplitude fatigue limit of 41 MPa is reached. This is shown in Fig. 5. If the holes have either been drilled or were sub-punched and then reamed, a further improvement is available. This occurs in the region 53 MPa down to 41 MPa. See Fig. 6.

The AREA rules simply capture the boundary of the test data, as can be seen in these figures. The lengths to which this standard has gone to provide rules that are as close to the test data as possible reflects the importance of this region to owners: a large portion of the stress ranges experienced in North American rail operations are in the region of 40 to 70 MPa. For proper

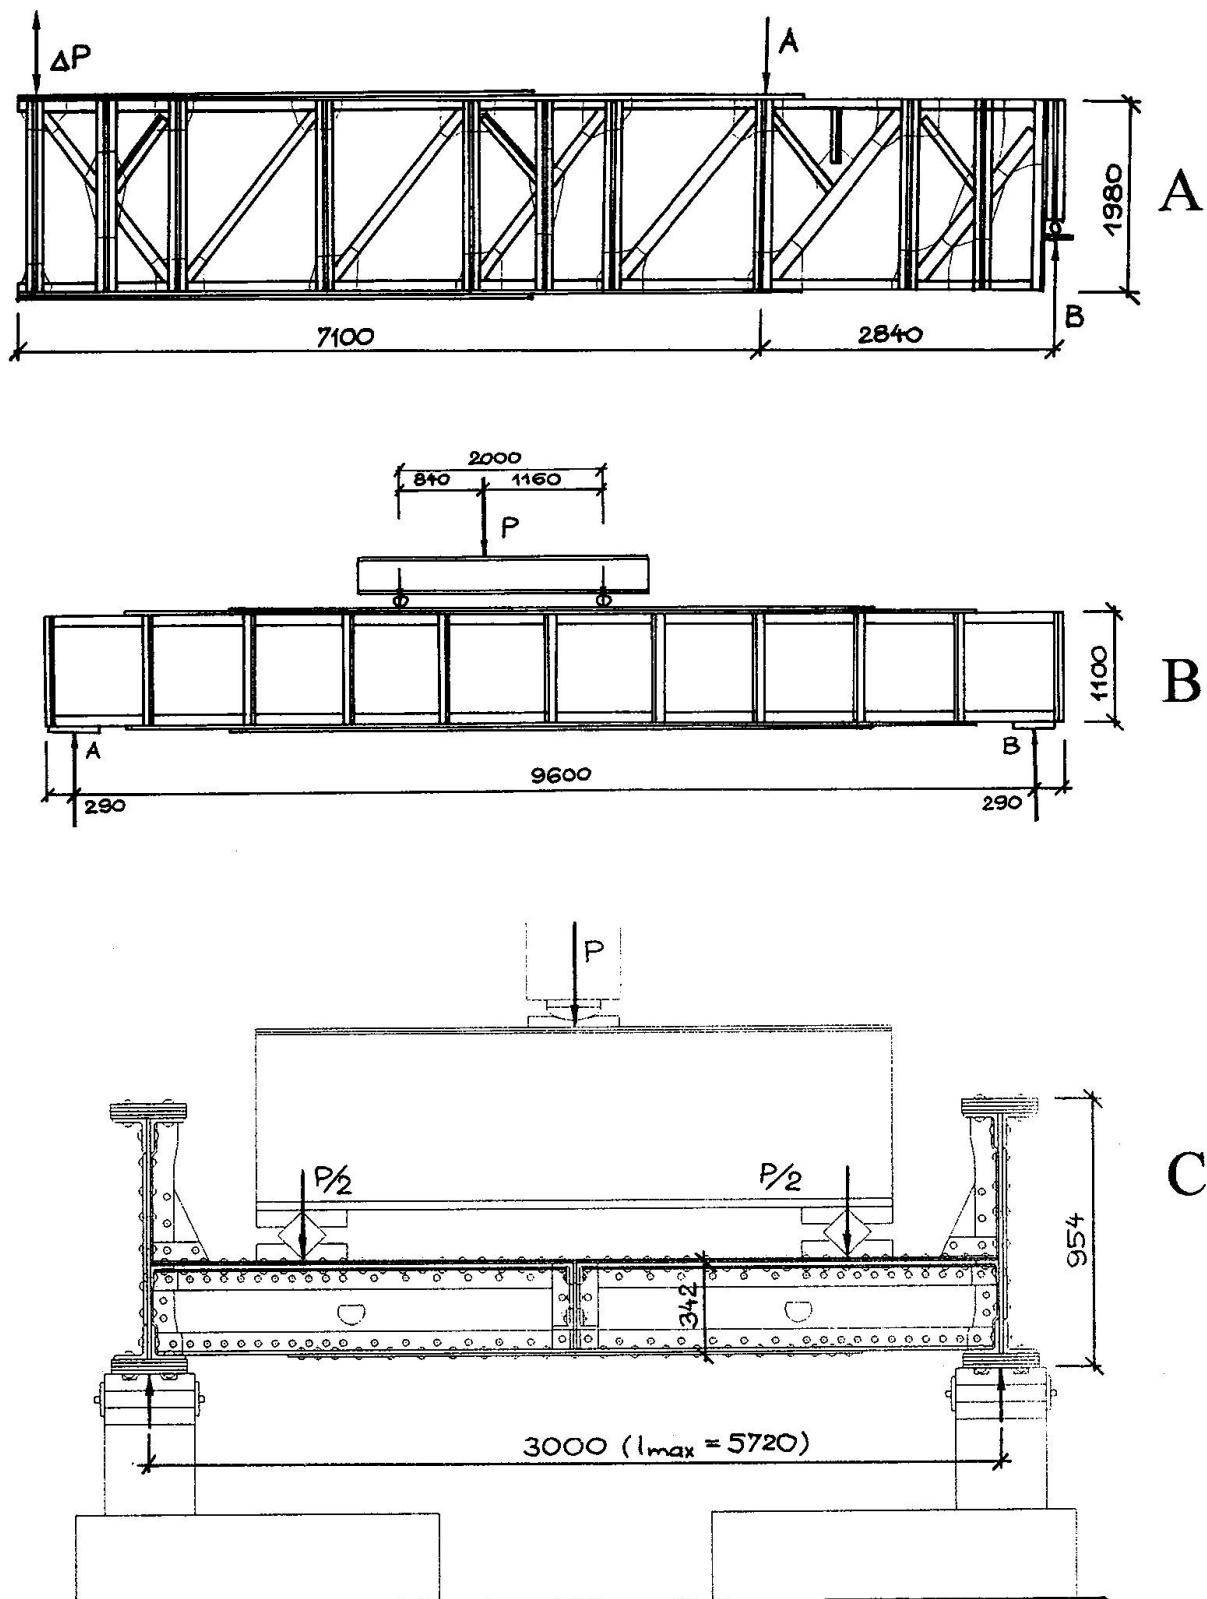
Fig. 1 Load arrangements : (A) main truss girder, (B) riveted plate cross girder, and (C) bridge parts made of wrought iron

All test specimens were subjected to constant amplitude load cycles. The nominal stress ratio was 0.1 in all tests. The maximum stress difference had to be higher than 71 N/mm^2 , corresponding to the ECCS 71 detail category (AASHTO D). Our main goal was to get results for high stress ranges in the region of the transition from $m=3$ to $m=5$ on the S-N (Wöhler) curves.

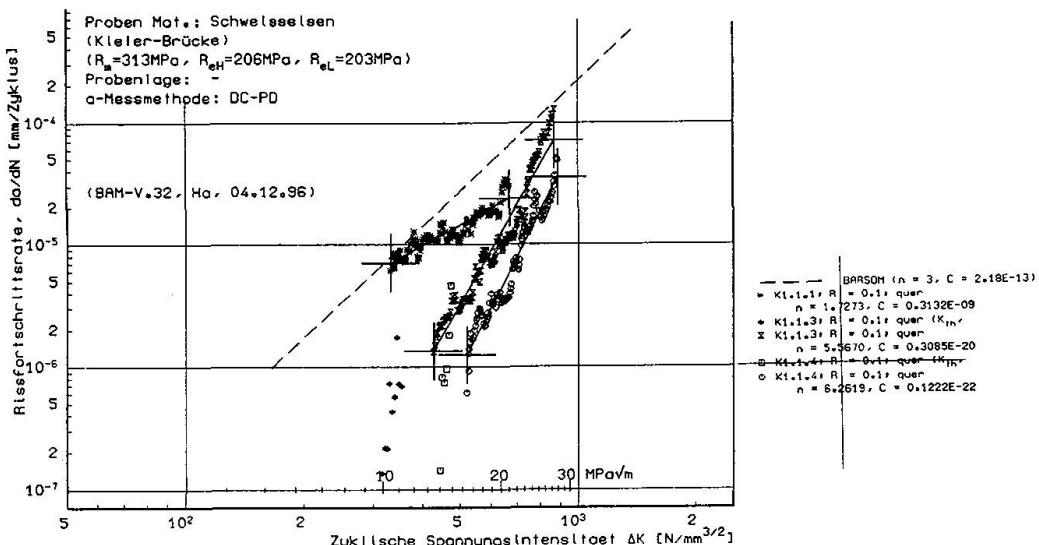
Fig. 2 Results of crack growth tests on wrought iron specimens

Crack growth tests of wrought iron were carried out. In these tests, the influence of lower temperatures was not taken into consideration. All test results for cracks perpendicular to the rolling direction were below the Barsom curve for contemporary steels. Rolfe and Barsom (1987) proposed this empirical approximation for steels with a yield strength greater than 250 N/mm^2 . Test results are shown in Figure 2 in relation to this curve. Tests for cracks oriented parallel to the rolling direction produced results above this curve, meaning that such cracks propagate faster. The cyclic stress intensity ΔK depends on the stress range; a higher stress range results in a lower cyclic stress intensity. The yield cyclic stress intensity ΔK_{th} of the investigated wrought iron was $\sim 10 \text{ MPa}\cdot\text{m}^{1/2}$ for a nominal stress ratio of 0.1.

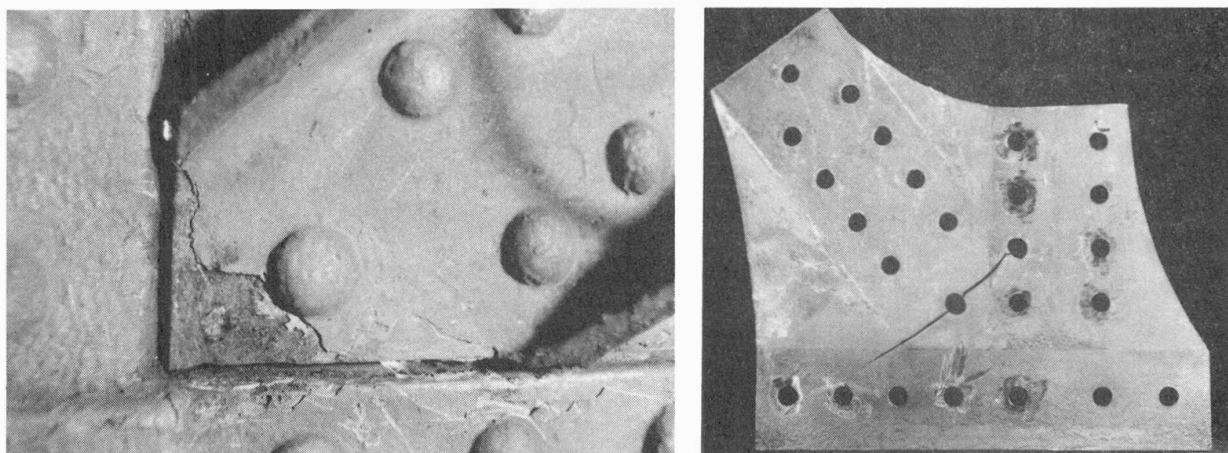
Fig. 3 Details of a cracked cover plate (A) concealed within the structure, (B) after disassembly

In the **truss girder** test series all fatigue cracks occurred in the gusset plates, indicated by increasing strains during the test. The cracks initiated in the region of the gusset plate near to the last rivets on the diagonal where the gusset is sandwiched between two diagonal elements. Details of the gusset plate with the crack after removing rivets and the diagonal elements are shown in Figure 3. After elongation of the rivet hole cracking began at the edge of the rivet hole. Additional factors contributing to crack growth, for example from rivet installation, were not found in our tests. As known from literature, at this time (1902) in Germany rivet holes had to be drilled; punching was not allowed in structures with traffic loads. Exceptions to this rule might have occurred.

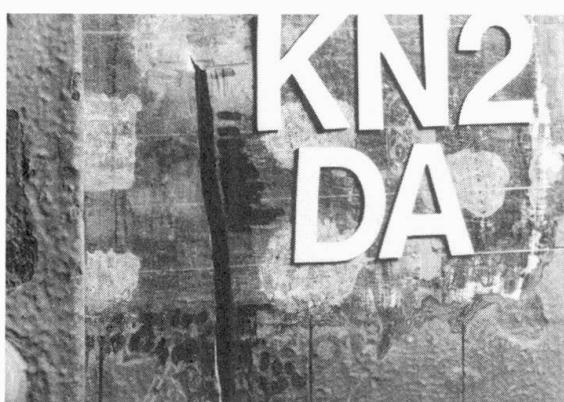
Fig. 4 Detail of crack tip in a web plate

In the **plate girder** test series (mild steel, 1906, Kn), all cracks initiated in the cover plate, sandwiched between angles and additional cover plates. Cracks were found after deflection and strains increased or when the crack was long enough to reach the edge of the sheet plate. When cracks reached the edge, they were only visible when the girder was loaded. All tests were continued to find out if crack growth became unstable. The result was plastification at the crack tip and crack dividing into two tips, but no unstable growth. In one of these tests the crack tip in the web plate had been cooled down to -30°C on both sides of the web plate. The crack tip detail is shown in Figure 4.

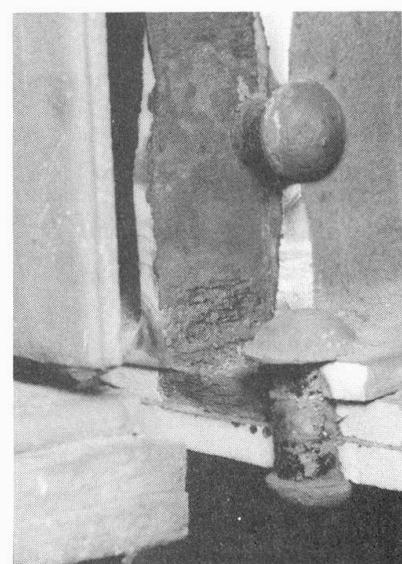
Fig. 5 Crack in the tension flange

The bridge crossing the Teltow canal "Knesebeck-bridge", had presumably been damaged during World War II. Almost every bridge crossing the canal had been blasted during the last days of the war. We found old corroded failures in the cross section of cover plates and untypical cracking behaviour in the region of constant moments. In the tension flange of the second plate girder the crack was growing from an old corroded failure, as shown in Figure 5. The third web plate girder seemed to have been exchanged. In material tests we found higher tensile strength, appropriate to Fe 360, in girder Kn 3. By means of strain measurement or deflection measurement it was possible to detect crack growth.

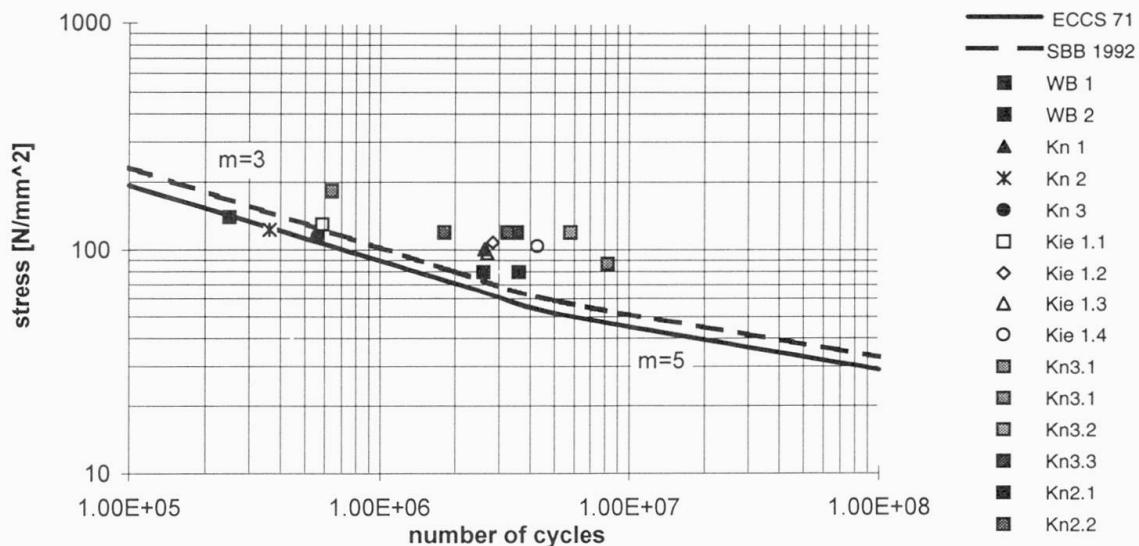
Fig. 8 Results of full scale tests in S-N-curve

In two tests the crack occurred in the plate under an additional plate at the first row of rivets. Crack growth was indicated by decreasing strains in the tension flange. All tests are summarized in the S-N-diagram in Figure 8.
