**Artikel:** Full scale laboratory fatigue tests on riveted steel bridges  
**Autor:** Helmerich, Rosemarie / Brandes, Klaus / Herter, Jürgen  
**DOI:** <https://doi.org/10.5169/seals-57473>

## Full Scale Laboratory Fatigue Tests on Riveted Steel Bridges

### Summary

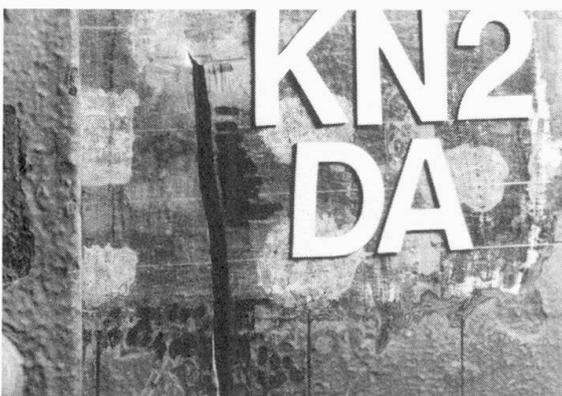
**Fig. 4** Detail of crack tip in a web plate

In the **plate girder** test series (mild steel, 1906, Kn), all cracks initiated in the cover plate, sandwiched between angles and additional cover plates. Cracks were found after deflection and strains increased or when the crack was long enough to reach the edge of the sheet plate. When cracks reached the edge, they were only visible when the girder was loaded. All tests were continued to find out if crack growth became unstable. The result was plastification at the crack tip and crack dividing into two tips, but no unstable growth. In one of these tests the crack tip in the web plate had been cooled down to  $-30^{\circ}\text{C}$  on both sides of the web plate. The crack tip detail is shown in Figure 4.

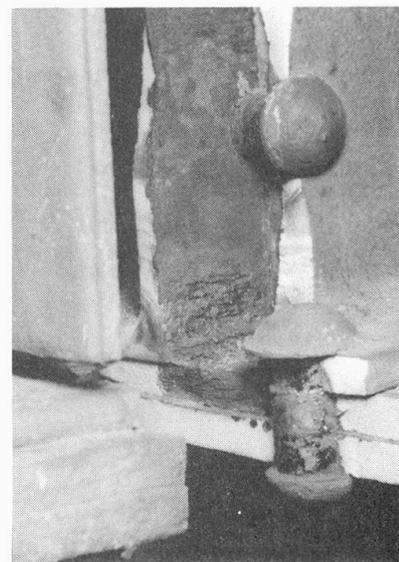
**Fig. 5** Crack in the tension flange

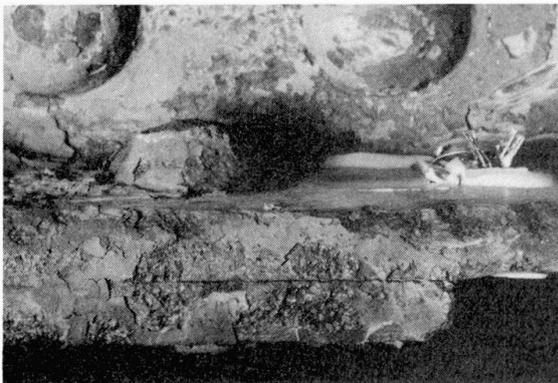
*Fig. 6 Cracked angle in tension flange*

In the last cross girder test, the last rivets of the cover plates were replaced by prestressed bolts. In this case, from the point at which strains had increased by 1%, it took 2 million high-stress-range load cycles until failure of the web-to-flange angle.
