Artikel: Damage of SRC building structures by 1995 Hyogo earthquake
Autor: Sakai, Junichi / Minami, Koichi / Matsui, Chiaki
DOI: <https://doi.org/10.5169/seals-1035>

Damage of SRC Building Structures by 1995 Hyogo Earthquake

A large number of Steel Reinforced Concrete (SRC) building structures were damaged seriously owing to 1995 Hyogoken-Nanbu Earthquake in Japan. The authors have investigated the damage of buildings and collected the data of 1,307 SRC buildings in and around Kobe city. Thirty-one SRC buildings collapsed by the story failure. All of them were constructed before 1972 and open-web type steels were used in SRC members. In this paper examples of damage of SRC buildings and members, and statistical analysis of damage are described.

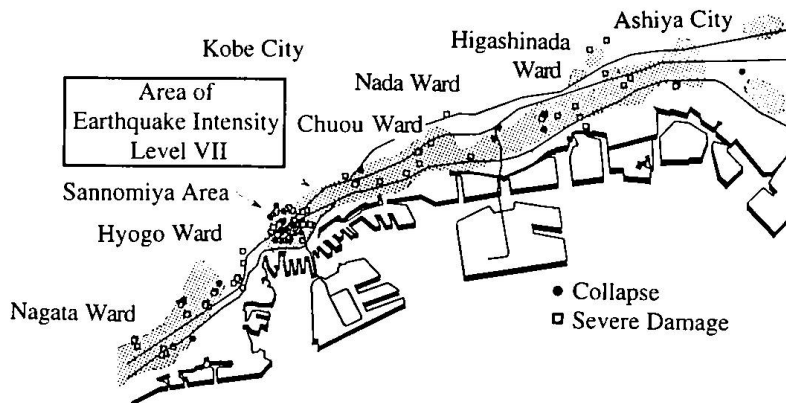
Fig. 1 Distribution of SRC buildings subjected collapse or severe damage.

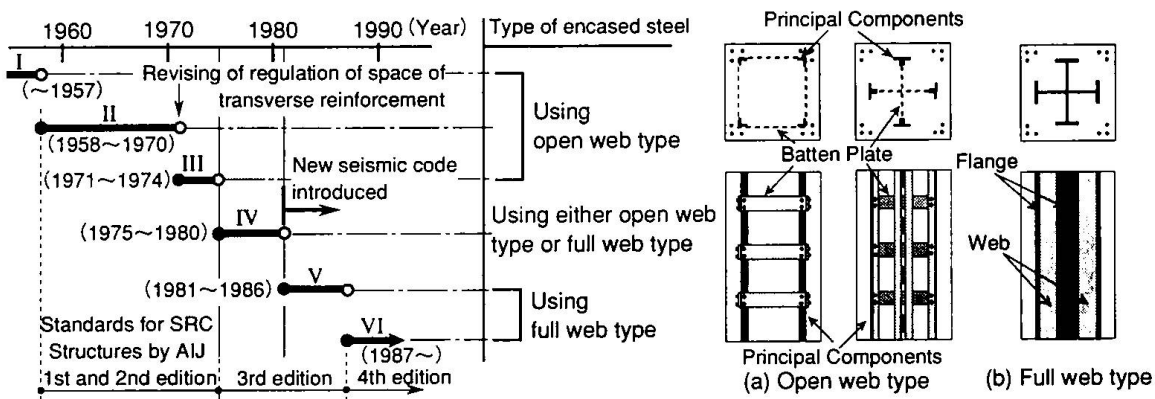
Figure 2 shows the relation of SRC type and construction year of buildings, and the construction years are divided into six periods according to the revising of the standards for structural calculation of SRC structures published by Architectural Institute of Japan [3] (AIJ standard). The term IV (1975-1980) show the period that buildings were constructed with either open web type or full web type.

Fig. 2 Decision of Classification of Years of Completion of Buildings

SRC members can be divided into two types. One of them is called open web type SRC, that was composed of angle steel as principal steel components and steel sections were fabricated with angles arranged to form lattices or ladders by rivet or bolt (see Fig. 2). This type of SRC had been used for most of SRC buildings constructed before 1975. The other is called full web type SRC, that is composed of H shaped steel as principal steel components (see Fig. 2). After 1968, it had made clear by some tests that earthquake resistant performance of SRC members using open web type steel was worse than one using full web type steel from the view point of shear behavior [2].

Construction year of buildings was divided as shown in Fig. 2. Distribution of building damages classified by construction years is shown in Fig. 3. The ratio of the number of the buildings collapsed or sustained severe damage to the total of buildings constructed before 1970 was up to 30 percent (40/134), and the ratio of buildings constructed before 1974 was 26 percent (70/266). Almost all of them were composed of open web type SRC. On the other hand, with full web type SRC constructed after 1981, only 3 percent of buildings sustained severe damage (18/618), and no such a building collapsed.

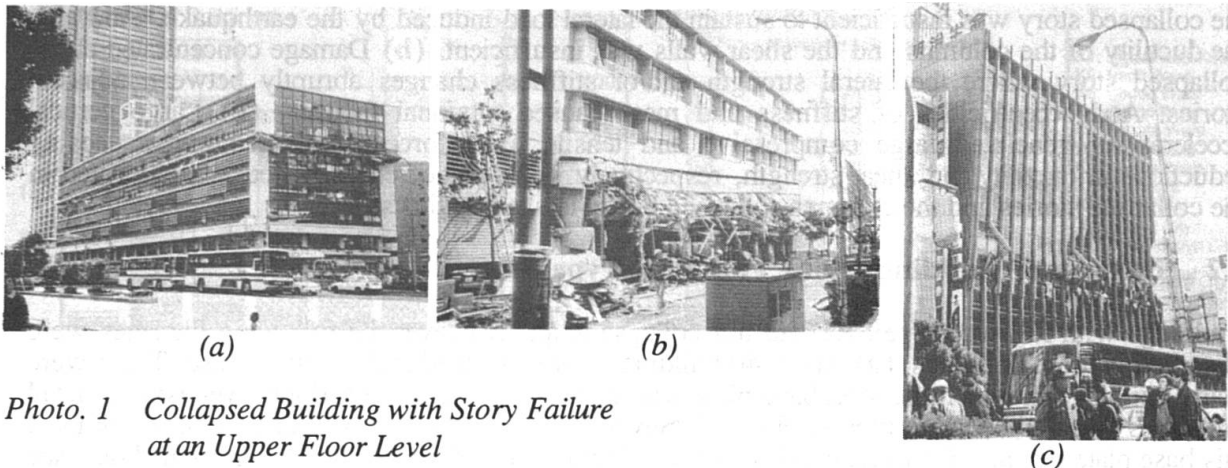
Photo. 1 Collapsed Building with Story Failure at an Upper Floor Level

Thirty-one of SRC buildings collapsed by the story failure. All of them were constructed before 1972 and composed of the open web type SRC. Twenty-seven buildings collapsed by the story failure at an upper floor level (see Photo. 1) and four buildings collapsed at the first story. At the failure story, SRC columns collapsed brittly in shear (see Photo. 2) and concrete in RC shear walls crushed to out of plane. Collapse by the story failure at an upper floor level was characterized of the damage caused by this earthquake. Several factors potentially responsible for these failures can be considered as follows: (a) The design earthquake force distribution over the height used in the old design codes is different from the one used now, and the proportion of design story shear force is smaller at the mid-stories in the old codes. Then the ultimate strength of

the collapsed story was insufficient to sustain the lateral load induced by the earthquake. And also the ductility of the columns and the shear walls was insufficient. (b) Damage concentrated at the collapsed story where the lateral strength and/or stiffness changes abruptly between adjacent stories. And eccentricities of stiffness and mass caused torsional failure. (c) Large vertical accelerations generated large compressive and tensile axial forces in the columns, causing reductions in ductility and shear strength, respectively. (d) Joint of encased steel was located in the collapsed stories and the columns collapsed brittly in shear at this story.

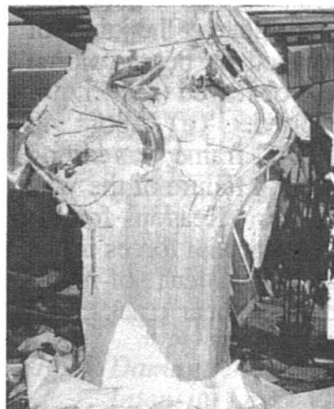
Photo. 2 Collapsed Column in Shear

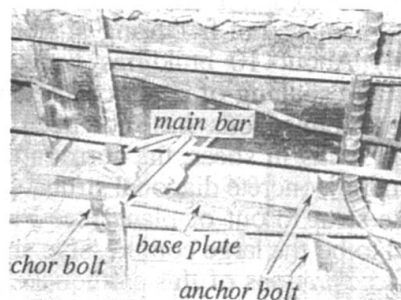
Photo. 3 Fracturing of Anchor Bolt at Column Base (after chipping concrete)

Buildings with full web type SRC did not collapse at all. However the following damages were observed in these buildings: (a) About 40 buildings were damaged at the column base. There were many buildings in which the steel base plate was anchored at the ground floor level using a detail known as "non-embedment type steel base". Severe damage was observed in buildings that used this base plate detail. Concrete crushed at the column base and anchor bolts were pulled out (see Photo. 3). (b) About 10 buildings were damaged of fracturing of encased steel flange plate (see Photo. 4). (c) About 10 buildings were damaged of fracturing of steel splice plate at the joints of columns or beams (see Photo. 5). (d) About 10 buildings were damaged at beam-column connections where diagonal shear cracks and spalling of cover concrete were observed (see Photo. 6), but severe damage at beam-column connections has not been reported. (e) About 40 buildings were damaged of the shear RC walls in shear; the surrounding SRC frame was strong enough to carry the forces delivered from the concrete diagonal struts, so sliding failure of the wall took place with crushing of the concrete strut to out of plane (see Photo. 7). Reasons for the damage from (a) to (d) were considered to be the large compressive and tensile axial forces in the columns generated by the large vertical accelerations of this earthquake and the existence of multi-story shear walls. A large number of columns or beams with flexural cracks, shear cracks, and shear bond cracks were observed, but severe damage has not been reported.

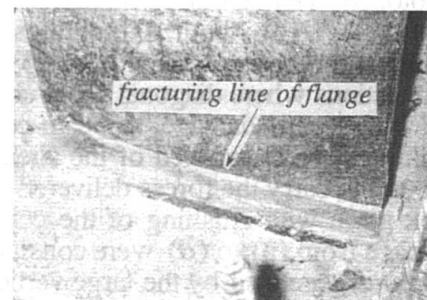
Photo. 4 Fracturing of Column Steel Flange Plate (after chipping concrete)

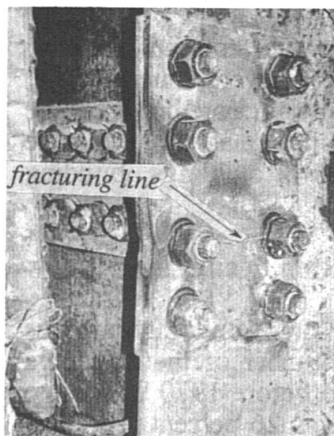
Photo. 5 Fracturing of Splice Plate at Column Joint (after chipping concrete)

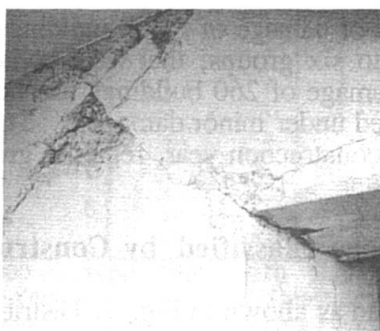
Photo. 6 Damage of Beam-Column Connection

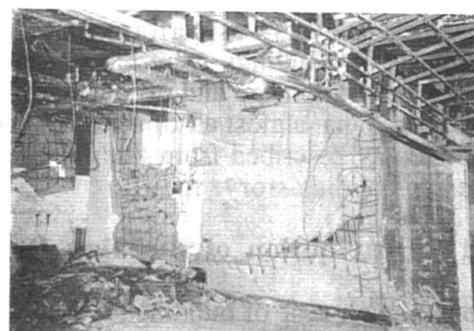
Photo. 7 Damage of RC Shear Wall
