**Zeitschrift:** IABSE reports = Rapports AIPC = IVBH Berichte  
**Band:** 999 (1997)

**Rubrik:** Diagnosis, maintenance, retrofitting, repair

## Stud Arrangement to Reduce Fatigue Cracks and Application of Drilled Holes

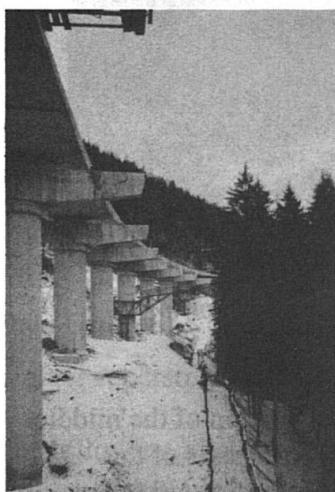
Fig. 4 Destruction outer deck slab

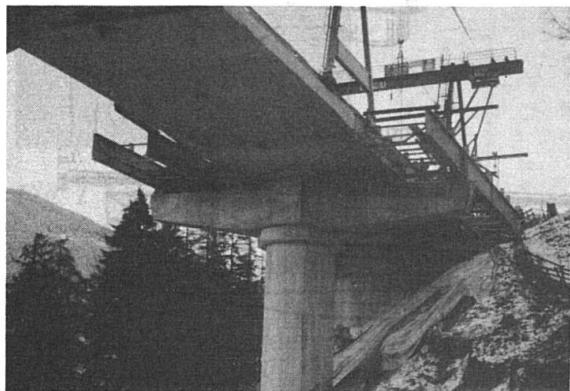
Fig. 7 Setting of steel units at outer structure

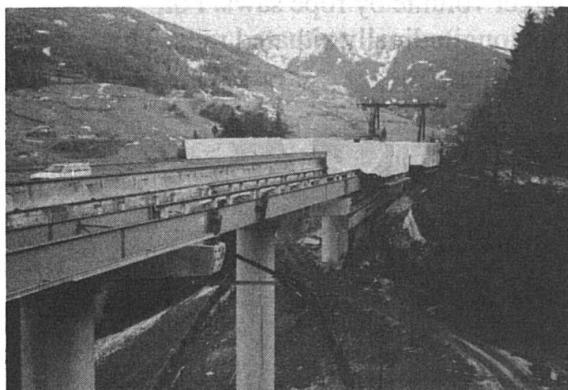
Fig. 9 Concreting at outer structure
