## Interlayer Bond Deterioration under Repeated Shear Load

Non-reinforced interlayer connections in an interlayered concrete composite slab under repeated shear load

**Ludovit NASCH**  
Principal R.W., Civil Eng.  
USTARCH - SAV  
Bratislava, Slovak Republic

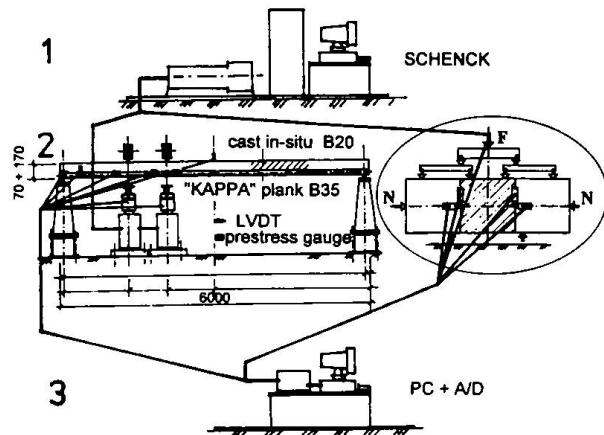
Figure 1

In this part of the research project made at the Institute of Construction and Architecture of the Slovak Academy of Sciences, two families of specimen, (Figure 1), were experimentally analysed under both, monotone and repeated loading. The first of the families (where the overall breaking mechanism was aimed at) comprise the full size 1200 x (70+170) x 6000 mm, (breadth x thickness x length) specimens based on the precast, prestressed wide planks KAPPA, produced by the ZIPP Ltd. - Bratislava. The second family of which only we will speak further, consists of the smaller size 200 x 200 x 600 mm three layer specimens, where the importance of such parameters as the interface roughness, the normal stress intensity, the cube strength, and the workability of the concrete, changes of the concrete mix, etc., to the overall behaviour of the interlayer connection can be investigated more readily. The surface roughness *left-as-vibrated, roughened by the sheep-leg roller* (as used for the KAPPA planks), and *trawled by the wooden lath trowel*, and three levels of the normal stress intensity (*0,0; 0,1; and 0,4 MPa*) has been chosen for analysis. The Hydopuls - Schenck loading apparatus was used to load the specimen placed appropriately between the upper cross beam and the loading piston of the loading machine. Both loading types were displacement controlled; *the monotone increasing load* by the constant loading piston velocity of 1/100 mm per second, and *the repeated loading* by the sinusoidal motion of the loading piston. Up to  $2,0 \times 10^6$  loading cycles with the 14 Hz frequency were imposed on the specimen. The piston's lower and upper position were so adjusted, to have

the upper loading force at the required level, and the lower value of the loading force to be approx. 10 or 15 kN. Altogether nine IWT 302 inductive gauges were used to measure changes of the length base across the interlayer connection, (channels 1-4), the vertical interlayer slip, (channels 6-9), and the loading piston position, (channel 10). The loading force intensity was acquired from the channel 5.

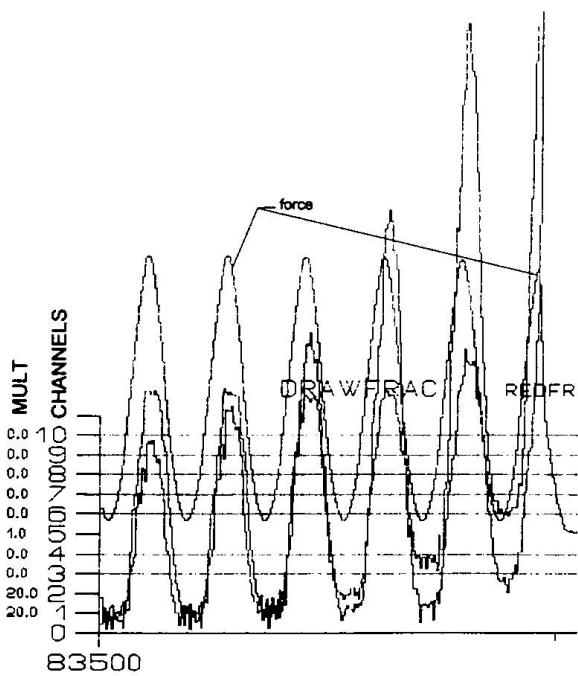
On the Figure 2 we can see selected primary data as acquired during the last 6 cycles (from approx. 14000) before final rupture of the second interlayer connection of the 25/VI three layer specimen (surface roughness *left as vibrated*, and  $\sigma_n = 0,4$  MPa). The whole experiment has been scanned with the sampling frequency of 600 Hz, and so the vertical line segments creating any of the depicted curves are, in this case, the 1/600 sec. apart. Length between the numbered ticks on the vertical axis equals 1/100 mm for the displacements, and 20kN for the loading force. We can see (alike the data for different normal stress, and interface roughness, and monotone load, published elsewhere, [1] ) the significant increase of the measured displacements in the pre-critical part of the diagrammed data. There is an increase of displacements across the connection plane between 12 and 13  $\times 10^{-2}$  mm for the last 100 cycles, (6 to  $10 \times 10^{-2}$  mm for the last 10 cycles) without any significant loss of the connection's stiffness, as well as the energy accumulated during the loading phase. It should be reminded at this place, that the crack opening of about 1/100 mm is discernible by the naked eye. On the ground of the experimental evidence could be stated, that not the

interlayer *adhesion* only, (accounted for in the fracture mechanics), but also the *mechanical interlock* due to the surface roughness, and the *friction* due to the normal stress intensity, together with the manufacturing conditions, play the main, if not the decisive role.
