Zeitschrift: IABSE reports = Rapports AIPC = IVBH Berichte
Band: 999 (1997)

Behavior of Composite Truss Girders

This paper reviews the results of a series of tests that focus on the behavior and strength of composite truss girders. Three laboratory size floors were constructed and loaded to failure. Top chord supported open web trusses were used as secondary members. Three unique methods of generating composite action in truss girders are examined.

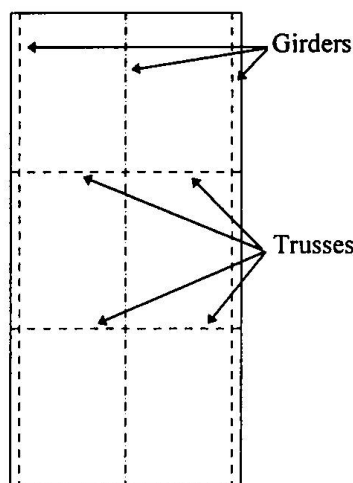
Fig. 1 Test Floor - Plan View

Each test setup used three full-size girders, spanning 9.1 m and spaced at 2.1 m on center. The setups consisted of an interior truss girder (IG) and two exterior truss girders (EGL, EGR). For the third setup only, a universal beam (EB) was substituted for one of the exterior truss girders to compare the composite action of the two girder types. Secondary trusses, which would generally span from 9 m to 20 m in an actual structure, were shortened for testing to about 2 m and placed between the girders at the third points. Steel sheeting was placed perpendicular to the secondary trusses and parallel to the truss girders. Figure 1 shows the typical framing plan.

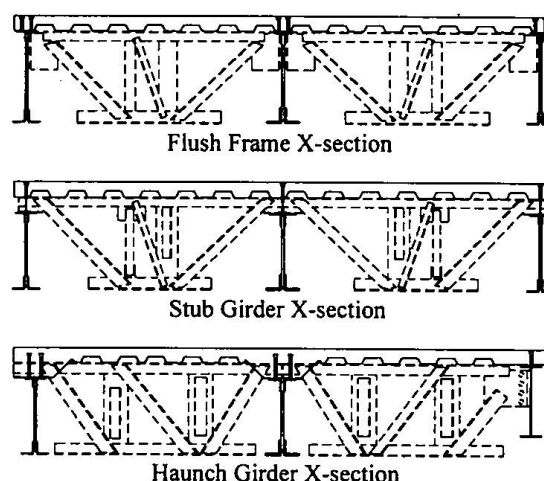
Fig. 2 Specimen Cross-Sections

The first setup was a flush framed configuration. The second setup involved the use of stub girders, while the third employed concrete haunches over the girders, as shown in Figure 2. The systems were all tested to observe their composite behavior. Several load applications were performed on each floor. The first application of each test was to load the exterior girders to their predicted service loads and then unload. The load points over the trusses were then repositioned to principally load the interior girder. The second application loaded the interior girder to its predicted service load. The third application loaded the interior girder to $1.67 \times$ service loading, which is the load at which the girder bottom chord would theoretically yield.

For this setup, the secondary trusses were connected to the truss girders with flush-framed, bolted connections. This allowed the top chords of the trusses to be positioned at the same elevation as the top chords of the girders. The steel sheeting could then be placed directly on the top chords of both the girders and the trusses. Shear studs were spaced along the girder lengths to provide sufficient shear resistance to develop the truss girder bottom chord nominal yield stress values. Three-bolt (on EGL) and four-bolt (on EGR) single plate (fin plate) framing connections were used for evaluation purposes.

The second setup utilized a stub girder arrangement, similar to the concept described by Chien and Ritchie (1984), to form the composite truss girders. The secondary truss top chords were seated directly on the girder top chords at the girder span third points. A series of three shallow universal steel beams, or stubs, each approximately 3 m in length, were welded along the length of each girder. The stubs were separated by 200 mm gaps where the secondary truss top chord seats framed in. These stubs filled the 127 mm gaps between the girder top chords and the truss top chords to provide a supporting surface for the steel sheeting. A single row of shear studs was placed directly over the girder centerlines along the girder lengths.

The third setup used concrete haunches over the girders. As a result, the concrete over the girders was twice the thickness of the normal slab and much longer studs were required. These studs were placed in double rows along the lengths of the girders. The haunches were formed to encase the truss seats. This meant that the seats were cast into the haunch concrete and could be considered additional shear connectors.
