Zeitschrift: IABSE reports = Rapports AIPC = IVBH Berichte

Artikel: Behavior of composite truss girders

Behavior of Composite Truss Girders

This paper reviews the results of a series of tests that focus on the behavior and strength of composite truss girders. Three laboratory size floors were constructed and loaded to failure. Top chord supported open web trusses were used as secondary members. Three unique methods of generating composite action in truss girders are examined.

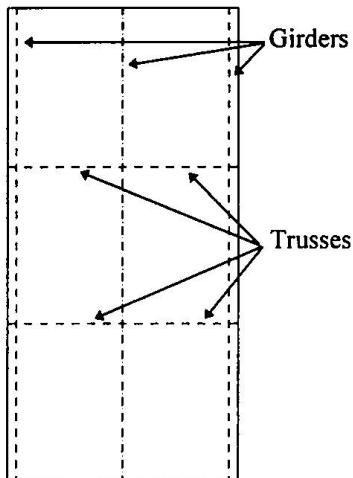
Fig. 1 Test Floor - Plan View

Each test setup used three full-size girders, spanning 9.1 m and spaced at 2.1 m on center. The setups consisted of an interior truss girder (IG) and two exterior truss girders (EGL, EGR). For the third setup only, a universal beam (EB) was substituted for one of the exterior truss girders to compare the composite action of the two girder types. Secondary trusses, which would generally span from 9 m to 20 m in an actual structure, were shortened for testing to about 2 m and placed between the girders at the third points. Steel sheeting was placed perpendicular to the secondary trusses and parallel to the truss girders. Figure 1 shows the typical framing plan.

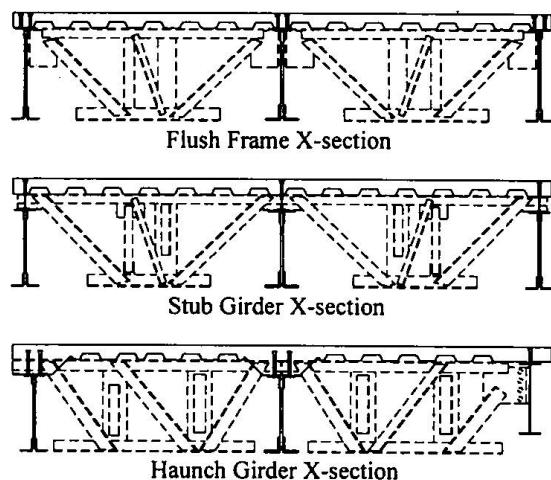
Fig. 2 Specimen Cross-Sections

The first setup was a flush framed configuration. The second setup involved the use of stub girders, while the third employed concrete haunches over the girders, as shown in Figure 2. The systems were all tested to observe their composite behavior. Several load applications were performed on each floor. The first application of each test was to load the exterior girders to their predicted service loads and then unload. The load points over the trusses were then repositioned to principally load the interior girder. The second application loaded the interior girder to its predicted service load. The third application loaded the interior girder to 1.67 x service loading, which is the load at which the girder bottom chord would theoretically yield.

For this setup, the secondary trusses were connected to the truss girders with flush-framed, bolted connections. This allowed the top chords of the trusses to be positioned at the same elevation as the top chords of the girders. The steel sheeting could then be placed directly on the top chords of both the girders and the trusses. Shear studs were spaced along the girder lengths to provide sufficient shear resistance to develop the truss girder bottom chord nominal yield stress values. Three-bolt (on EGL) and four-bolt (on EGR) single plate (fin plate) framing connections were used for evaluation purposes.

The second setup utilized a stub girder arrangement, similar to the concept described by Chien and Ritchie (1984), to form the composite truss girders. The secondary truss top chords were seated directly on the girder top chords at the girder span third points. A series of three shallow universal steel beams, or stubs, each approximately 3 m in length, were welded along the length of each girder. The stubs were separated by 200 mm gaps where the secondary truss top chord seats framed in. These stubs filled the 127 mm gaps between the girder top chords and the truss top chords to provide a supporting surface for the steel sheeting. A single row of shear studs was placed directly over the girder centerlines along the girder lengths.

The third setup used concrete haunches over the girders. As a result, the concrete over the girders was twice the thickness of the normal slab and much longer studs were required. These studs were placed in double rows along the lengths of the girders. The haunches were formed to encase the truss seats. This meant that the seats were cast into the haunch concrete and could be considered additional shear connectors.
