Zeitschrift: IABSE reports = Rapports AIPC = IVBH Berichte
Band: 999 (1997)

Artikel: Compression membrane action in composite slabs
Autor: Peel Cross, R.J. / Rankin, G.I.B. / Gilbert, S.G.
DOI: <https://doi.org/10.5169/seals-999>

Compression Membrane Action in Composite Slabs

This paper discusses the results from a two year research project which studied the effects of Compressive Membrane Action (CMA) on composite metal decking/concrete slabs before and after fire. The paper concentrates on work carried out on full scale slabs in the BRE test building at Cardington, but compares these results with those obtained from slab strips tested in the laboratory. It was found that fire damaged slabs exhibited far greater strengths than previously supposed, some held loads higher than those predicted by yield line analysis.

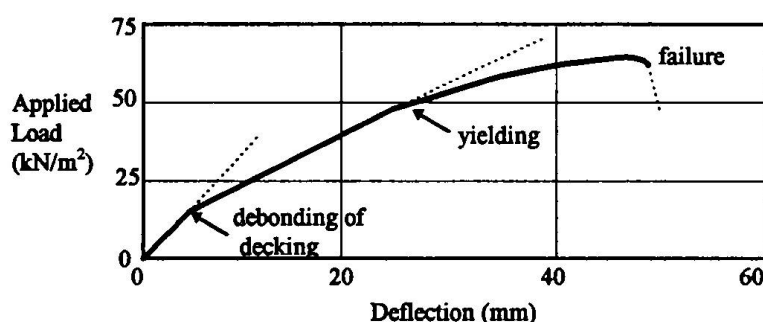
The slabs were loaded in 1.2kN/m² intervals, until they approached failure when the loading increments were reduced to 0.6kN/m². At a load of about 15kN/m², the decking began to debond noisily from the concrete. It is likely that this was the point at which the concrete began to crack as well, but this was impossible to see with the decking in place. At this point, the stiffness of the slab reduced by about 60%. At about 2/3 of the ultimate load level, yielding of the decking began to occur and the rate of deflection progressively increased until failure.

Fig.4 Pre-Fire Load/Deflection Results for Internal Panel
