**Artikel:** Compression membrane action in composite slabs

## Compression Membrane Action in Composite Slabs

### Summary

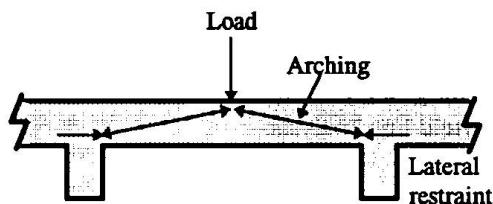
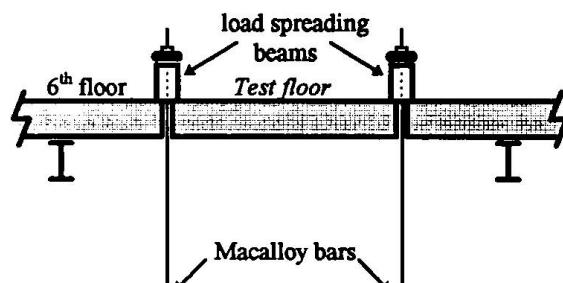
Fig.1 Arching action

Compressive Membrane Action is the two way arching effect which occurs when a laterally restrained slab is loaded (1). The load is resisted by a compressive force which extends through the slab from the load to the supports (see Fig 1). The greater the element depth/length ratio is, the greater is the amount of arching which occurs. CMA is already used to justify a reduction in the amount of reinforcing steel used in certain beam and slab bridge decks (2), but has not yet been applied in practice to other structures (3). The purpose of this research was to find out whether CMA contributes to the strength of composite metal decking/concrete slabs in buildings, and whether it helps to sustain load in a composite slab which has been badly damaged by fire (4).

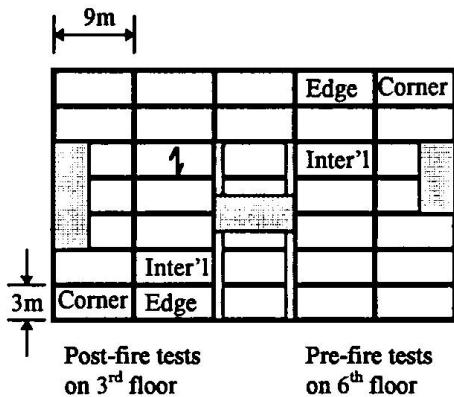
Fig.2 Cardington test panels

The tests were carried out in two phases, the first on undamaged slabs (pre-fire tests) and the second on fire damaged slabs (post-fire tests) at the locations indicated in Fig 2. Each set of slabs underwent two tests, the first being a proof load test and the second an ultimate load test. Loads were applied along the quarterpoints of the slab in order to simulate the bending moments due to a uniformly distributed load. The load was applied hydraulically using ten 30 tonne jacks (Fig 3), except for the service load on the fire damaged slabs which was applied incrementally with 1.1 tonne sandbags. This was mainly because the panels were so distorted by the fire that it would have been difficult to line up holes for the Macalloy bars over two floors. In addition, it was known that the slabs had sustained a superimposed load of about 2.4kN/m<sup>2</sup> during the fire test and it was decided not to load the slab more than this in case the beam connections failed.

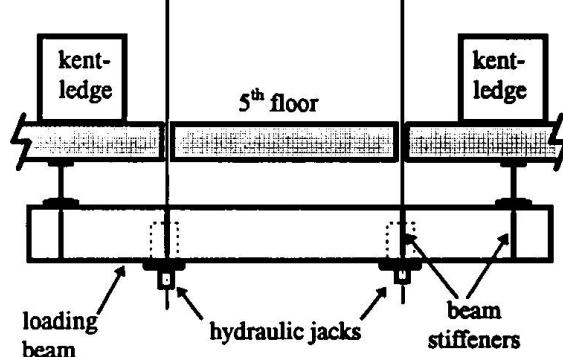
Fig.3 Hydraulic floor loading system

The test rig set up was slightly different from the proof load tests (Fig 3), because only the slab was to be loaded to failure. As it was imperative that the steel frame did not fail, the test rig was moved up one floor so that it was immediately under the slab being tested. This created a self-straining system whereby the load on the slab was resisted by the reactions of the loading rig against the steel beams.

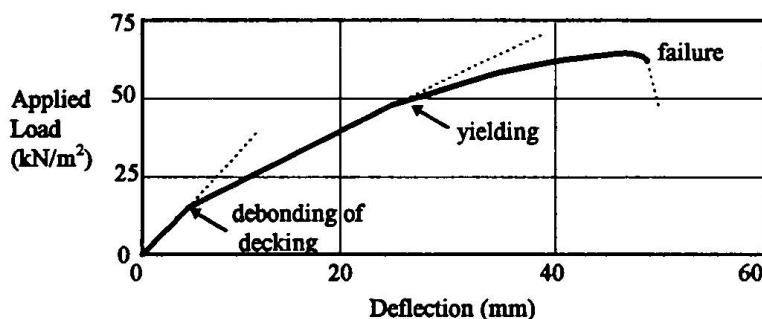
Fig. 4 Pre-Fire Load/Deflection Results for Internal Panel

The slabs were loaded in  $1.2\text{kN/m}^2$  intervals, until they approached failure when the loading increments were reduced to  $0.6\text{kN/m}^2$ . At a load of about  $15\text{kN/m}^2$ , the decking began to debond noisily from the concrete. It is likely that this was the point at which the concrete began to crack as well, but this was impossible to see with the decking in place. At this point, the stiffness of the slab reduced by about 60%. At about 2/3 of the ultimate load level, yielding of the decking began to occur and the rate of deflection progressively increased until failure.

In all cases, failure consisted of a sudden, shear failure along one of the edges parallel to the spanning direction of the slab. The failure loads are shown in Table 2. It can be seen that the strengths of the panels (except the post-fire internal panel) were considerably greater than the predicted yield line loads, particularly for the pre-fire internal panel.

In general, the failure load was related to the depth of the slab, which varied across the floor. However, the internal panel sustained a significantly higher load than the edge and corner slabs, even though it was the least deep. This implies that the internal slab was restrained to a greater extent by the surrounding slabs and beams indicating that there was a greater contribution of CMA to the load carrying capacity of the internal slab.

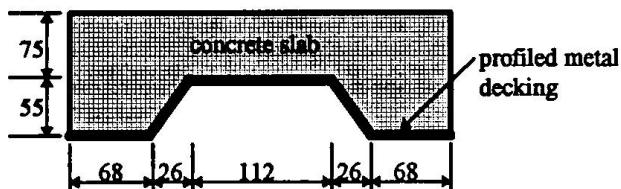
Fig. 5 Cross-section of composite slab strip

Four tests were carried out to assess the effect of fire on a slab. Two of the slabs were simply supported and two were laterally restrained using a rig that had been built for the purpose. The specimens were designed to be similar to the slabs at Cardington, so were made 3000 mm long and 130 mm deep. Comflor CF70 metal decking was used, as at Cardington, and a typical decking profile is shown in Fig 5. Debonding of the decking due to fire damage was simulated by greasing the decking with a release agent before casting the slab. The results of the tests are shown in Table 3.
