## Fire-resistant Structure: The Concrete Filled Steel Tubular Column

### Summary

The concrete filled steel tubular column for supporting a furnace at one glass factory has been firstly used in the world, with a total number of 70 columns in four rows. Hundreds of tons of high-temperature molten glass leaked out onto the ground at the bottom of the furnace columns and caused the fire. These columns had not miraculously been burnt away in the fire and had still effectively supported the furnace weight. This paper presents the fire situation, structure damaged status and mending work, and evaluates the fire-resistant characteristics of these columns.

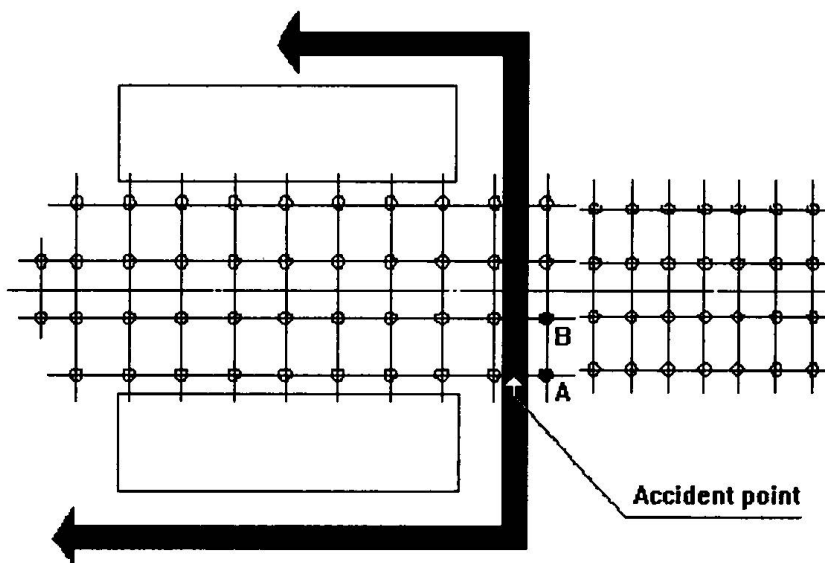
Figure 1

The concrete filled steel tubular column for supporting glass furnace was firstly used at one Chinese large glass factory in 1992, and it succeeded completely. The plane size of the furnace is  $50\text{ m} \times 10\text{ m}$ . At the furnace bottom, there are 70 columns altogether, four rows, eighteen teams (figure 1). The column grid is  $3\text{ m} \times 4\text{ m}$ . Each column is 7300 mm high,  $\Phi 245\text{ mm}$ , C 30 concrete used. The cross-section of the column is only 1/14 of the traditional reinforced concrete square column for  $3' \times 3'$  ( $914\text{ mm} \times 914\text{ mm}$ ) in size.

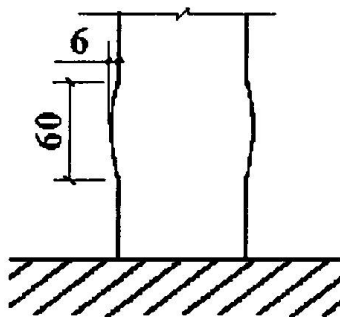
Figure 2

After cutting off the solidified glass rock which was still over  $100^{\circ}\text{C}$  on its surface, we found that there was a circle of convex vestige at each root of column A and B which had risen because of buckling (figure 2). The convex vestige rise cylinder about 6 mm. The leaning lateral deflection of the lower part of column A was about 3.0 cm. But the two column were still supporting about 80 % of the design load acting on their top. The steel II-beam was roasted by the poured down molten glass from the accident point, and had about 3.0cm shear deformation (figure 3). The rendering and protective coating of the boundary beam on the second floor were scoured and peeled off. By the flowing molten glass, several hoop reinforcements in the boundary beam had already been faintly visible. The concrete floor slab was already map cracking and loose.

We sleeved the root of column A and B with two  $\Phi 500 \text{ mm} \times 5 \text{ mm}$  semicircle steel tubes 2.5 m high, then butted and welded them together, and poured the gap with C 30 concrete. The work finished in eight hours. In addition, we added the channel steel to both side of the damaged main steel II-beam and laid them directly onto the top of column to replace the action of the former main beam. The loose concrete of the platform was cut off and repaired after the production resumed. The resumption of the normal production showed that the reinforcement we did was successful.
