Artikel: Fire-resistant structure: the concrete filled steel tubular column

Fire-resistant Structure: The Concrete Filled Steel Tubular Column

Summary

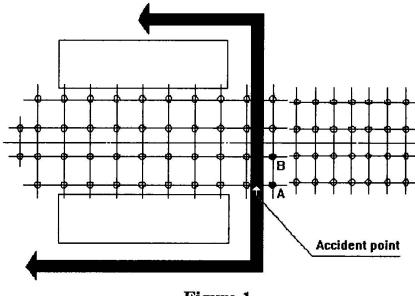
Figure 1

The concrete filled steel tubular column for supporting glass furnace was firstly used at one Chinese large glass factory in 1992, and it succeeded completely. The plane size of the furnace is 50 m \times 10 m. At the furnace bottom, there are 70 columns altogether, four rows, eighteen teams (figure 1). The column grid is 3 m×4 m. Each column is 7300 mm high, Φ 245 mm, C 30 concrete used . The cross-section of the column is only 1/14 of the traditional reinforced concrete square column for 3 ' \times 3 '(914 mm \times 914 mm) in size.

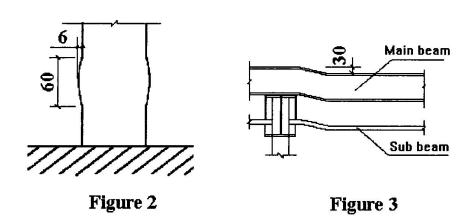
After cutting off the solidified glass rock which was still over 100 °C on it's surface, we found that there was a circle of convex vestige at each root of column A and B which had risen because of buckling(figure 2). The convex vestige rise cylinder about 6 mm. The leaning lateral deflection of the lower part of column A was about 3.0 cm. But the two column were still supporting about 80 % of the design load acting on their top. The steel II-beam was roasted by the poured down molten glass from the accident point, and had about 3.0 cm shear deformation (figure 3). The rendering and protective coating of the boundary beam on the second floor were scoured and peeled off. By the flowing molten glass, several hoop reinforcements in the boundary beam had already been faintly visible. The concrete floor slab was already map cracking and loose.

We sleeved the root of column A and B with two Φ 500 mm \times 5 mm semicircle steel tubes 2.5 m high, then butted and welded them together, and poured the gap with C 30 concrete. The work finished in eight hours. In addition, we added the channel steel to both side of the damaged main steel II-beam and laid them directly onto the top of column to replace the action of the former main beam. The loose concrete of the platform was cut off and repaired after the production resumed. The resumption of the normal production showed that the reinforcement we did was successful.

(1) The buckling deformation of column A and B under high temperature was similar to that of short concrete filled steel tubular column pressed by axial pressure under normal temperature in laboratory. The common ground was that the column top did not unload or unloaded little when the cross-section at column root yielded. The whole column could still keep safe and work on, and the vicious sudden failure did not occur like reinforced concrete structure or steel construction did when the cross-section yielded or the stability lost. It kept the structure safe fundamentally.
