Artikel: Fire-resistant structure: the concrete filled steel tubular column
Autor: Lin, Ping-Zhou / Zhu, Zong-Cheng / Li, Zhi-Jun
DOI: <https://doi.org/10.5169/seals-1001>

Fire-resistant Structure: The Concrete Filled Steel Tubular Column

Summary

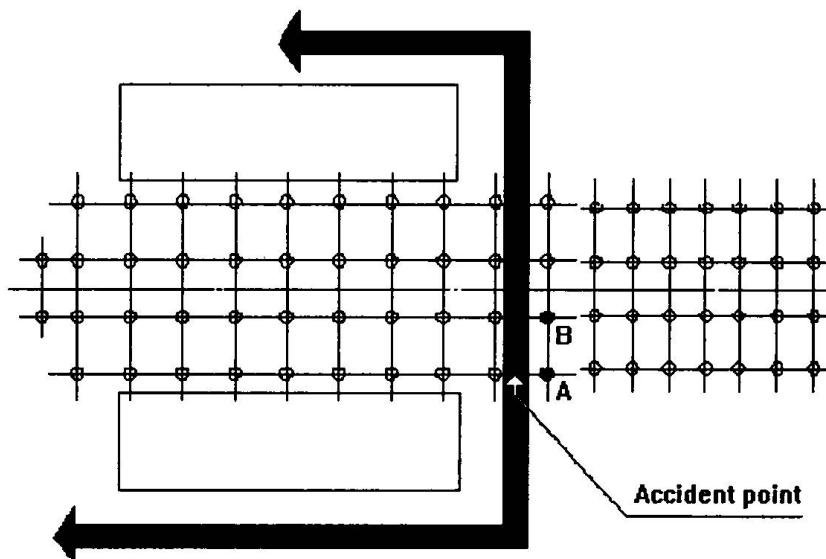
Figure 1

The concrete filled steel tubular column for supporting glass furnace was firstly used at one Chinese large glass factory in 1992, and it succeeded completely. The plane size of the furnace is 50 m × 10 m. At the furnace bottom, there are 70 columns altogether, four rows, eighteen teams (figure 1). The column grid is 3 m × 4 m. Each column is 7300 mm high, Φ 245 mm, C 30 concrete used. The cross-section of the column is only 1/14 of the traditional reinforced concrete square column for 3' × 3' (914 mm × 914 mm) in size.

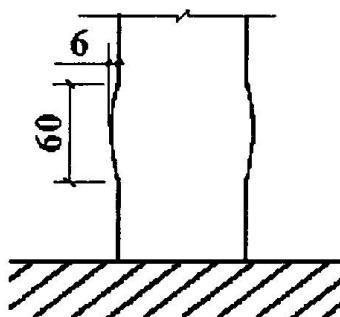
Figure 2

After cutting off the solidified glass rock which was still over 100 °C on its surface, we found that there was a circle of convex vestige at each root of column A and B which had risen because of buckling (figure 2). The convex vestige rise cylinder about 6 mm. The leaning lateral deflection of the lower part of column A was about 3.0 cm. But the two column were still supporting about 80 % of the design load acting on their top. The steel II-beam was roasted by the poured down molten glass from the accident point, and had about 3.0cm shear deformation (figure 3). The rendering and protective coating of the boundary beam on the second floor were scoured and peeled off. By the flowing molten glass, several hoop reinforcements in the boundary beam had already been faintly visible. The concrete floor slab was already map cracking and loose.

We sleeved the root of column A and B with two $\Phi 500 \text{ mm} \times 5 \text{ mm}$ semicircle steel tubes 2.5 m high, then butted and welded them together, and poured the gap with C 30 concrete. The work finished in eight hours. In addition, we added the channel steel to both side of the damaged main steel II-beam and laid them directly onto the top of column to replace the action of the former main beam. The loose concrete of the platform was cut off and repaired after the production resumed. The resumption of the normal production showed that the reinforcement we did was successful.
