Artikel: Fire-resistant structure: the concrete filled steel tubular column
Autor: Lin, Ping-Zhou / Zhu, Zong-Cheng / Li, Zhi-Jun
DOI: <https://doi.org/10.5169/seals-1001>

Fire-resistant Structure: The Concrete Filled Steel Tubular Column

Summary

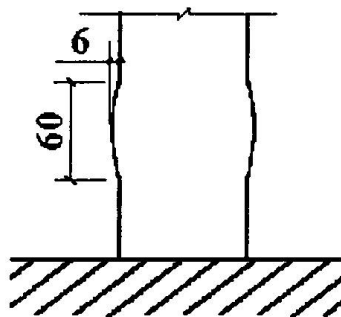
Figure 2

After cutting off the solidified glass rock which was still over 100°C on its surface, we found that there was a circle of convex vestige at each root of column A and B which had risen because of buckling (figure 2). The convex vestige rise cylinder about 6 mm. The leaning lateral deflection of the lower part of column A was about 3.0 cm. But the two columns were still supporting about 80 % of the design load acting on their top. The steel I-beam was roasted by the poured down molten glass from the accident point, and had about 3.0 cm shear deformation (figure 3). The rendering and protective coating of the boundary beam on the second floor were scoured and peeled off. By the flowing molten glass, several hoop reinforcements in the boundary beam had already been faintly visible. The concrete floor slab was already map cracking and loose.

We sleeved the root of column A and B with two $\Phi 500 \text{ mm} \times 5 \text{ mm}$ semicircle steel tubes 2.5 m high, then butted and welded them together, and poured the gap with C 30 concrete. The work finished in eight hours. In addition, we added the channel steel to both side of the damaged main steel II-beam and laid them directly onto the top of column to replace the action of the former main beam. The loose concrete of the platform was cut off and repaired after the production resumed. The resumption of the normal production showed that the reinforcement we did was successful.
