**Zeitschrift:** IABSE reports = Rapports AIPC = IVBH Berichte  
**Band:** 77 (1998)

**Artikel:** Fatigue life of railway bridge welded joints  
**Autor:** Wichtowski, Bernard / Czajkowski, Tomasz  
**DOI:** <https://doi.org/10.5169/seals-58197>

## Fatigue Life of Railway Bridge Welded Joints

### ABSTRACT

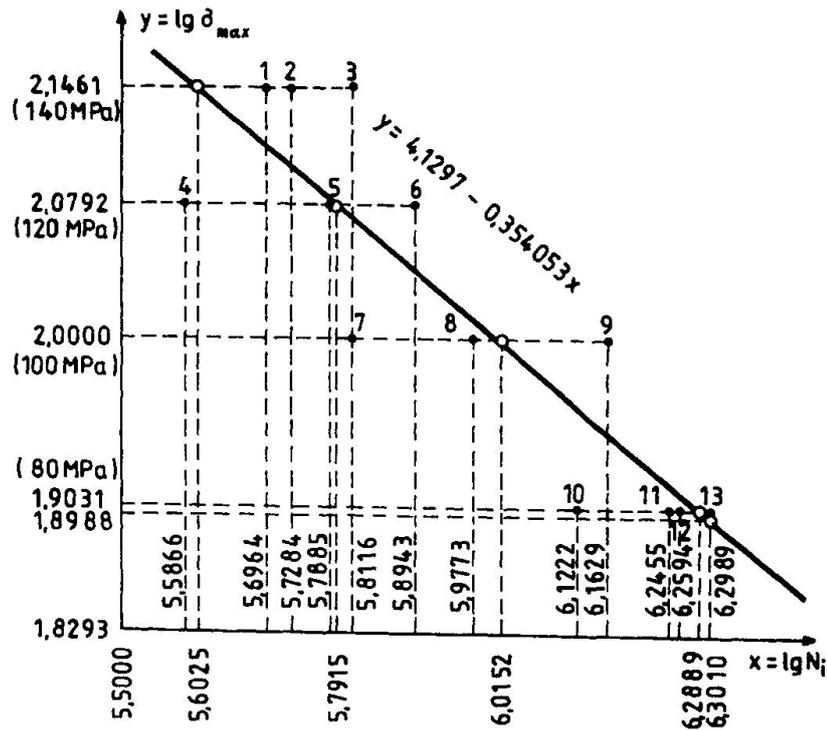
The tests were carried out under pulsating tension at 4 levels of the nominal stress: 140, 120, 100 and 80 MPa, by means of a pulsator at frequency of 500 cycles per minute. The cycle stress ratio ( $R = \sigma_{\min} / \sigma_{\max}$ ) was equal to  $R = 0,1$ . On the basis of the test results, by means of the least square method, the following regression line equation was formulated:

$$y = 4,1297 - 0,354053 x$$

where:  $x = \lg N_i$ ,  $y = \lg \sigma_{\max}$ ,  $N_i$  - number of cycles to the specimen failure,  $\sigma_{\max}$  - maximum value of stress, in MPa.

The value of mean safe fatigue strength derived from the regression line equation for  $N_i = 2 \cdot 10^6$  cycles was  $Z_{ij} = 79,2$  MPa, and for  $N_i = 10^5$  cycles was  $Z_{ij} = 228,8$  MPa.

Regression line derived from fatigue tests

The analysis of the unfactored stresses calculated at joints under the dead and service load as compared to the fatigue limits obtained from the laboratory test as well as from the literature data was a decisive factor in the way of treating the joints with cracks.

4 bridges were reinforced with additional cover plates riveted to the flanges. The welds with cracks in 5 other bridges, though inadmissible in bridge structures, were decided to be left without reinforcement - which was based on the relatively small value of the computed stresses, lower than the safe fatigue strength obtained from the laboratory tests. At the same time a periodical X-ray inspections of the joints were recommended. The subsequent, three-times-repeated inspections of these bridges did not show any changes or development of new cracks, and this despite a great number of train passages which was estimated at  $1,6 \cdot 10^6$  cycles within a 50-year period of bridge operation.
