**Zeitschrift:** IABSE reports = Rapports AIPC = IVBH Berichte  
**Band:** 77 (1998)

**Rubrik:** Session 4: Materials and technology

## Strengthening of Building Structures with FRP-Fabrics

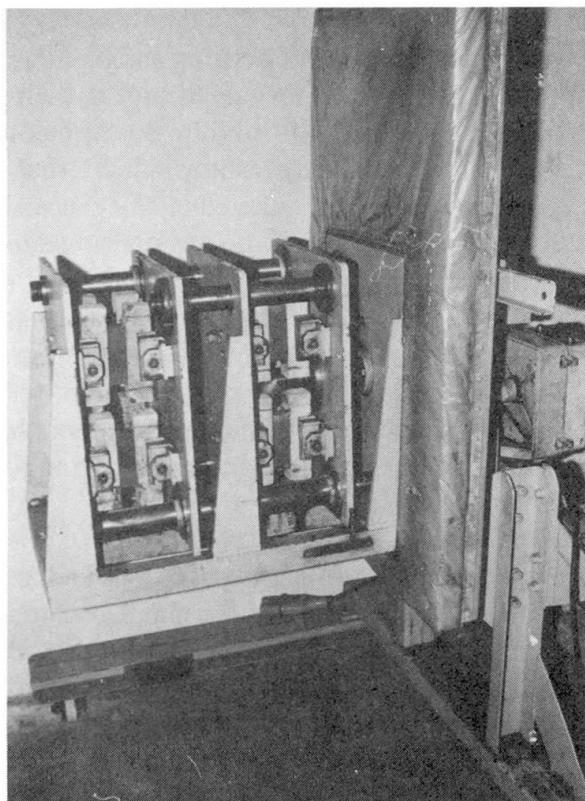
*Fig. 2 Extension/compression test machine*

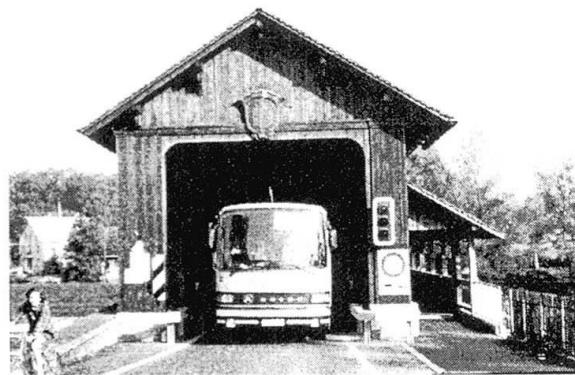
Fig. 3: Bridge Luzern

Wooden bridges are often classified as monuments. It is therefore essential that the increased safety demands are met with almost unvisible measures without changing exterior appearance.
