Zeitschrift: IABSE reports = Rapports AIPC = IVBH Berichte
Band: 77 (1998)

Rubrik: Session 4: Materials and technology

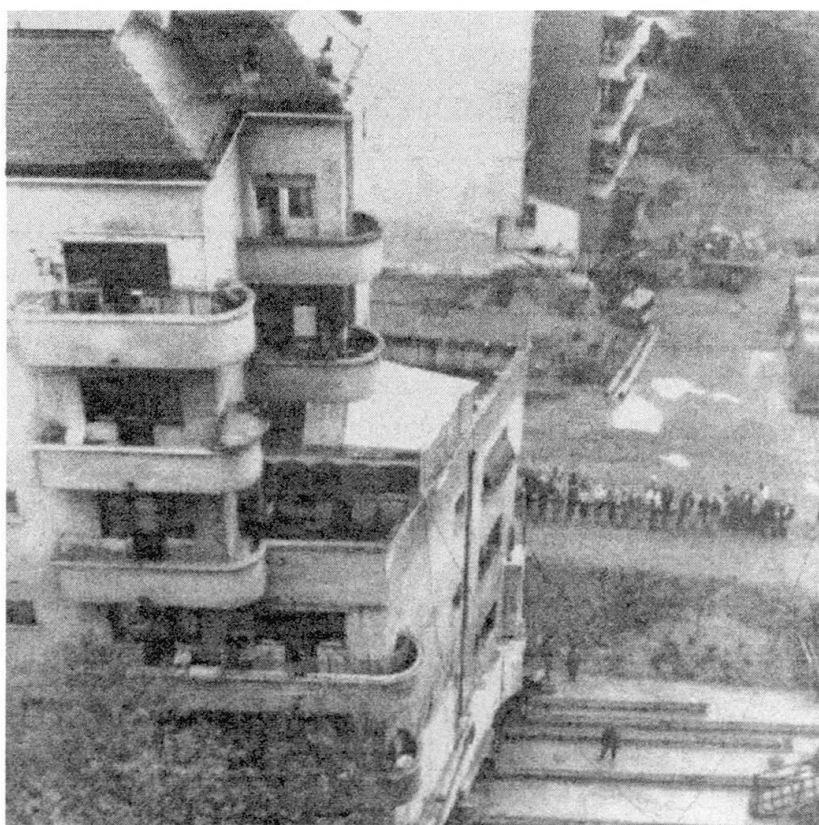
Fig.1 Translation of building from Aurel Vlaicu Street, Bucharest

The replaced constructions were churches, dwelling and social-administrative buildings, hospitals, memorial houses etc. Fig. 1 presents the displacement of a seven story block of flats in Aurel Vlaicu Street, Bucharest, on a built surface of 2245 m² and a structural weight of 5100 tones. The considerably height building was 14.4 m displaced at a speed of 1.9 m/h by means of 52 bogies pulled by two electrical cable hoists.
