Session 4: Materials and technology

Zeitschrift: **IABSE reports = Rapports AIPC = IVBH Berichte**

Band (Jahr): **77 (1998)**

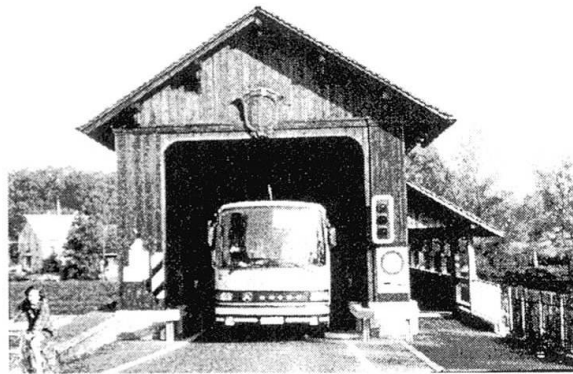
Fig. 3: Bridge Luzern

Wooden bridges are often classified as monuments. It is therefore essential that the increased safety demands are met with almost invisible measures without changing exferion appearance.
