**Zeitschrift:** IABSE reports = Rapports AIPC = IVBH Berichte  
**Band:** 77 (1998)

**Rubrik:** Session 4: Materials and technology

## Strengthening of Building Structures with FRP-Fabrics

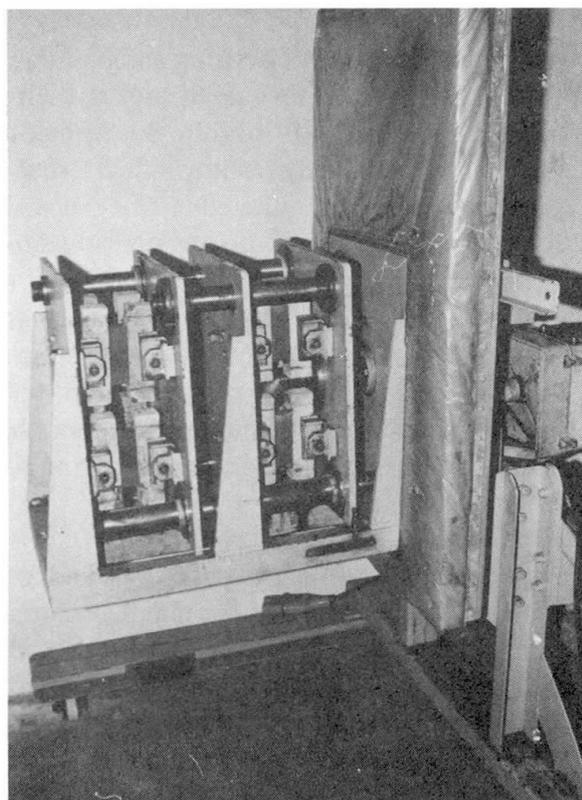
*Fig. 2 Extension/compression test machine*

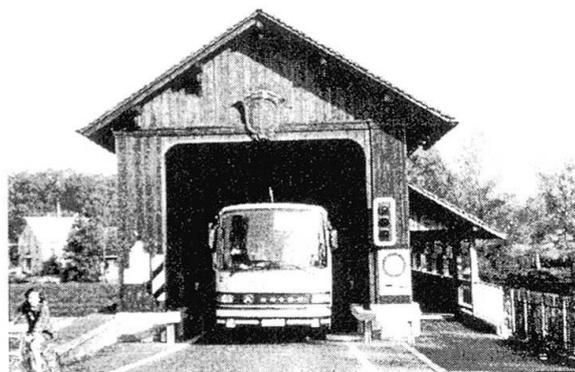
Fig. 3: Bridge Luzern

Wooden bridges are often classified as monuments. It is therefore essential that the increased safety demands are met with almost invisible measures without changing exferion appearance.
