Zeitschrift: IABSE reports = Rapports AIPC = IVBH Berichte

Band: 77 (1998)

Rubrik: Session 6: Repair and rehabilitation methods of historical buildings

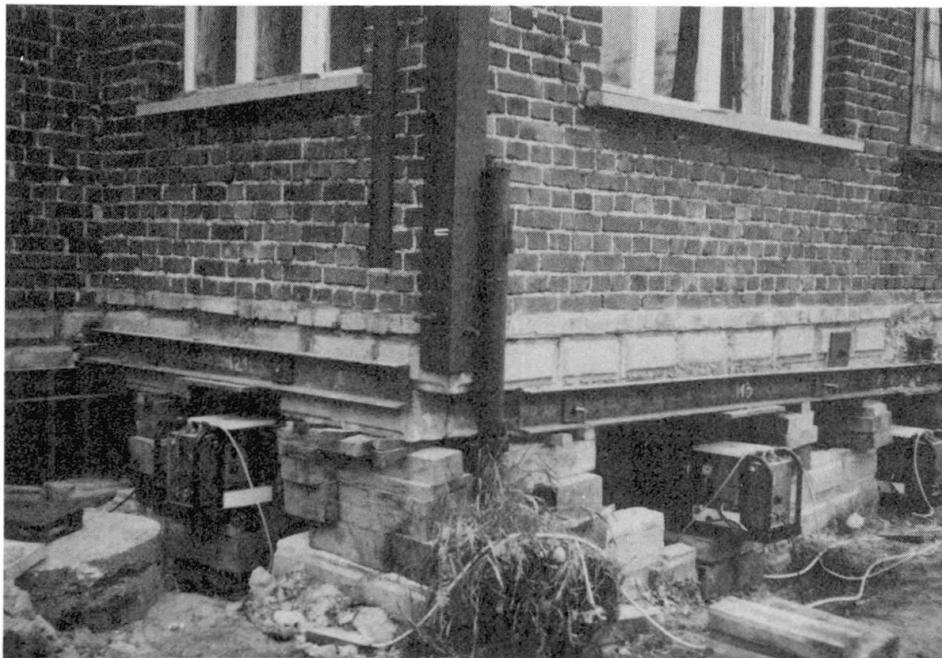
Fig.2 Built in jacks in cellar storey

is two channel bars running on both sides of the torn walls. Fig.2 shows built in jacks in cellar storey.
