Zeitschrift: IABSE reports = Rapports AIPC = IVBH Berichte

Band: 77 (1998)

Rubrik: Session 6: Repair and rehabilitation methods of historical buildings

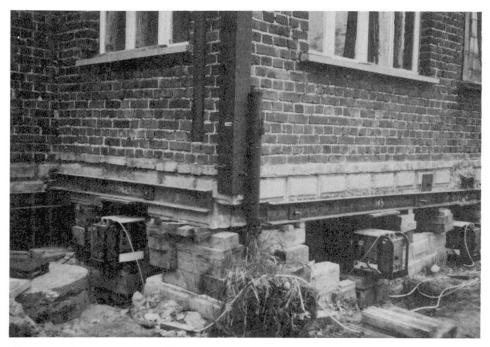
Fig. 2 Built in jacks in cellar storey

is two channel bars running on both sides of the torn walls. Fig.2 shows built in jacks in cellar storey.

The process of rectification of the building comprises three stages. During stage one the building is being torn. Stage two is parallel lifting. Levelling stage is the essential rectification stage and it resolves itself into non- uniform lift of the building.
