# Session 1: Evaluation of deterioration of buildings

Zeitschrift: **IABSE reports = Rapports AIPC = IVBH Berichte**

Band (Jahr): **77 (1998)**

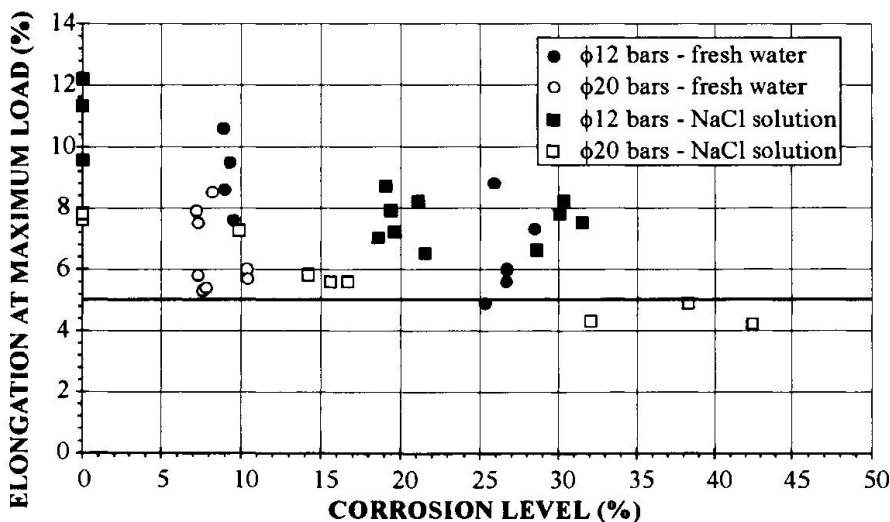
Fig 2. Relationship between elongation at maximum load and corrosion level

The results of tensile tests hint yield stress and tensile stress do not decrease for cross section losses lower than 20%, corrosion range that includes the majority of actual cases of generalized corrosion. On the other hand, a systematic and important reduction of elongation at maximum load was observed both for rebars corroded in water with chlorides and those damaged in fresh water (Fig. 2). The results indicate reductions of elongation at maximum load of about 20% for cross section losses of 10%. When corrosion level achieves values about of 25%-30%, elongation at maximum load decreases 40% approximately.
