**Zeitschrift:** IABSE reports = Rapports AIPC = IVBH Berichte  
**Band:** 77 (1998)

**Rubrik:** Session 1: Evaluation of deterioration of buildings

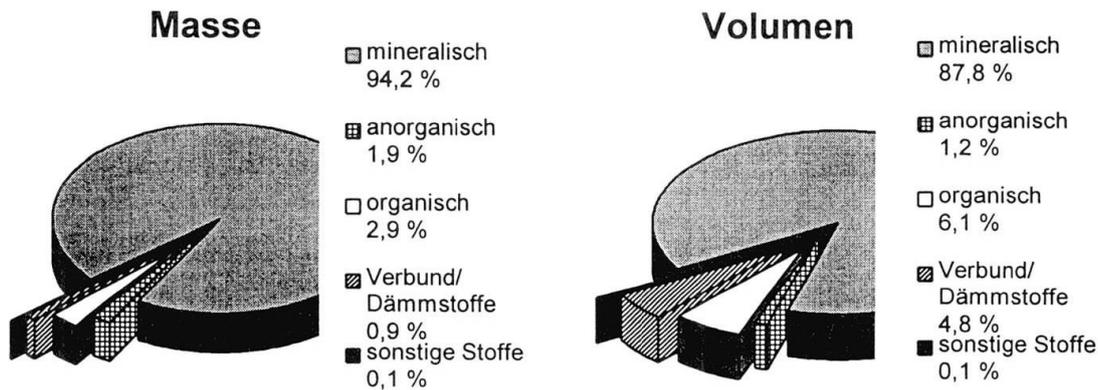
Fig. 1 Usage of Building Materials in Buildings of Various Age Groups as a Mass Percentage Distribution

The investigation has shown that more than 80 % of the building material masses of the examined residential buildings can be apportioned to the loadbearing structure, and less than 20 % on the finishes. A displacement of the building material masses from the loadbearing construction to finishes is recognisable in the younger building groups. This emphasises the increased use of building materials in the area of finishes due to the increasing requirements made for thermal and sound insulation. The classification of the total mass of all examined residential buildings into the individual building element groups according to DIN 276 has shown the dominance of external walls and floor/ceiling construction each with a value of 31 % for multi-family houses, followed by internal walls with 21 %. For single family houses the proportion for external walls with 39 % is much more characteristic, instead the floor/ceiling construction portion is barely 21 % and the internal walls with 14 % are of less influence. Taking the external and internal walls together, it becomes apparent that the proportion of the walls for single and multi-family housing in total are almost identical with just over 50 % of the total mass.

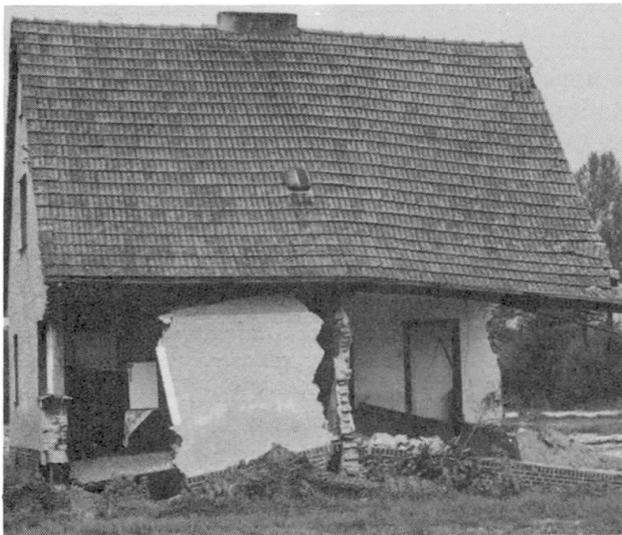
*Fig 1. Sudeten development destroyed by the flood in 1997.*

These have lost also their functional and aesthetic qualities. Due to age distribution of this development and lack of repairs 54.4% of buildings approach the limit of functional deterioration which is assumed to be 90 years. About 42% of dwellings are without bathrooms, 63% have no WCs and 28% are without sanitary system. Presently, this situation is even worse due to damages caused by flood in July 1997. A full scope of damages is now difficult to determine precisely since in the winter, the frozen water in soaked walls will surely cause additional damages.

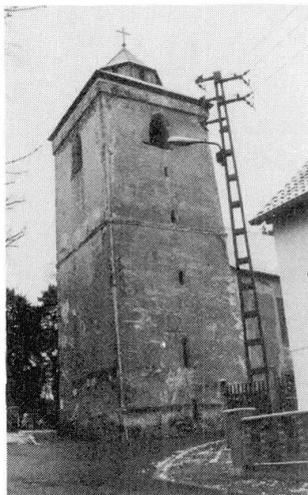
Fig. 1 : The bell tower, view from south-west

The appearance of the medieval Krölpa church tower is significantly characterized by its inclination which was caused by an uneven settlement of the ground. Today the tower is about 2.2 degrees out of the vertical and shows deep vertical cracks in the masonry of its four walls. These damages gave the reason for an investigation of the dynamic structural behaviour of the tower in its current state. It was intended to identify dynamic system properties as well as to model the structure with its specifics numerically.

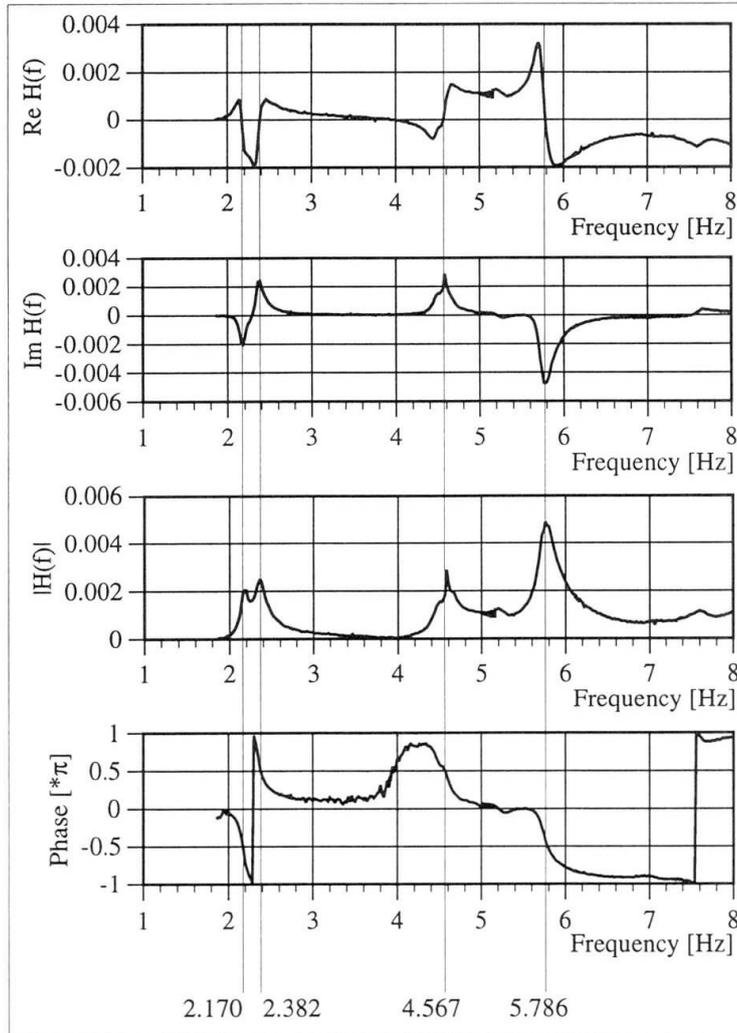
Fig. 2: Complex transfer function of acceleration obtained from the measurements (accelerometer at level B, NE-corner, N-S-direction, excitation E-W, max.  $F=2.0$  kN)

The phase angles were directly determined from the complex transfer functions. The obtained curves allowed the identification of four resonances. Modal damping ratios for the resonance frequencies could be deduced from the phase angles at resonance.

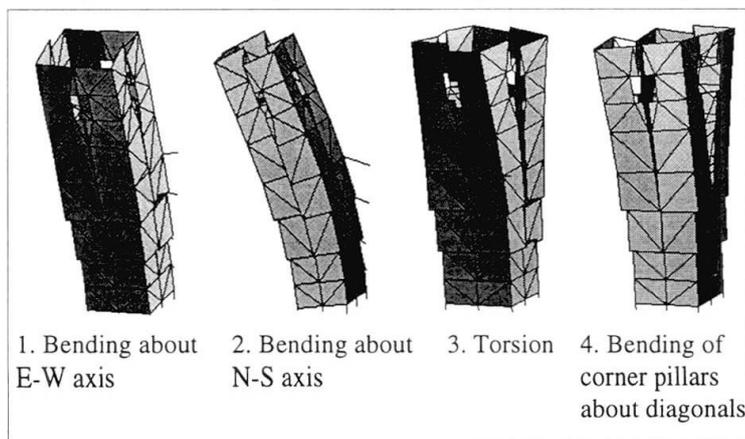
Fig. 3: First four identified mode shapes

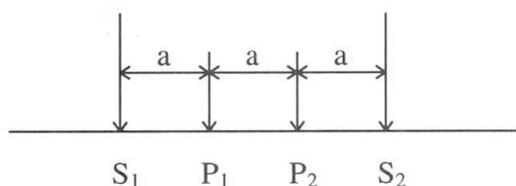
Fig. 1: Electrode configuration of the Wenner spread

The physical model used in this research consists of an insulated sandbox with embedded blocs (fig 2). The physical model simulates a wall of which the geometrical boundaries, the localisation and dimensions of the inhomogeneities, the electrical properties and the moisture content of the masonry are well known. The inhomogeneities are simulated by insulated cubes with varying dimensions which are burried in the sand at a certain depth. The measurements are done with the electrode configuration of the Wenner-spread (fig 1).

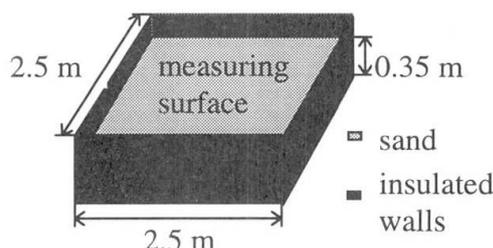
Fig. 2: Physical model: insulated sandbox

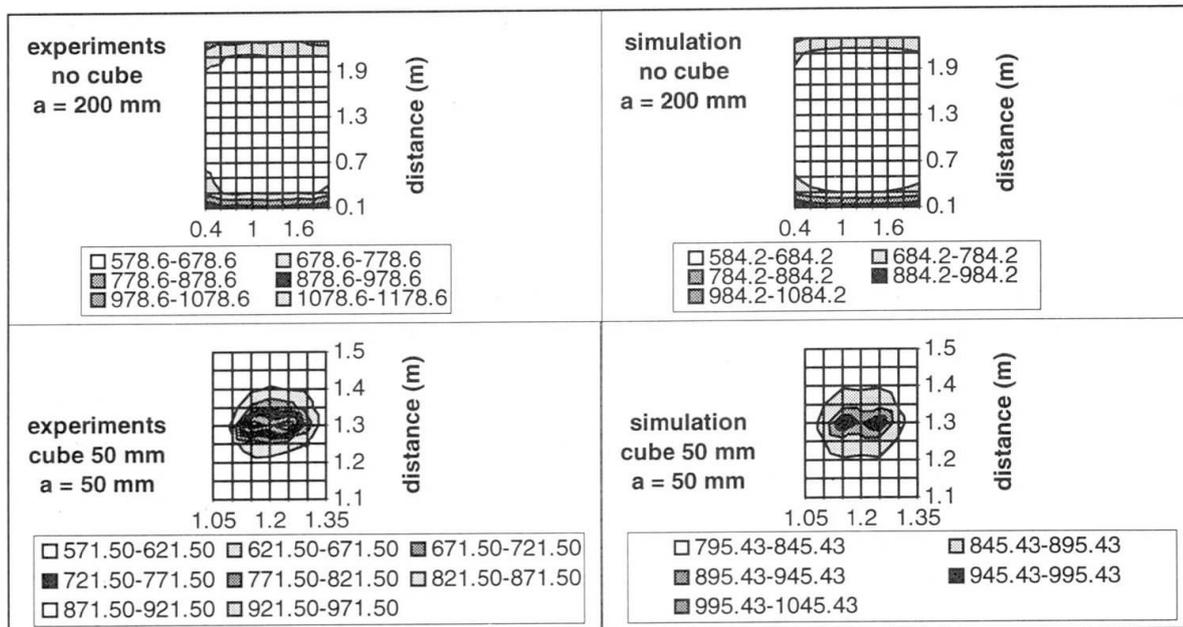
Fig 4: Comparison between experimental research and simulations (values in ohmm)

Some typical results of the measurements and the simulations are given in figure 4.

From this research we may conclude that the numerical model is able to simulate the influence of the geometrical boundaries and the inhomogeneities. It is accurate enough to be used for calibration and filtering of site measurements.

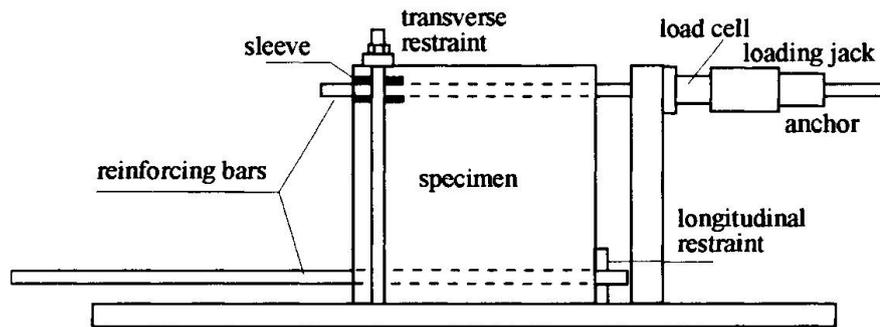
Fig 1. Bond test arrangement

Pullout bond tests were carried out on  $300 \times 350 \times 350$  mm concrete specimens with 20 mm diameter bars arranged in the four corners. A cover to diameter ratio of 1.5 was examined and the embedded length was  $14\phi$  in all cases. The test method used simulates anchorage conditions in a part of a beam submitted to constant shear force, and allows to reproduce the most usual bond failure on reinforced concrete structures: splitting failure in the concrete cover (Fig. 1). For corroding the rebars the concrete in which they were embedded was contaminated with 3% calcium chloride by weight of cement and later a direct current of a  $0.1\text{mA}/\text{cm}^2$  density was impressed on each bar embedded in the pullout specimens. Several corrosion levels were reached producing crack widths ranging from 0.1 mm to 0.4 mm and cross section loss up to 5%. Various amounts of transverse reinforcement were also arranged: no stirrups,  $\phi 6$  mm stirrups at 200 mm and  $\phi 8$  mm stirrups at 10 mm.

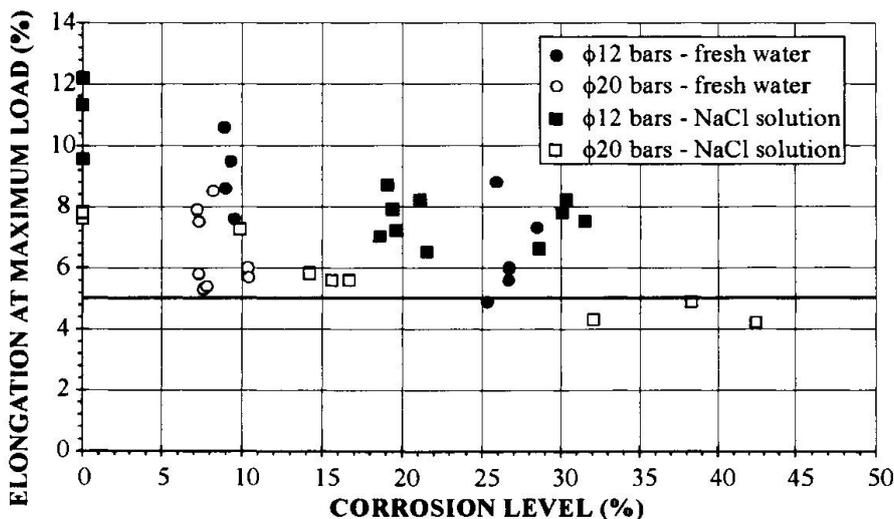
Fig 2. Relationship between elongation at maximum load and corrosion level

The results of tensile tests hint yield stress and tensile stress do not decrease for cross section losses lower than 20%, corrosion range that includes the majority of actual cases of generalized corrosion. On the other hand, a systematic and important reduction of elongation at maximum load was observed both for rebars corroded in water with chlorides and those damaged in fresh water (Fig. 2). The results indicate reductions of elongation at maximum load of about 20% for cross section losses of 10%. When corrosion level achieves values about of 25%-30%, elongation at maximum load decreases 40% approximately.

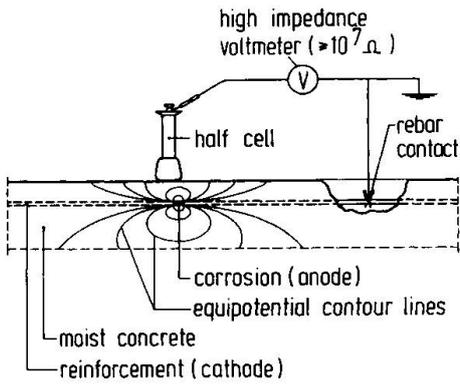
Fig. 1 Scheme for potential measurements with a half cell on the surface of a reinforced concrete member

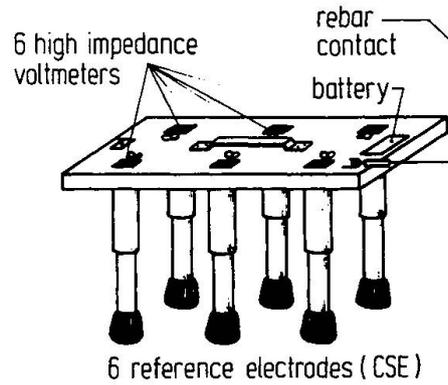
Fig. 4 View of the developed frame with 6 CSE half cells

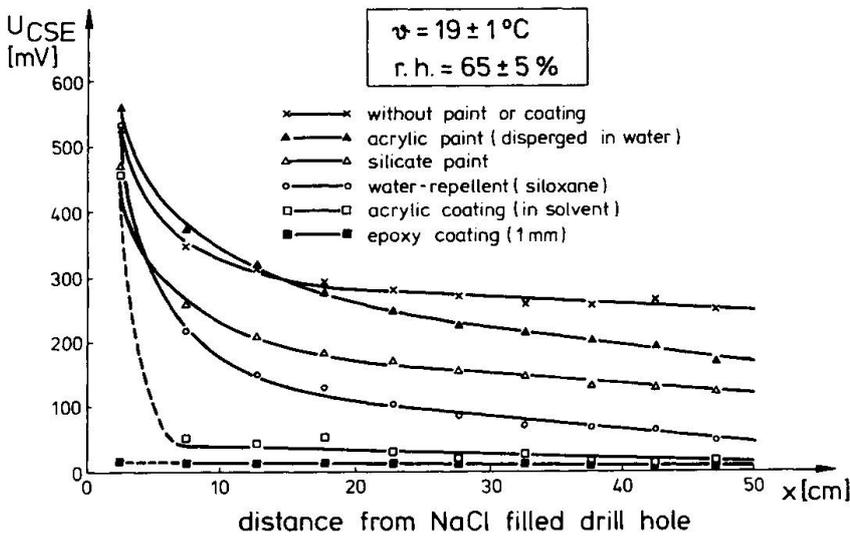
Fig. 2 Dependence of the potential  $U_{CSE}$  on the distance  $x$  to the NaCl filled drill hole for different paints or coatings on the concrete surface

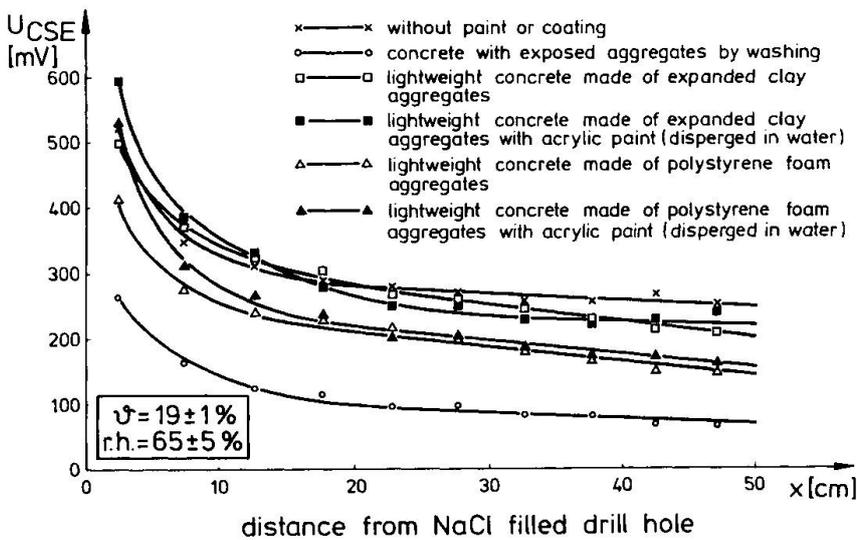
Fig. 3 Dependence of the potential  $U_{CSE}$  on the distance  $x$  to the NaCl filled drill hole for different lightweight concretes with or without thin acrylic paint

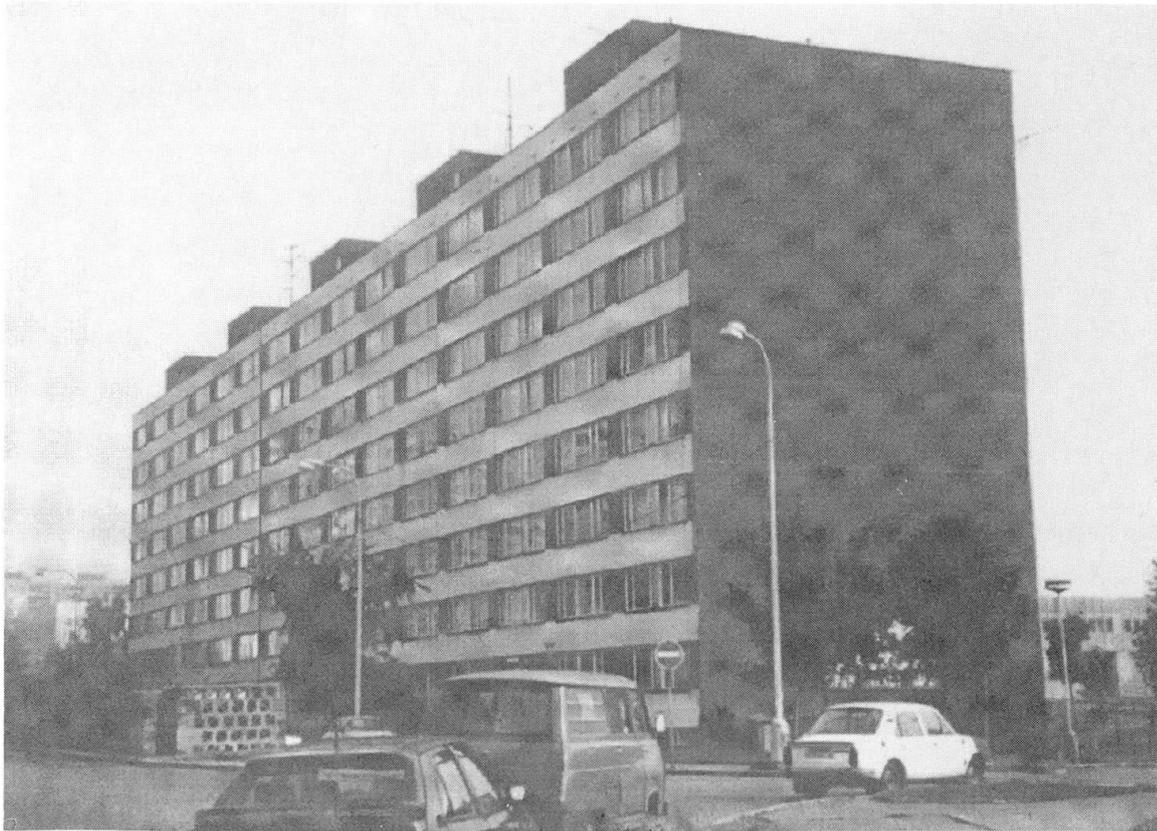
*Fig. 1: Photograph of the tested panel building*

The experiments described below were proposed in order to elaborate data on the true mechanical behaviour of panel buildings in the horizontal direction. The aim of the experiments was to make an experimental evaluation of the sensitivity of the compressive stresses due to the horizontal movement of the structure. The horizontal movement of the structure was measured from the ambient vibrations of the structure simultaneously with the stresses in the base of the structure.

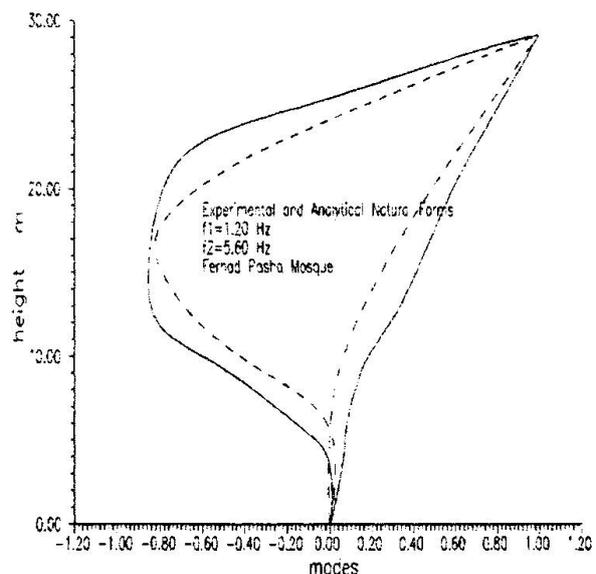
Fig. 1 Calculated and measured mode forms

Experimental results indicated poor structural state and they were used to establish a real distribution of mass and stiffness along the height and to attribute earthquake forces, according to the real stiffness distribution. By knowing the measured results, reliable mathematical model could have been established and further analytical studies were made. Seismic strengthening was necessary and the chosen strengthening method did not disturb the mosque's historic value and was simple enough for construction.

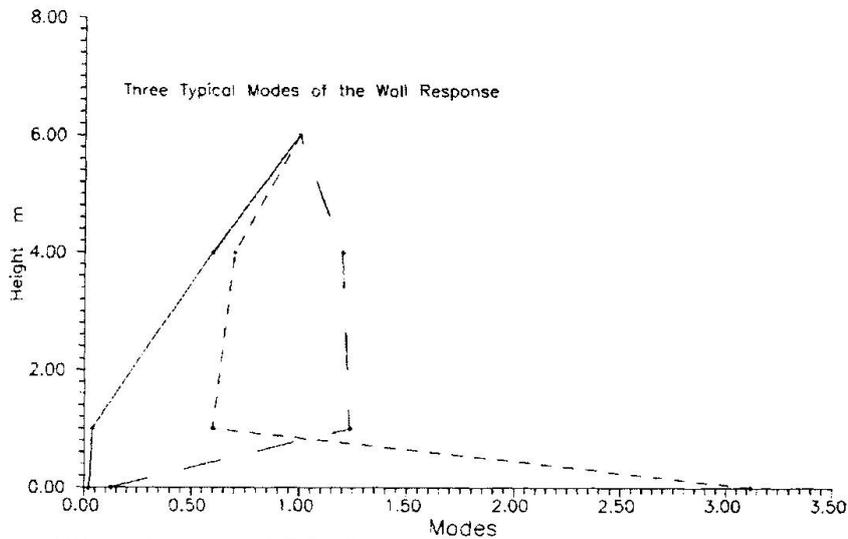
*Fig 2. Three typical measured mode forms*

Dynamic testing of the wall sections was performed as the only applicable method for evaluation of the structural state. Two methods were applied: (a) impulse tests and (b) transfer function test. As a result of both methods, wall response to dynamic excitation along the height was obtained, and the mode shapes of vibration

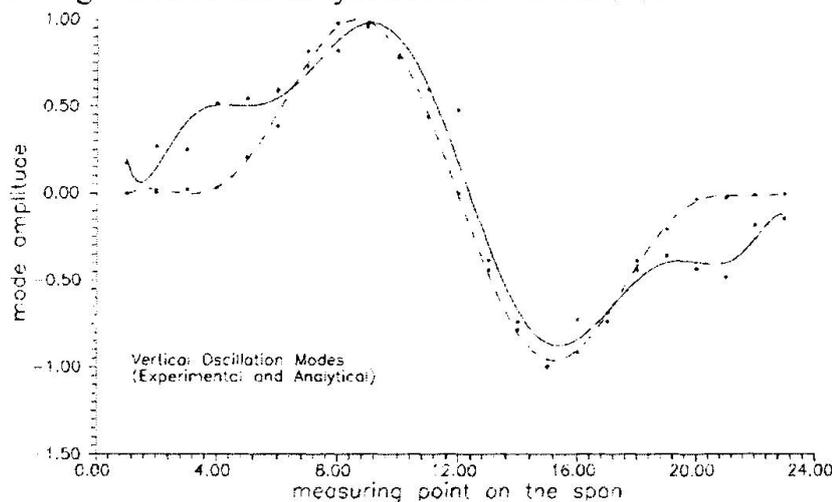
*Fig. 3 Vertical mode shapes*

The measured mode shapes revealed that for vertical loading bridge behaves as an arch but of a smaller span, while for the perpendicular direction it behaves as a beam with fixed supports. Based on the experimental results, analytical model was modified until a satisfactory correlation among measured and analytical results was achieved.

Good correlation is obvious, and such mathematical model could be used for structural analysis and to check the influence and meaning of the various strengthening methods.

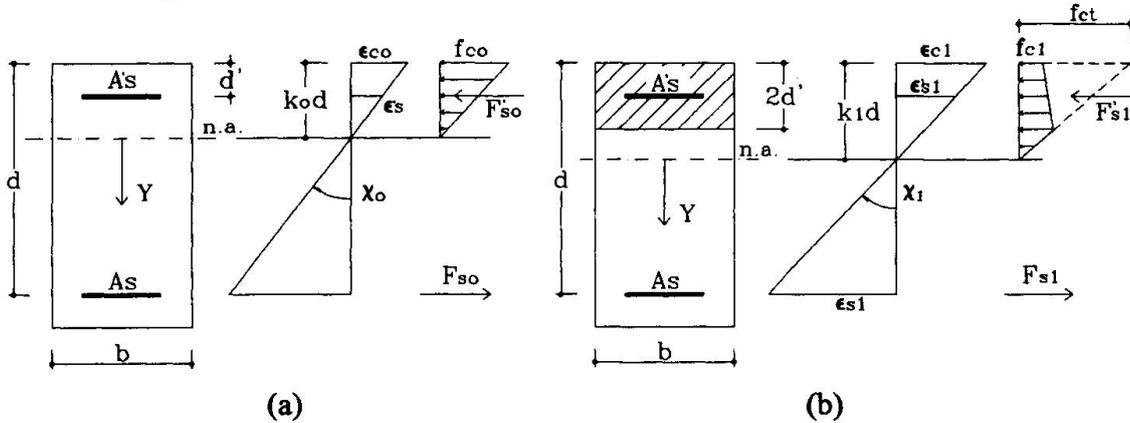
Fig. 1 - (a) Undamaged section ; (b) Damaged section

$$D.F. = D \cdot \left(1 - \frac{k_1}{2 \cdot \alpha}\right) - \left(\frac{D}{2 \cdot \alpha}\right) \cdot \eta \quad (4)$$

The value of  $D$  may be related to the strain  $\epsilon_{c1}$  of the extreme fiber of compressive concrete of damaged section :
