**Zeitschrift:** IABSE reports = Rapports AIPC = IVBH Berichte  
**Band:** 77 (1998)

**Rubrik:** Session 8: Assessment and rehabilitation of existing buildings after accidents

## Seismic Rehabilitation of Existing Buildings in Romania

## War and Earthquake Damage in Dubrovnik: Preventive and Remedial Measures

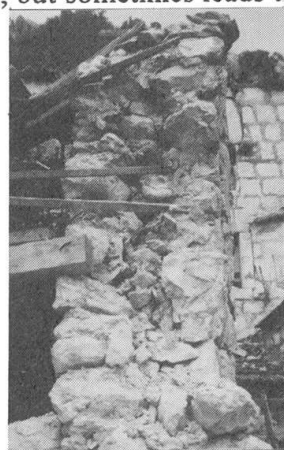
Fig. 2

*Intrinsic weakness of the sack masonry* (weak bond, decay of the mortar): which explains the detachment of blocks in the external skin and the collapse of entire sections of wall. (Fig. 2).

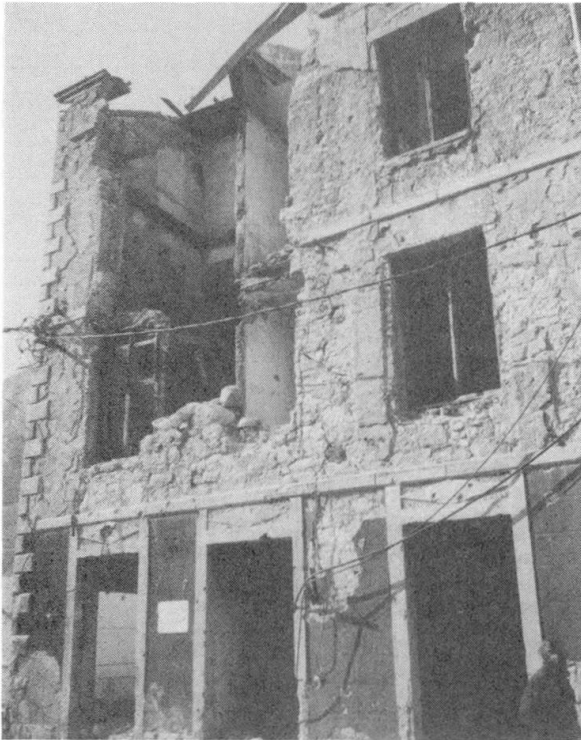
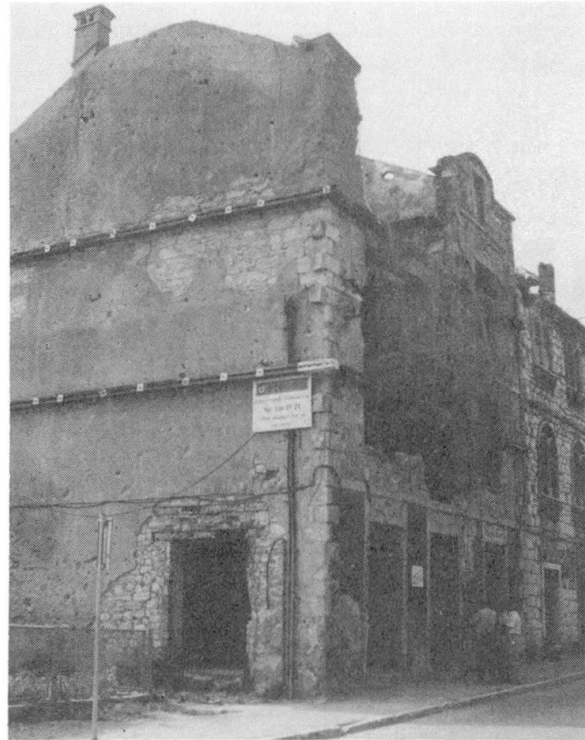
*Fig. 1 & 2 Example on Emergency Protection of building with historical value.*
