Zeitschrift: IABSE reports = Rapports AIPC = IVBH Berichte

Band: 77 (1998)

Rubrik: Session 8: Assessment and rehabilitation of existing buildings after accidents

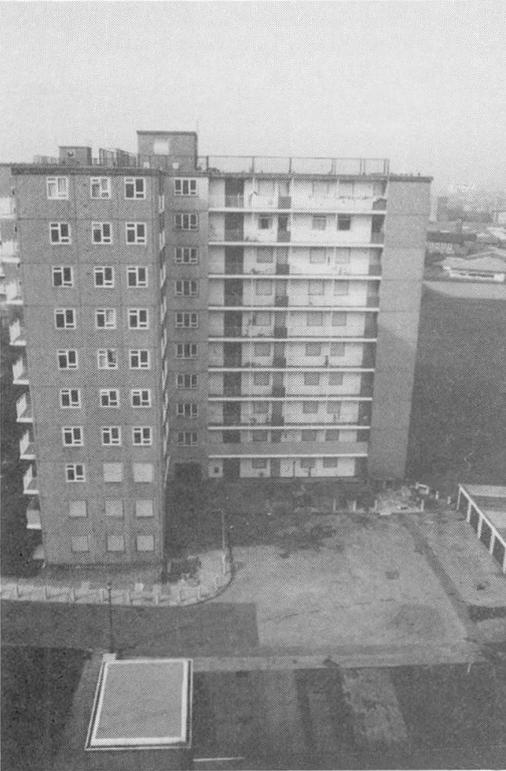
Fig. 1 External view of a Reema Conclad block
