**Zeitschrift:** IABSE reports = Rapports AIPC = IVBH Berichte  
**Band:** 77 (1998)

**Rubrik:** Session 8: Assessment and rehabilitation of existing buildings after accidents

## Seismic Rehabilitation of Existing Buildings in Romania

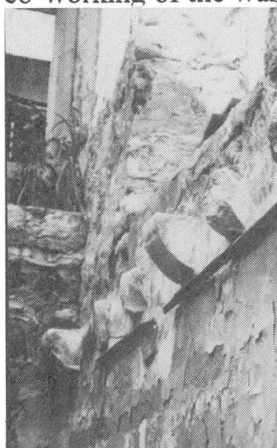
Fig. 1

In Dubrovnik the signs of shell impacts are still visible on the fronts of the houses: direct hits struck about 70 % of the 824 buildings of the inner city. Further damage was produced by the fires following to the explosions (Fig. 1): the roofs of 5 buildings were affected by fire and in 9 buildings the roofs and floors were completely destroyed. The damage caused by the earthquake of September 5<sup>th</sup> 1996 (peak ground acceleration of 0.6 g, epicentre 10 km SE from Ston) can be traced, however, to other causes. These are:

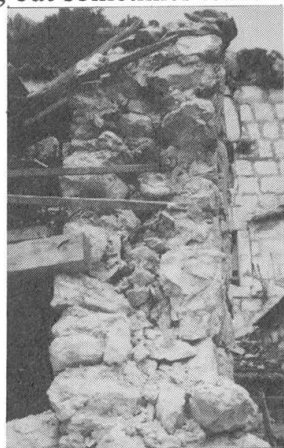
Fig. 2

*Intrinsic weakness of the sack masonry* (weak bond, decay of the mortar): which explains the detachment of blocks in the external skin and the collapse of entire sections of wall. (Fig. 2).

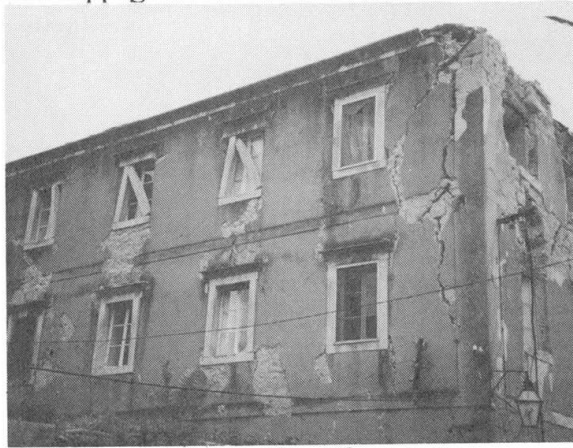
Fig. 3

*Structural weakness of the walls*: in the façades which were almost parallel to the seismic action (left façade in Fig. 3) cracks under the windows, due to the insufficient stiffness of the floor bands (reduced thickness of the zone under the windows, the lack of horizontal ties), were frequently noted; the façades almost perpendicular to the seismic action were often detached due to the inadequate connections to the lateral walls (left façade in Fig. 3).

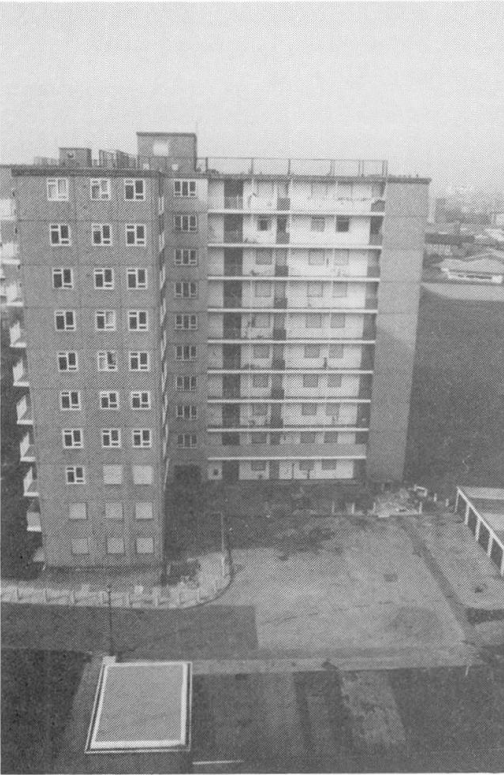
*Fig. 1 External view of a Reema Conclad block*
