Session 8: Assessment and rehabilitation of existing buildings after accidents

Zeitschrift: **IABSE reports = Rapports AIPC = IVBH Berichte**

Band (Jahr): **77 (1998)**

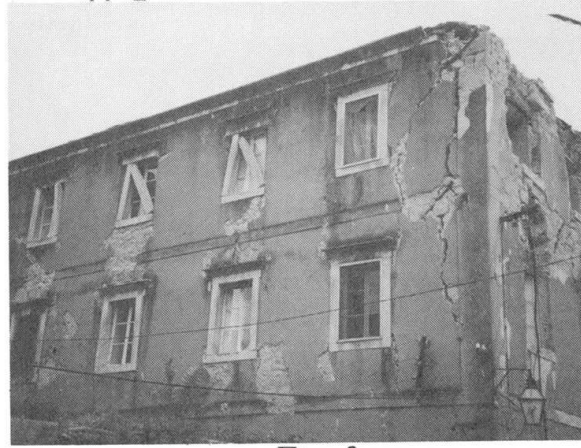
Fig. 3

Structural weakness of the walls: in the façades which were almost parallel to the seismic action (left façade in Fig. 3) cracks under the windows, due to the insufficient stiffness of the floor bands (reduced thickness of the zone under the windows, the lack of horizontal ties), were frequently noted; the façades almost perpendicular to the seismic action were often detached due to the inadequate connections to the lateral walls (left façade in Fig. 3).

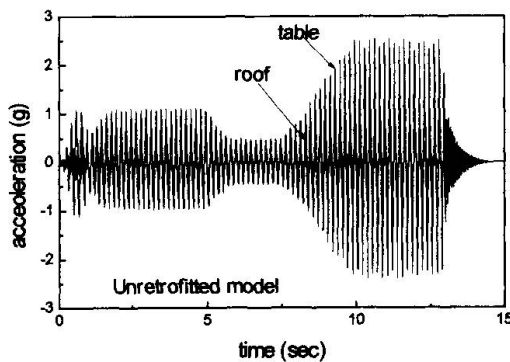
Fig. 1 Acceleration time histories on the table and on the roof of the unretrofitted model

Seismic tests were performed on the unretrofitted model with an additional load of 10 kN on the top of the specimen to increase the induced inertia forces. Testing was stopped just one step before total collapse of the specimen with severe damages at the top and bottom of the columns. The initial natural frequency of the specimen in the longitudinal axis was found to be 26.7 Hz. However, the natural frequency dropped to 8.7 Hz when a kentledge of 10 kN was positioned on the top of the model. Failure of the model occurred in a peak table acceleration of 2.5g, and the last seismic test was interrupted to prevent total collapse. Plastic hinges created in the columns resulted in the development of a column-sidesway failure mechanism as was anticipated. This, final shake was performed using a sine dwell input motion of 6.0 Hz. The natural frequency before the test was 6.75 Hz, and it dropped to 4.86 Hz after testing. In Fig. 1, acceleration time histories on the table and on the roof of the model are shown. It is clear that damage to the model initiated very early.
