Zeitschrift:	IABSE reports = Rapports AIPC = IVBH Berichte
Band:	77 (1998)
Rubrik:	Session 8: Assessment and rehabilitation of existing buildings after accidents

Seismic Rehabilitation of Existing Buildings in Romania

War and Earthquake Damage in Dubrovnik: Preventive and Remedial Measures

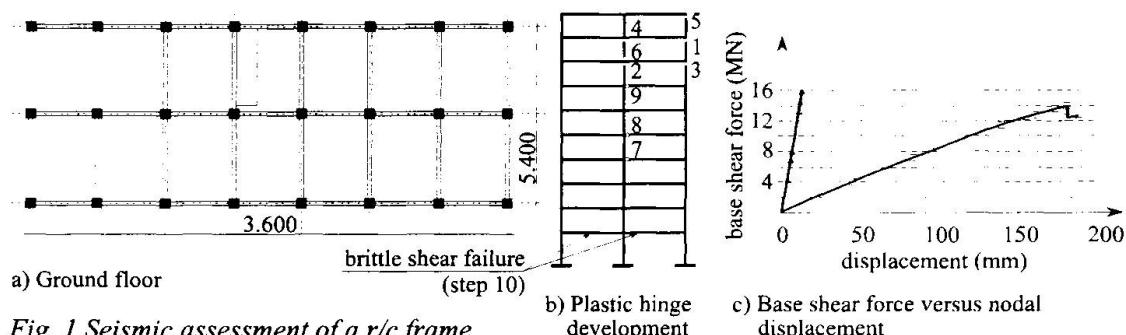
Fig. 1 Seismic assessment of a r/c frame

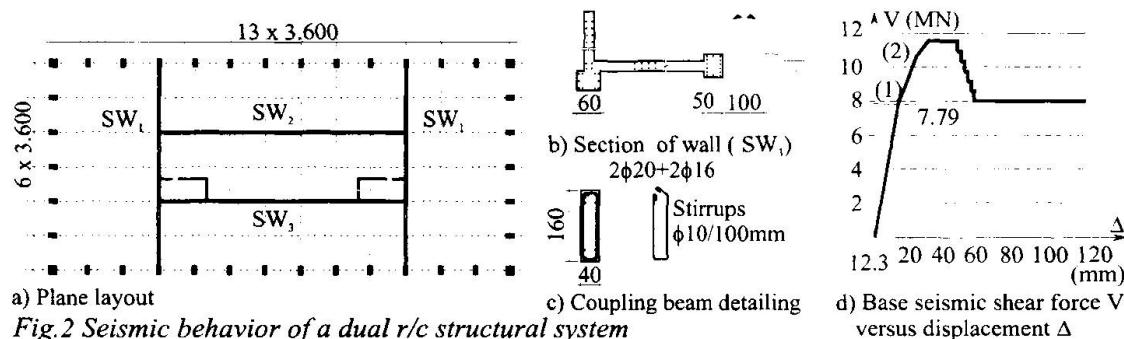
Fig. 2 Seismic behavior of a dual r/c structural system

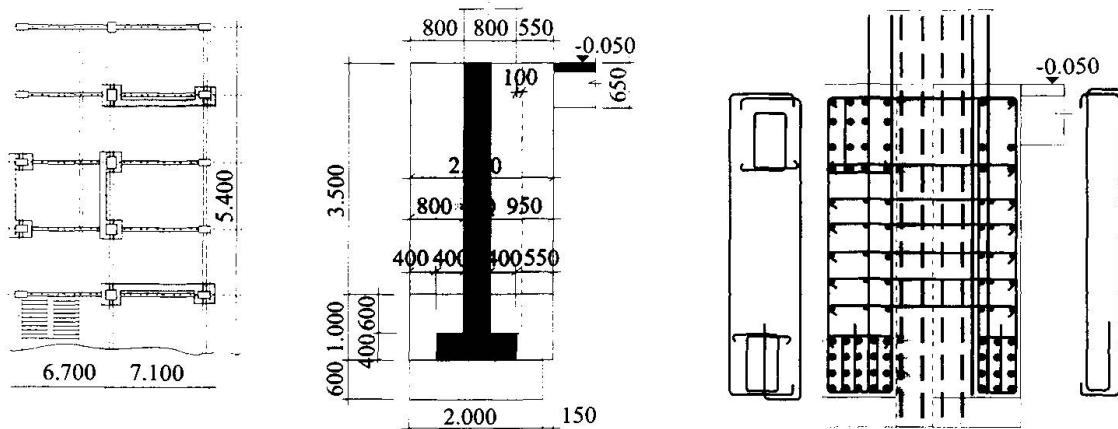
Fig. 5 Foundation system of a newly added structural wall.

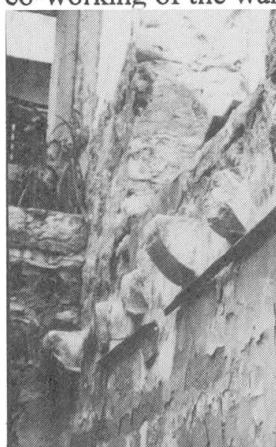
Fig. 1

In Dubrovnik the signs of shell impacts are still visible on the fronts of the houses: direct hits struck about 70 % of the 824 buildings of the inner city. Further damage was produced by the fires following to the explosions (Fig. 1): the roofs of 5 buildings were affected by fire and in 9 buildings the roofs and floors were completely destroyed.

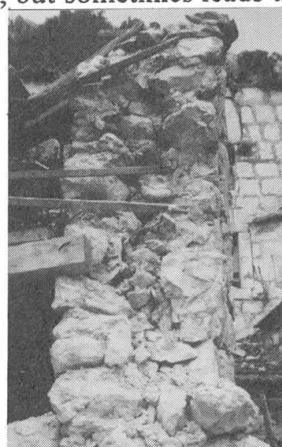
Fig. 2

Intrinsic weakness of the sack masonry (weak bond, decay of the mortar): which explains the detachment of blocks in the external skin and the collapse of entire sections of wall. (Fig. 2).

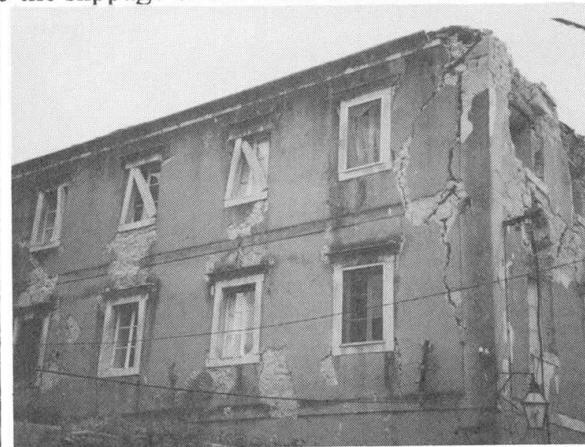
Fig. 3

Structural weakness of the walls: in the façades which were almost parallel to the seismic action (left façade in Fig. 3) cracks under the windows, due to the insufficient stiffness of the floor bands (reduced thickness of the zone under the windows, the lack of horizontal ties), were frequently noted; the façades almost perpendicular to the seismic action were often detached due to the inadequate connections to the lateral walls (left façade in Fig. 3).

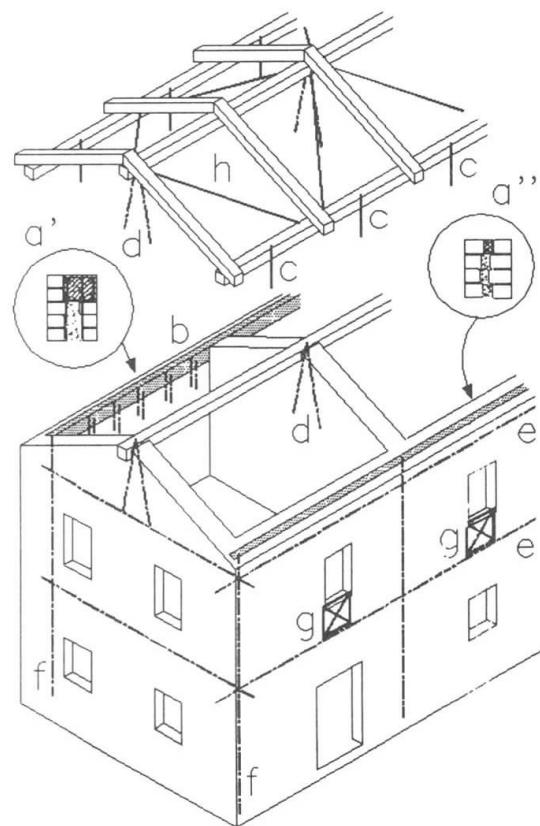
Fig. 4

- Insertion of horizontal ties at floor level to connect the walls together.
- Construction of a kind of "kerb" (Fig. 4a), using various possible technical solutions (Fig. 4a', 4a''), at the level of the roof to connect the upper part of the walls (fig. 4b) and to connect the roof to the main walls (Fig. 4c).

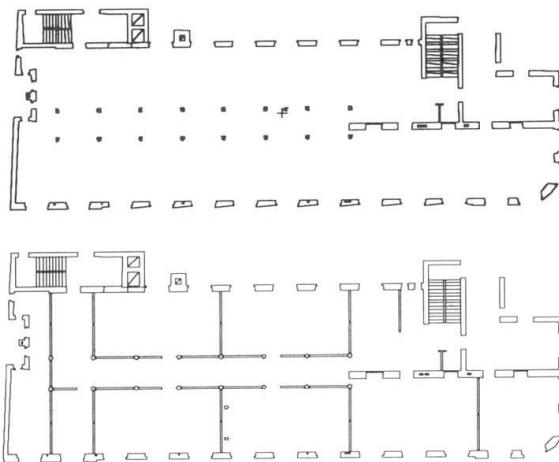
configurations of plan layouts, the one that is shown in Figure 2 was chosen. It was a compromise between the structural and the future user demands.

Figure 2 The plan of the existing and strengthened 1st floor

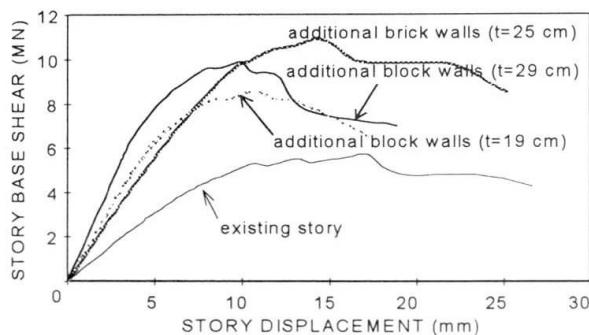
The earthquake resistance analysis is based on inelastic method. In Figure 3 the storey diagrams calculated for the weaker direction of building are compared.

Figure 3 Comparison of storey base shear diagrams in the case of confined walls

The influence of additional walls on the existing structure caused the lowering of torsional effects. The results of the analysis clearly show the importance of proper selection of materials and confinement of walls. It can be concluded that the most effective walls can be built from solid clay brick masonry that is less stiff than hollow block masonry of the same strength. Therefore one of the main tasks in the structural design of strengthening is selection of suitable materials. They should be compatible to the original materials as it can be seen from this case study.

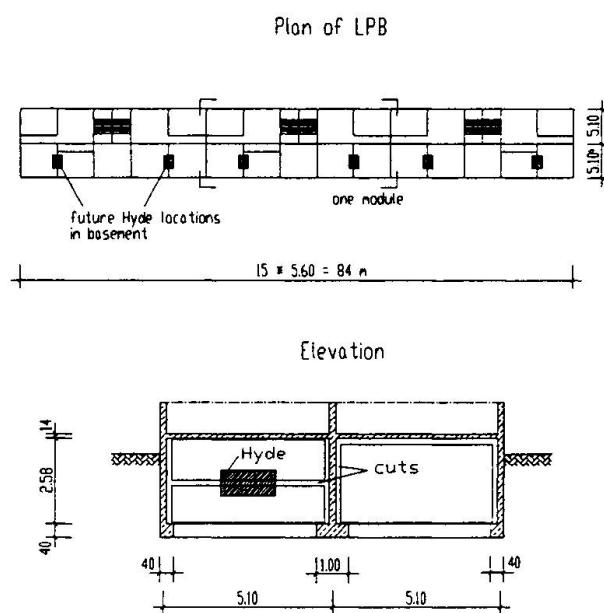
Fig 1: Plan and basement elevation of a typical 6 story LPB with possible Hyde locations.

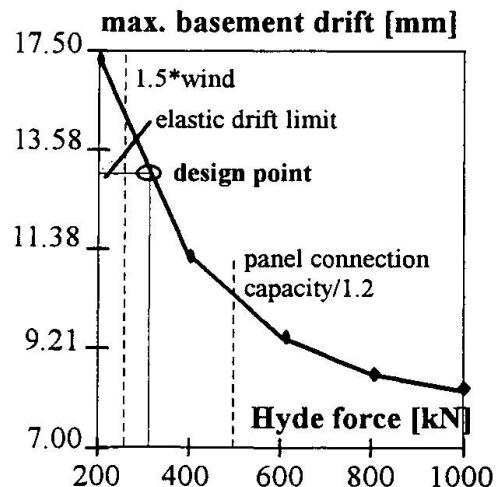
Large panel prefabricated buildings (LPBs) are very stiff by nature. Introducing only one seismic link in the basement produces a hysteretic device system which can be appropriately termed a "basement isolation" system. For this, all transverse walls in the basement must be cut free so that all horizontal forces are transmitted through the remaining walls with the seismic links (fig 1). A reliability study of a 6 story basement isolated LPB based on 500 generated earthquakes (Dorka, Ji, & Dimova 1997) yielded the design curve for the device forces (fig 2).

Fig 2: Design curve for Hyde forces in a 6 story LPB under Kalamata

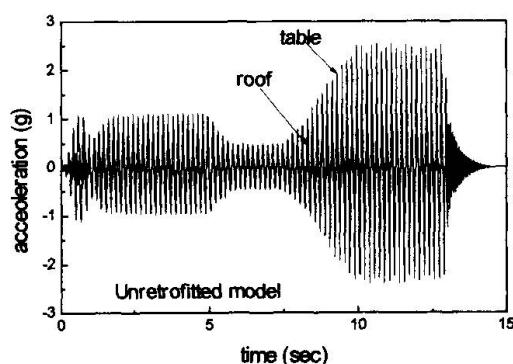
Seismic tests were performed on the unretrofitted model with an additional load of 10 kN on the top of the specimen to increase the induced inertia forces. Testing was stopped just one step before total collapse of the specimen with severe damages at the top and bottom of the columns. The initial natural frequency of the specimen in the longitudinal axis was found to be 26.7 Hz. However, the natural frequency dropped to 8.7 Hz when a kentledge of 10 kN was positioned on the top of the model. Failure of the model occurred in a peak table acceleration of 2.5g, and the last seismic test was interrupted to prevent total collapse. Plastic hinges created in the columns resulted in the development of a column-sidesway failure mechanism as was anticipated. This, final shake was performed using a sine dwell input motion of 6.0 Hz. The natural frequency before the test was 6.75 Hz, and it dropped to 4.86 Hz after testing. In Fig. 1, acceleration time histories on the table and on the roof of the model are shown. It is clear that damage to the model initiated very early.

Fig. 1 Acceleration time histories on the table and on the roof of the unretrofitted model

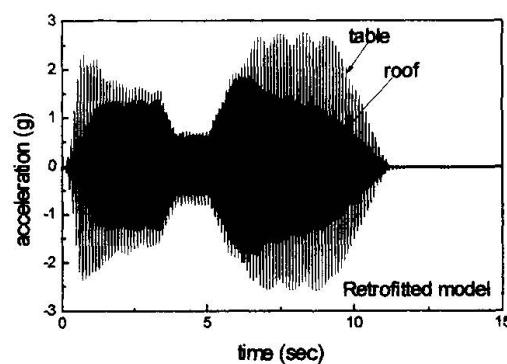
Fig. 2 Acceleration time histories on the table and on the roof of the retrofitted model

The natural frequency in the longitudinal axis of the retrofitted specimen was found to be 47.3 Hz which dropped to 11.75 Hz when a kentledge of 10 kN was added at the top of the specimen. Eleven seismic tests were performed with a kentledge of 10 kN at the top in a range of 0.50g to 2.60g peak table accelerations. In Fig. 2 the acceleration time histories on the table and on the roof of the model are shown for the test with a peak table acceleration 2.60g where plastic hinges started to form at the bottom of the columns and beam ends. At the end of testing the natural frequency was measured to be 5.45 Hz. However, the natural frequency dropped to 4.25 Hz when the additional weight on the top increased from 10 kN to 30 kN. Finally, four more seismic tests were performed with a kentledge of 30 kN at the top up to a shaking table acceleration 1.65g. From the test series it was evident that the concrete jacket contributed significantly to the seismic resistance of the structure. High levels of strains were measured on the longitudinal reinforcement of the jackets while the strains were considerably lower in the respective bars of the original columns. Finally it is concluded that concrete jacketing is a very effective seismic strengthening technique for reinforced concrete frame buildings, since stiffness, strength and ductility can be significantly enhanced. Moreover an undesirable column-sidesway failure mechanism can be transferred to a desirable beam-sidesway one.

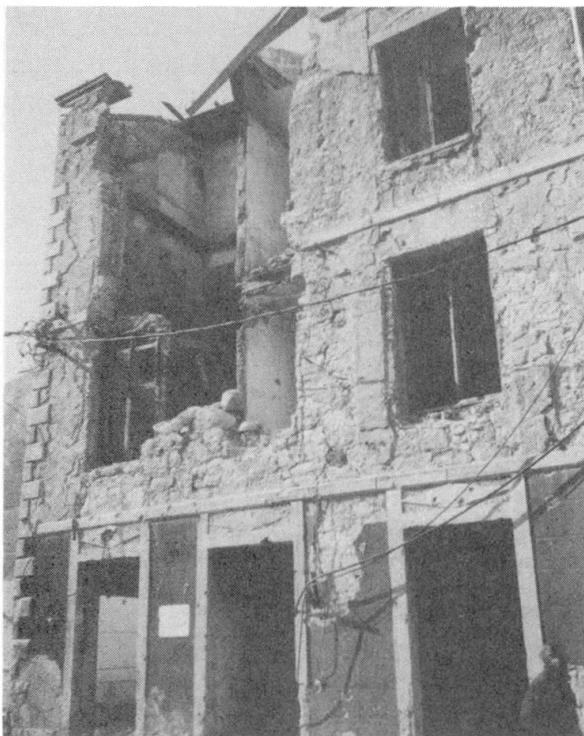
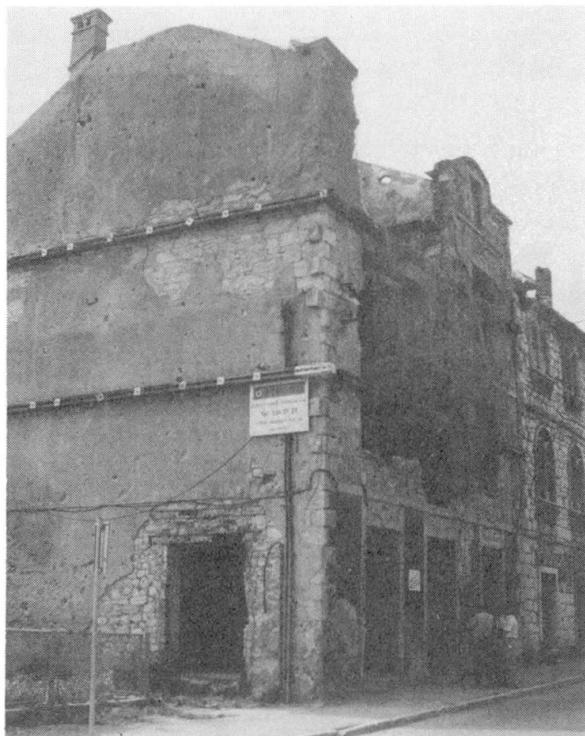
Fig. 1 & 2 Example on Emergency Protection of building with historical value.

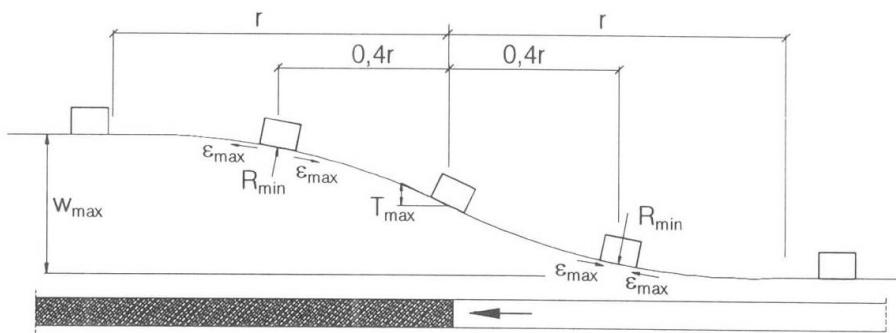
Land deformations which result from underground excavation activities, are manifested on the surface mostly in the form of regular subsidence trough (Fig. 1).

Fig. 1. Typical layout of a building situated in mine-induced subsidence trough, r - radius of mining impact range.

The shape of the subsidence trough may be described by the following indices, whose rate is determined by the geological and mining conditions pervading in given areas [1]: vertical displacement (subsidence) w , horizontal displacement u , tilt T , curvature K (or curvature radius $R = 1/K$) and horizontal strains ε .

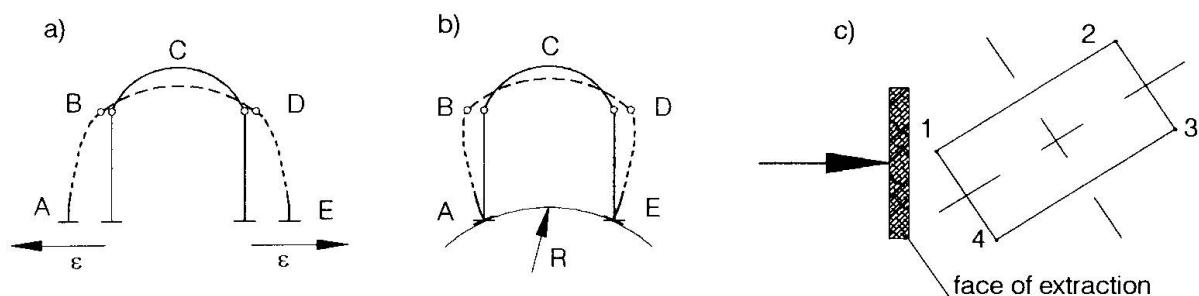
The diagram of the impact of convex subsidence trough upon the diagonal bearing elements of the discussed structures is illustrated in Fig. 2. Following the horizontal displacement of the foundations of pillars and walls due to the impact of horizontal strains, the supports at the vault abutments level are also displaced (Fig. 2 a). The impact of curvature radius evokes analogous results as to the quality of structure condition. Following the rotation of the supports of the structure, its abutments may also be horizontally displaced (Fig. 2 b). In both cases, the values of initial compressive stresses are reduced in all structural elements, which poses particular hazards to arches and vaults. Nevertheless, the most disadvantageous effect is produced when the building is set diagonally in the subsidence trough (Fig. 2 c), because its corners subside at different rates ($w_1 \neq w_2 \neq w_3 \neq w_4$). Due to low spatial stiffness characterising traditionally constructed church buildings, such impact results in considerable hazards to the resistance and stability of church vaults.

Fig. 2 Diagrams of the impact of subsidence trough on buildings.
