Artikel: Evaluation of deterioration of rural buildings in Poland
Autor: Trocka-Leszcynska, Elzbieta
DOI: <https://doi.org/10.5169/seals-58177>

Evaluation of Deterioration of Rural Buildings in Poland

Elzbieta TROCKA-LESZCZYNsKA

1. Sudeten Region

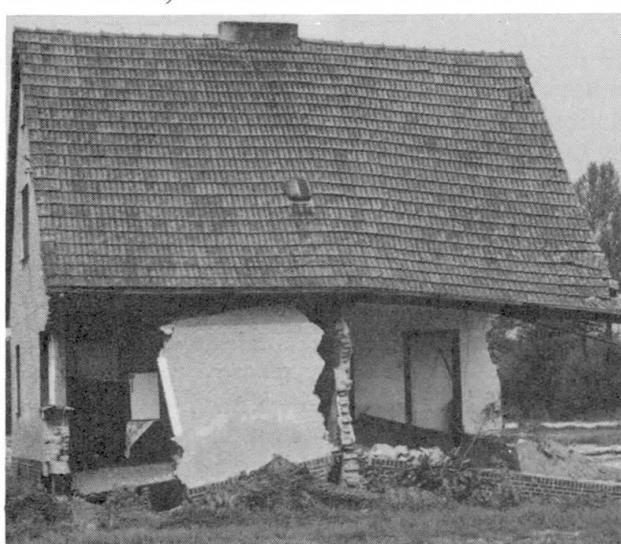
Fig 1. Sudeten development destroyed by the flood in 1997.

These have lost also their functional and aesthetic qualities. Due to age distribution of this development and lack of repairs 54.4% of buildings approach the limit of functional deterioration which is assumed to be 90 years. About 42% of dwellings are without bathrooms, 63% have no WCs and 28% are without sanitary system. Presently, this situation is even worse due to damages caused by flood in July 1997. A full scope of damages is now difficult to determine precisely since in the winter, the frozen water in soaked walls will surely cause additional damages.
