**Zeitschrift:** IABSE reports = Rapports AIPC = IVBH Berichte  
**Band:** 77 (1998)

**Artikel:** Locating rebar corrosion in concrete walls by potential measurements  
**Autor:** Marquardt, Helmut  
**DOI:** <https://doi.org/10.5169/seals-58183>

## Locating Rebar Corrosion in Concrete Walls by Potential Measurements

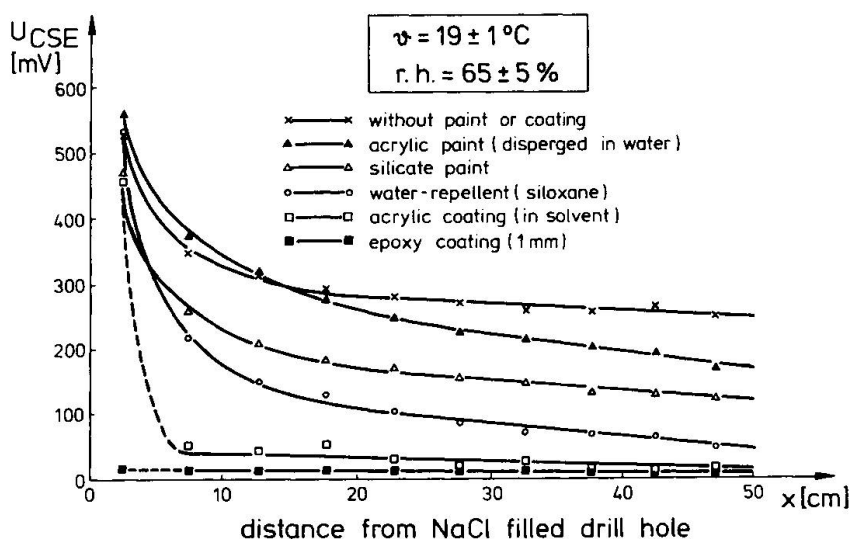
Fig. 2 Dependence of the potential  $U_{CSE}$  on the distance  $x$  to the NaCl filled drill hole for different paints or coatings on the concrete surface

- temperature and moisture of the concrete,
- thickness of the concrete covering,
- concrete surfaces with or without paints or coatings (fig. 2 and 3),
- components of zinc galvanized steel in concrete.

It could be shown that potential measurements do not depend on the temperature of the concrete but they were only possible between 30 and 90 % relative humidity of the surrounding atmosphere. Thick concrete coverings make it difficult to find small corrosion areas; fair-faced concrete walls coated e.g. with a thin acrylic paint are no problem (fig. 2), but on concrete surfaces with exposed aggregates by washing it is difficult to contact the cement grout (fig. 3). The interpretation of potential measurements in concrete walls with components of zinc galvanized steel is very difficult or impossible.

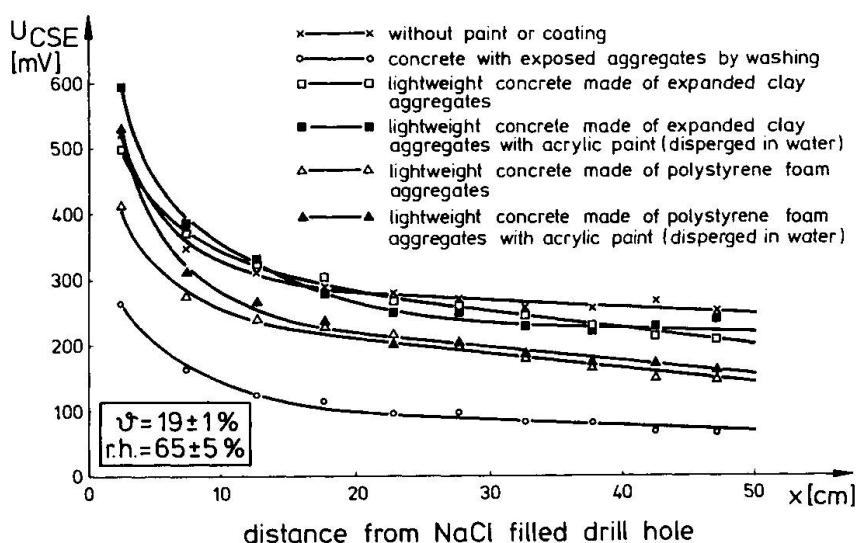
Fig. 3 Dependence of the potential  $U_{CSE}$  on the distance  $x$  to the NaCl filled drill hole for different lightweight concretes with or without thin acrylic paint
