**Zeitschrift:** IABSE reports = Rapports AIPC = IVBH Berichte  
**Band:** 77 (1998)

**Rubrik:** Session 2: Structural safety and durability of existing buildings

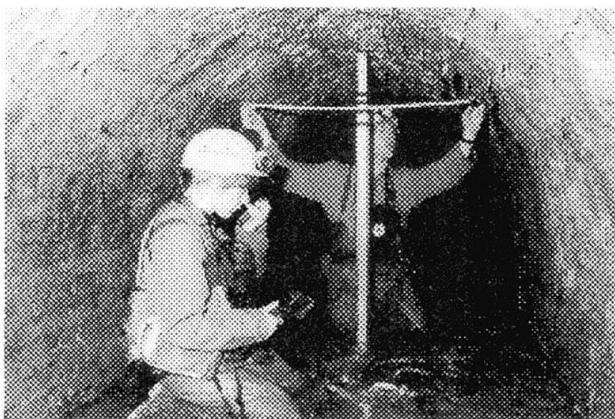
Fig.2: Sewer system Schiffweiler - Neuland

The method was applied in a restoration project to calculate a first value for the safety level of a masonry sewer system, figure 2. In this application, reaching the compressive strength of the masonry was the only ultimate limit state considered:  $g(x_1, x_2) = x_1 - x_2$ . The calculated probability of failure amounts:  $p_f = \Phi(-\beta) \approx 10^{-3}$ .
