Session 2: Structural safety and durability of existing buildings

Zeitschrift: **IABSE reports = Rapports AIPC = IVBH Berichte**

Band (Jahr): **77 (1998)**

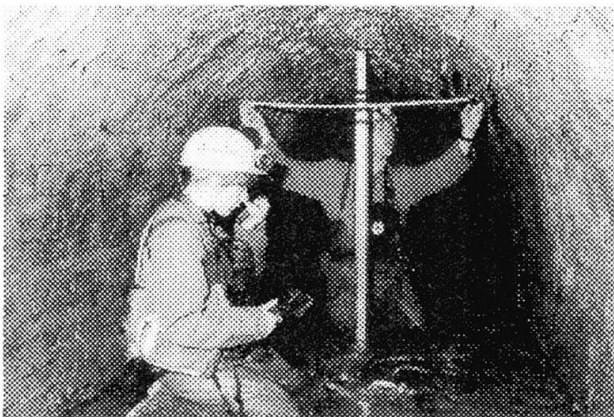
Fig. 2: Sewer system Schiffweiler - Neuland

The method was applied in a restoration project to calculate a first value for the safety level of a masonry sewer system, figure 2. In this application, reaching the compressive strength of the masonry was the only ultimate limit state considered: $g(x_1, x_2) = x_1 - x_2$. The calculated probability of failure amounts: $p_f = \Phi(-\beta) \approx 10^{-3}$.

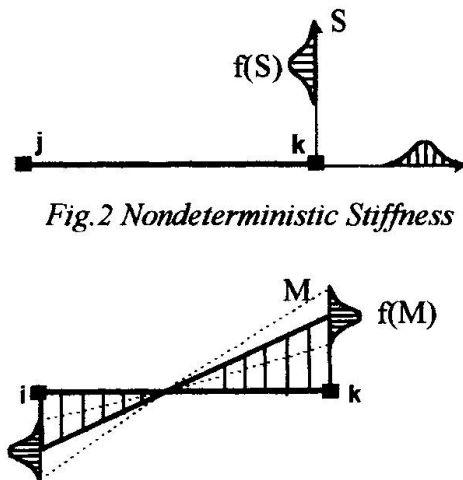
Fig. 3 Nondeterministic Bending Moment
