Zeitschrift: IABSE reports = Rapports AIPC = IVBH Berichte
Band: 77 (1998)

Rubrik: Session 2: Structural safety and durability of existing buildings

Deterioration of Reinforced Concrete Structures under Normal Conditions

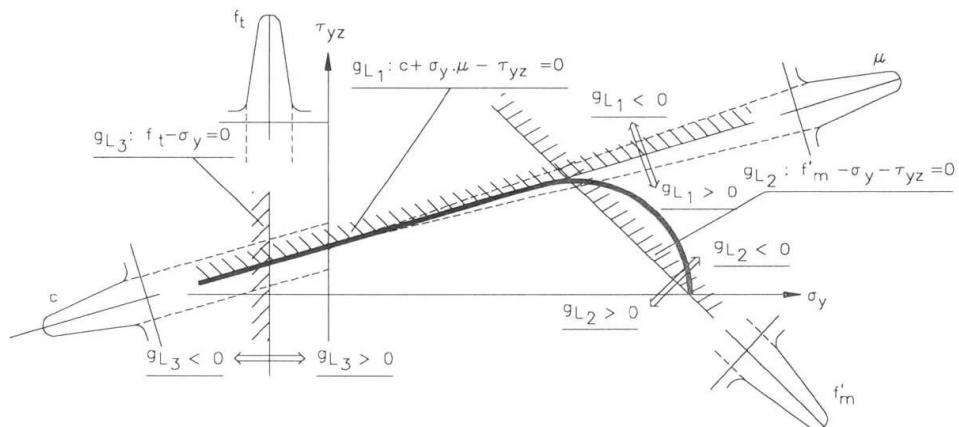
Fig. 1: Linearised "Cap-model" for unreinforced masonry shear walls

A reliability analysis is performed to calculate the reliability index β or the local probability of failure p_f of masonry shear panels. Attention is paid to the applied methodology, the algorithm (FORM : First Order Reliability Method), the different failure modes and corresponding limit state functions, figure 1, and the probability distributions for the basic variables in these limit state functions : the masonry material properties and stresses in the masonry due to external loads. The probability of failure p_f or the reliability index β , is calculated in different points of the masonry shear panels. The obtained results are plotted in contour graphs. These provide a

visual interpretation of the local probability of failure or of the reliability index.

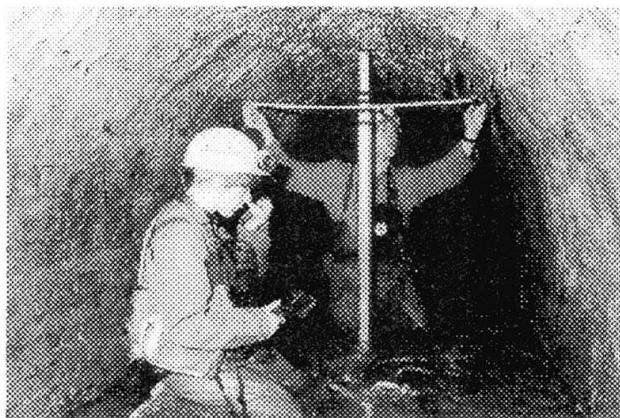
Fig. 2: Sewer system Schiffweiler - Neuland

The method was applied in a restoration project to calculate a first value for the safety level of a masonry sewer system, figure 2. In this application, reaching the compressive strength of the masonry was the only ultimate limit state considered: $g(x_1, x_2) = x_1 - x_2$. The calculated probability of failure amounts: $p_f = \Phi(-\beta) \approx 10^{-3}$. Whether such a safety level is acceptable or not is a socio-economical problem. The probabilistic analysis provides a quantitative measure of the safety that can be used to compare different alternatives.

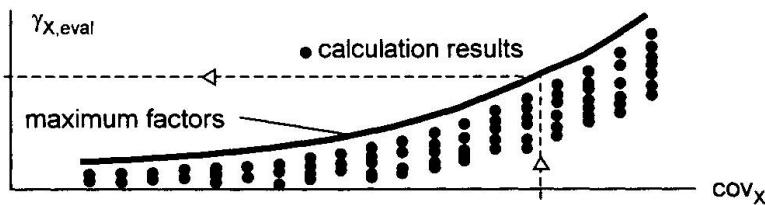
Fig.1 Schematic representation of partial safety factors for deterministic assessment, $\gamma_{X,eval}$, as a function of the coefficient of variation of the corresponding variable, cov_X

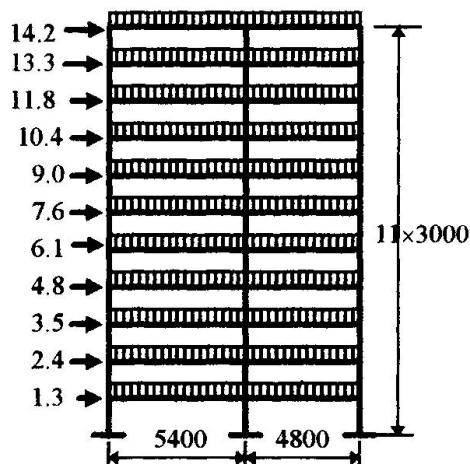
Fig. 1 RC Plane Frame

The method application is exemplified for the nondeterministic analysis of a reinforced concrete plane frame (fig. 1). The frame was subjected in the past to strong earthquake motions which caused partial damages. The existing cracks, especially at the members' ends decrease the stiffness, so that the end-connections behave like partial hinges. Because the stiffness value of members and connections is uncertain, they were defined as nondeterministic variables (fig. 2, table 1). As a result, the member stresses have nondeterministic values (fig. 3, table 2). According to the Romanian Code P100-91, the interstorey drift condition, is: $\Delta_r / H_e \leq 0.0035$. The condition checked at the first floor, for the values of the displacements is as follows: $\Delta_r / H_e = \{0.748, 0.00419, 0.849, 0.00304, 0.803, 0.00229, 0.736, 0.00209, 0.698, 0.00201\} \leq 0.0035$. The result is: 0.849 \text{TRUE}. Finally, the drift condition is satisfied if $0.849 \geq \mu_{\min}$, where μ_{\min} is the minimum value required for the confidence degree of the condition.

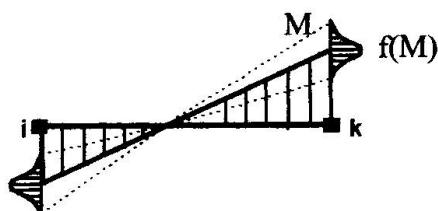
Fig. 3 Nondeterministic Bending Moment

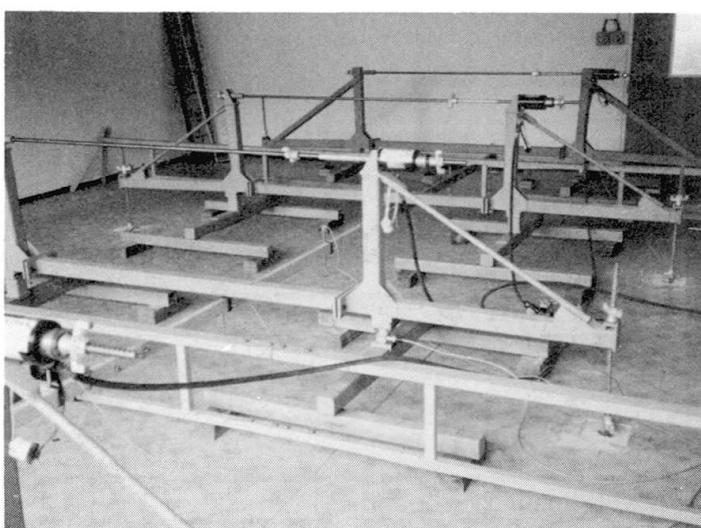
Fig. 1 Set up for proof load testing of slabs

Fig. 1 shows a set up for tests of slabs built as a component system in existing buildings. Tensile forces are induced in the upper chord of a truss. The compressive forces at the bottom are distributed by a leverage system to get quasi-equally distributed loads. The reactive forces are induced into neighbouring walls or into the support of the slabs in the floor below.

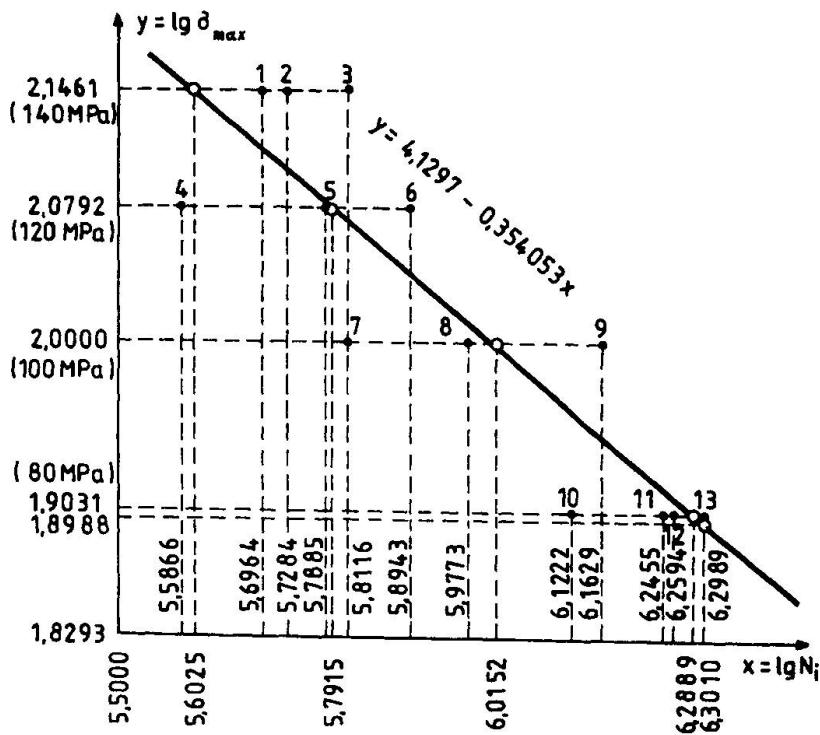
Regression line derived from fatigue tests

where: $x = \lg N_i$, $y = \lg \sigma_{\max}$, N_i - number of cycles to the specimen failure, σ_{\max} - maximum value of stress, in MPa.

The value of mean safe fatigue strength derived from the regression line equation for $N_i = 2 \cdot 10^6$ cycles was $Z_{ij} = 79,2$ MPa, and for $N_i = 10^5$ cycles was $Z_{ij} = 228,8$ MPa.
