Zeitschrift: IABSE reports = Rapports AIPC = IVBH Berichte

Band: 77 (1998)

Rubrik: Session 2: Structural safety and durability of existing buildings

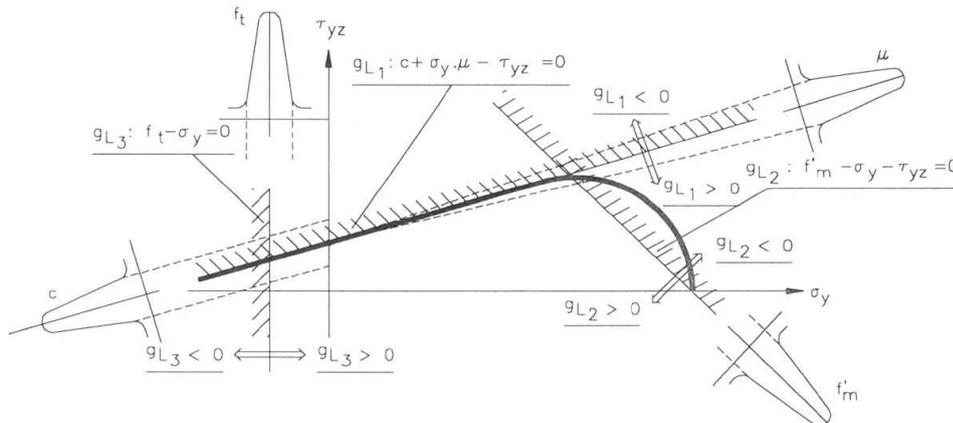
Fig. 1: Linearised "Cap-model" for unreinforced masonry shear walls

A reliability analysis is performed to calculate the reliability index β or the local probability of failure p_f of masonry shear panels. Attention is paid to the applied methodology, the algorithm (FORM : First Order Reliability Method), the different failure modes and corresponding limit state functions, figure 1, and the probability distributions for the basic variables in these limit state functions : the masonry material properties and stresses in the masonry due to external loads. The probability of failure p_f or the reliability index β , is calculated in different points of the masonry shear panels. The obtained results are plotted in contour graphs. These provide a

visual interpretation of the local probability of failure or of the reliability index.

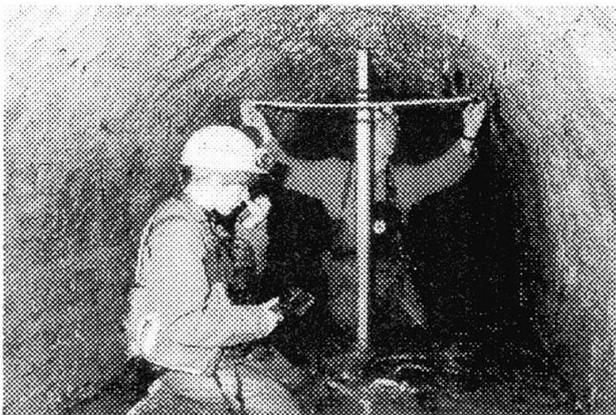
Fig. 2: Sewer system Schiffweiler - Neuland

The method was applied in a restoration project to calculate a first value for the safety level of a masonry sewer system, figure 2. In this application, reaching the compressive strength of the masonry was the only ultimate limit state considered: $g(x_1, x_2) = x_1 - x_2$. The calculated probability of failure amounts: $p_f = \Phi(-\beta) \approx 10^{-3}$.

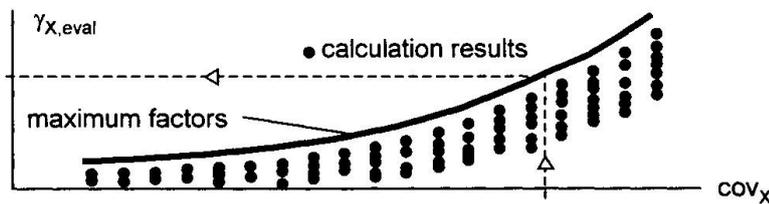
Fig.1 Schematic representation of partial safety factors for deterministic assessment, $\gamma_{X,eval}$, as a function of the coefficient of variation of the corresponding variable, cov_X

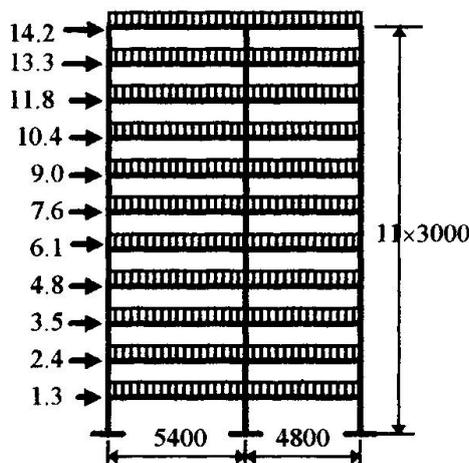
Fig. 1 RC Plane Frame

The method application is exemplified for the nondeterministic analysis of a reinforced concrete plane frame (fig. 1). The frame was subjected in the past to strong earthquake motions which caused partial damages. The existing cracks, especially at the members' ends decrease the stiffness, so that the end-connections behave like partial hinges. Because the stiffness value of members and connections is uncertain, they were defined as nondeterministic variables (fig. 2, table 1). As a result, the member stresses have nondeterministic values (fig. 3, table 2). According to the Romanian Code P100-91, the interstorey drift condition, is: $\Delta_r / H_e \leq 0.0035$. The condition checked at the first floor, for the values of the displacements is as follows:

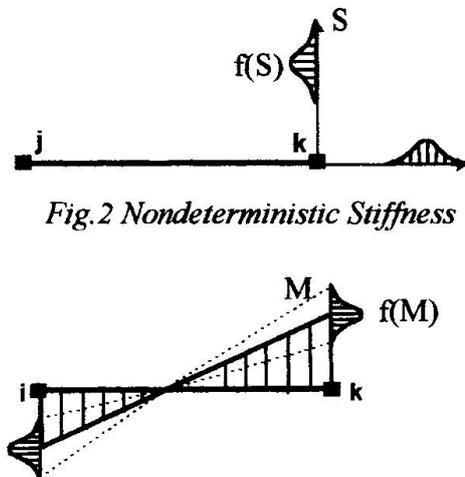
Fig. 3 Nondeterministic Bending Moment

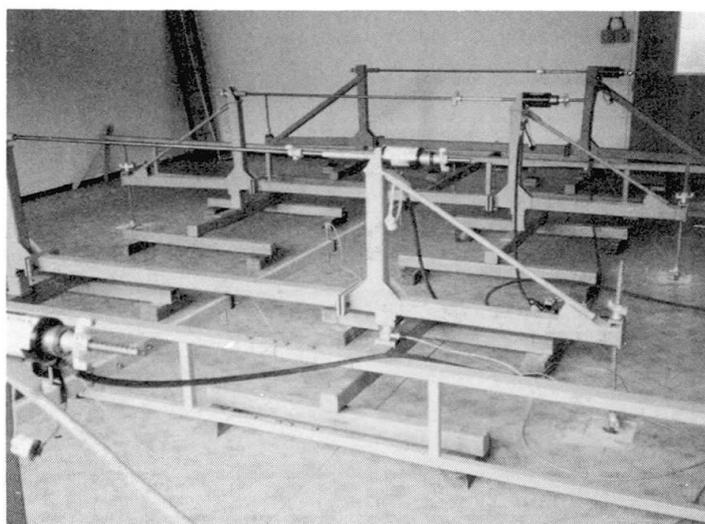
Fig.1 Set up for proof load testing of slabs

Fig. 1 shows a set up for tests of slabs built as a component system in existing buildings. Tensile forces are induced in the upper chord of a truss. The compressive forces at the bottom are distributed by a leverage system to get quasi-equally distributed loads. The reactive forces are induced into neighbouring walls or into the support of the slabs in the floor below.

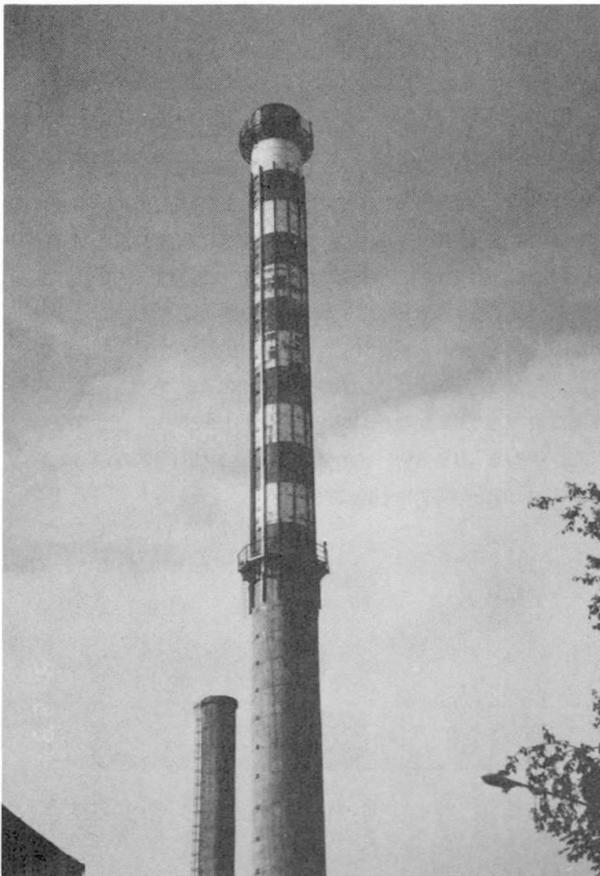
Fig.1: Overall-view of strengthened chimney

Finally, the steel external structure consisting of 12 columns and system of crossing tie-bars was designed. The vertical columns were fixed in the reinforced concrete shell of the lower part, made from the strong concrete. It created the kind of braid which was matched exactly to the real shape of structure. To ensure the possibility of simple and safe work, without heavy cranes, the elements of columns were divided into segments about 4.0 m long. All the assembly connections were bolted. High strength friction grip bolts were used in joints. The base of the braid was provided in form of strong ring with twelve arms anchored in the lower concrete part. Before fixing the anchors the layer of epoxy mortar was used to adjust the rigid ring to the existing concrete set-off. It was the only "wet" work during assembly. After preparation of steel members and trial assembly in the workshop, all the strengthening structure was erected in about six weeks with few breaks according to weather conditions. Another four weeks took the finishing of the surfaces of concrete and final painting. In this particular case the method of strengthening was assessed as over two times cheaper than the new external concrete shell.
