Zeitschrift: IABSE reports = Rapports AIPC = IVBH Berichte
Band: 78 (1998)

Artikel: An effective and eternal maintenance method for concrete tunnel structures
Autor: Furuya, Tokiharu / Iwasa, Takayoshi / Sasajima, Yoshihiro
DOI: <https://doi.org/10.5169/seals-59068>

An effective and eternal maintenance method for concrete tunnel structures

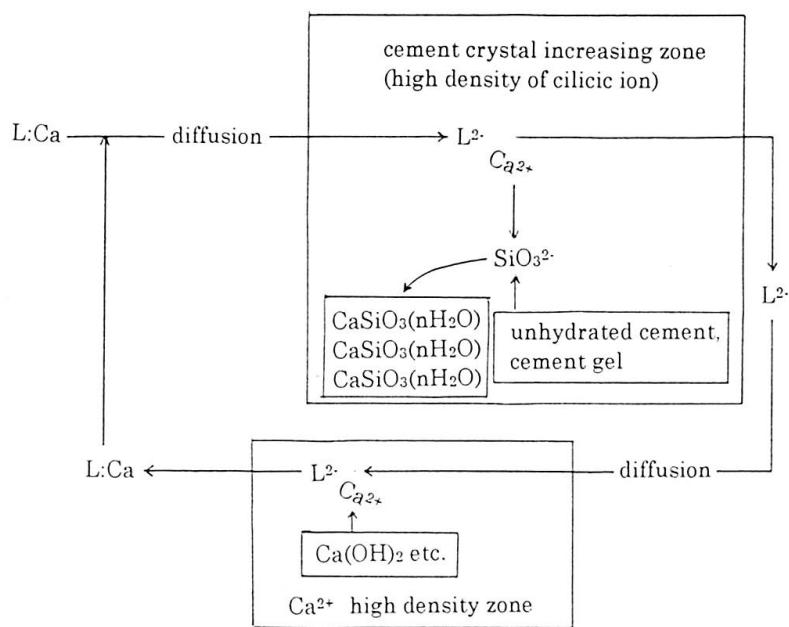
Figure 1. Basic Mechanism of Cement Crystal Increasing

O^{6-}_7) not only in young concrete or mortar but in those of over 20 years. Those silicic ions are combined with Ca^{2+} which are carried as Calcium Complexes (L : Ca) and produce cement gel ~ crystals. The basic mechanism of cement gel ~ crystals increased by L: Ca is shown in Figure 1. This reaction continues repeatedly in concrete or mortar as follows.

L: Ca combined with Ca^{2+} diffuse though the solution in pores and voids of concrete or mortar and within the high density zone of silicic ions, Ca^{2+} of L: Ca combine with silicic ions and precipitate as Calcium silicate $CaSiO_3$ (main gel ~ crystal of cement) due to the difference of solubility products of them. After splitting off Ca^{2+} , the complex ions L^{2-} diffuse in concrete or mortar again. And when L^{2-} ions come into the high density zone of Ca^{2+} , from $Ca(OH)_2$, L^{2-} combine with Ca^{2+} and diffuse as L: Ca again. These reactions occur repeatedly and increase cement gel ~ crystals with passage of time. This is the basic mechanism of cement gel ~ crystals increasing. As the result, these reactions improve the concrete lining itself to be an impermeable concrete and suppress every cause of deterioration.

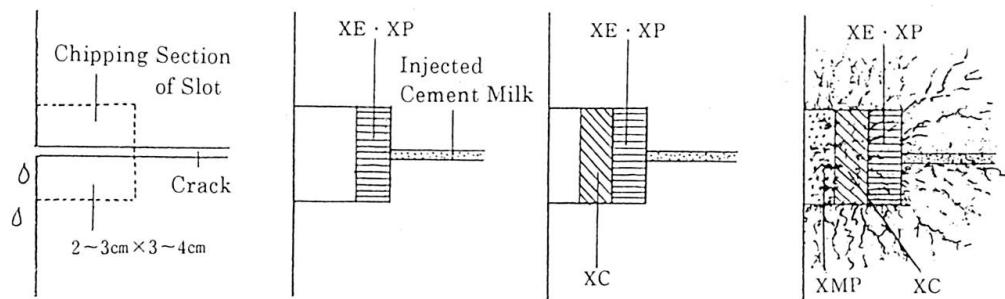
Figure 2. Rough Sketch of Triple Plugging Method

Basically, triple

plugging method

as shown in

Figure 2, is

applied

commonly to the

cracks with water leakage. Aims

of this method. In case of big

cracks, as shown in Figure 2,

inorganic cementitious materials

such as cement milk etc. are

injected into them. And XC

increases crystals inside of such

injected materials and in the

contact surface between the

material and concrete, and

impermeate the cracks

completely.

In case of applying XC to water leaking cracks, basic point is to make a small chipping slot (standard size of section is 2~3cm wide \times 3~4cm in depth) along the crack, and plug it with XC as main material. According to the size of the crack and degree of water leakage, we should choose to apply double

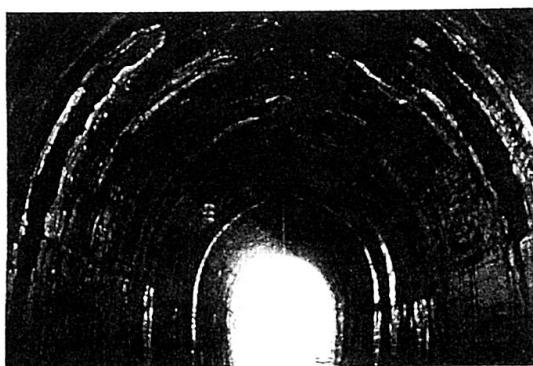
N.Railway Tunnel of JR is located at the northern and mountainous region of Japan, 110m long and was constructed in 1962. The thickness of the concrete lining is 50cm, and with passage of time water leakage through cracks and deteriorated construction joints of the lining have been increased, in addition, it is located in such cold region that the damages of the lining have been accelerated in winter by freezing damage by water leakage from the cracks. Any repairing method by physical barriers such as resinous materials were unusable no longer for these heavy damage by freezing. Therefore, 1993 repairing work was conducted by applying XC as main material to suppress water leakage and freezing damage, deterioration of lining. Repairing methods applied according to the degree of the damage of the lining are shown in Table 4.

**Figure 3. The surface before repair**

Degree of Damage	Application Method	
crack (more than 5mm in wide) with water leakage	· inject cement milk · 3 plugging method · coating method

crack (5mm~0.3mm wide) with water leakage	· inject colloidal cement milk · 3 plugging method · coating method

crack (less than 0.3mm wide) with light water leakage	· 2 plugging method · coating method

crack (less than 0.3mm wide) no water leakage	· coating method

sectional caving damage (10cm or there- abouts in depth)	· 3 plugging method · coating method

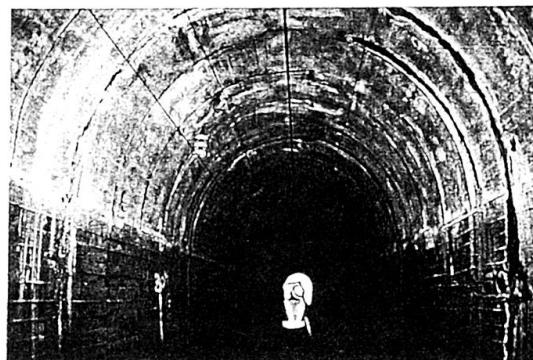
**Figure 4. The surface after repair**

4 years have passed since this repair was conducted, now no water leakage and deterioration by freezing damage are observed, and the result of repair are going on quite satisfactory.

The final process of coating on the whole surface of the lining was double coating method which applied XM on XC coating.
