**Zeitschrift:** IABSE reports = Rapports AIPC = IVBH Berichte  
**Band:** 79 (1998)

**Artikel:** Reconstruction of the Benten Viaduct after the 1995 earthquake  
**Autor:** Hayashida, Mitsuhiro / Hayashi, Hidenao / Kawakita, Shiro  
**DOI:** <https://doi.org/10.5169/seals-59867>

## Reconstruction of the Benten Viaduct after the 1995 Earthquake

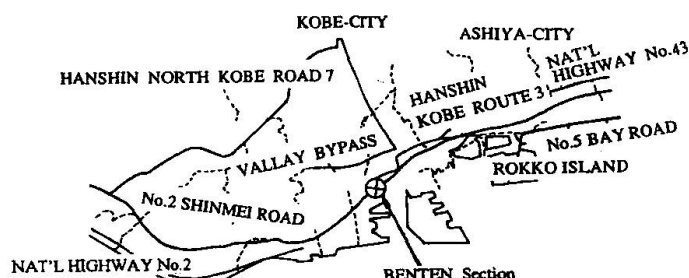
Fig. 1 Location

The Hanshin/Awaji Earthquake occurred on January 17, 1995, caused tremendous damage on the Hanshin Expressway Kobe Route, especially at Benten section (referred in Figure 1). The reconstructed bridge, “Benten Viaduct”, was determined to be the 19-span continuous rigid frame with steel deck along with the installation of seismic isolator. The general view of structure is shown in Figure 2.

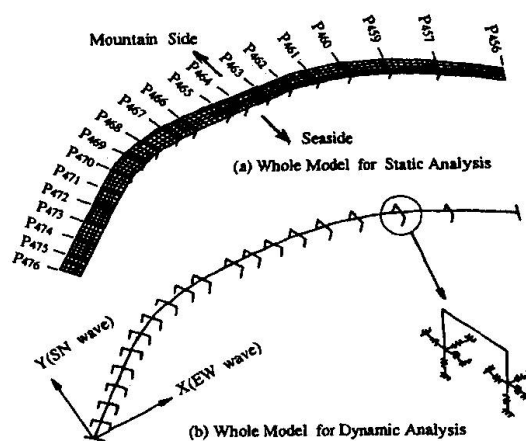
Fig. 3 Entire Models for Analysis

According to the strategy above, it was decided to adopt a continuous rigid frame. It was supposed that the additional piling reinforcement was needed for rigid connection or for hinge connection and finally it was concluded to adopt the structure of installing seismic isolation bearing on the foundation (referred in Table 1). Since the Benten Viaduct is warped to the seaside and the overhang length of cross beams differs slightly, analysis was made on the entire structural model of the two types shown on Figure 3.

In static analysis model (a) in the Figure 3 was used. The superstructure consisted of main girders, beams, and piers which was supported by the two way horizontal spring as well as perpendicular and rotational ones. The characteristic of isolator is expressed in natural period (T) and the ratio of yield point load ( $Q_d/W_u$ )[2]. In order to give an appreciate initial coefficient of bearing reaction for the static analysis model, the period and the ratio of yield point load were decided by applying a representative bridge pier that would satisfy the following three design objects.

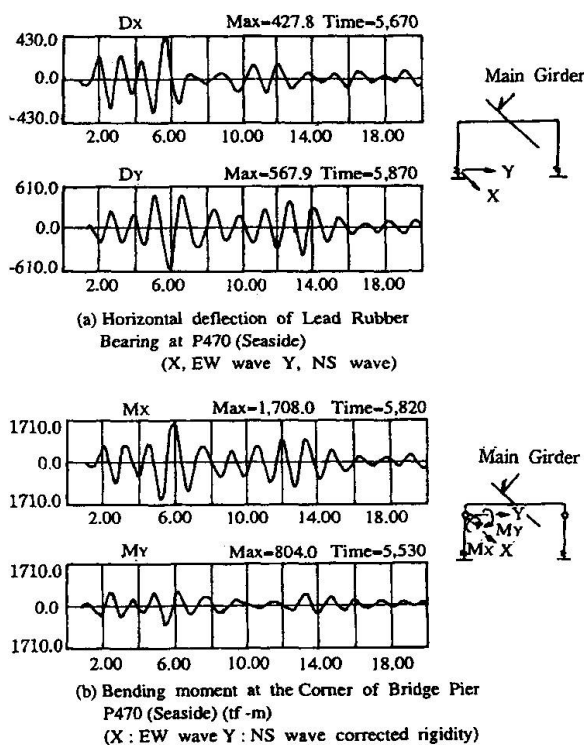
Fig. 4 An Example of Response Analysis  
On Time History

The time histories were exemplified in the Figure 4 for the response in the horizontal deflection of the seismic isolator and the bending moment at the beam joint at P470. Maximum deflections were 428mm in the longitudinal direction of bridge and 568mm in the transverse direction, which were observed after 6 seconds from the beginning of earthquake.

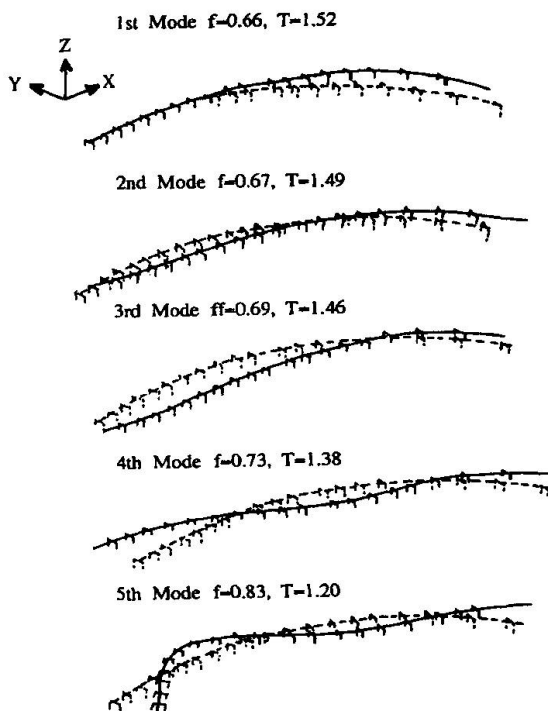
Fig. 5 Results of  
Natural Vibration Analysis

The results of natural vibration analysis on the entire model is shown on Figure 5 and all up to 5th modes shows inherent mode of horizontal direction. From the result of natural vibration analysis applied on a plane model, the mode for horizontal move at the bearing position is so remarkable that the similar tendency may be seen in a three dimensional model.

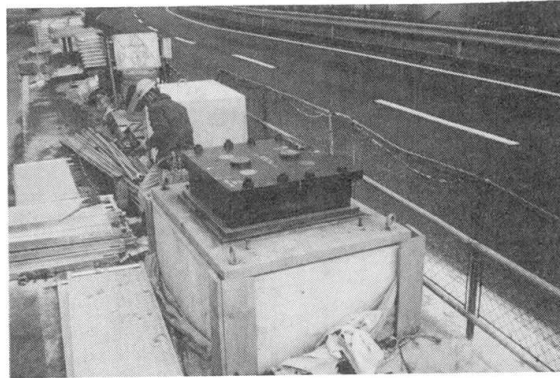
Photo. 1 Seismic Isolation Bearing

Seismic isolation bearing was designed referring to the “Manual of Isolation Design for Highway Bridge.” There are two types of seismic isolator, LRB (Lead Rubber Bearing) and HDR (High Dumping Rubber). LRB is a laminated-rubber bearing concluding lead plugs inside to give bi-linear deformation characteristic, while HDR is made of laminated super elastic gum.

Benten Viaduct has so much dimension of statically indeterminate that LRB was supposed to be more effective than HDR, because it is softer on various temperature range and harder under strong earthquake force. Each LRB bearings was designed in the same height nevertheless the difference of their design load in order to make the deformation characteristics regular. The appearance of seismic isolation bearing is shown in Photograph 1.

- T (natural period of whole superstructure) = 1.45 sec
- h (dumping constant of isolator when horizontal displacement=100mm) = 22 %
- shear deflection of isolator (when  $K_h=0.23$ ) = 50% (design capacity=150%)
- shear deflection of isolator (when  $K_h=0.68$ ) = 196% (design capacity=250%)
- shear deflection of isolator (dynamic analysis) = 357% (design capacity=400%)

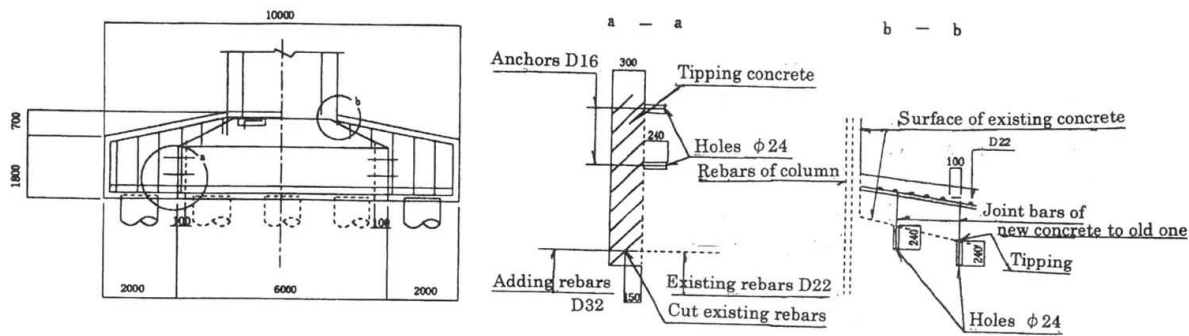
Fig 6 Reinforcement of Pile and Footing

Before the reconstruction project, bearing capacity (qd) of existing pile foundation was researched by means of corn penetrating test. Bearing capacity of 300 to 600 tf/m<sup>2</sup> was confirmed in most part, however, there still found some foundations which had only 150 tf/m<sup>2</sup> of qd. Therefore, these foundations had to be reinforced with adding piles, and the number of them were fourteen, which was 30% of the foundations among Benten section.

Also, the reinforced bars were jointed to the existing ones by means of enclosed arc welding. Details of reinforcement of footing are shown in figure 6.

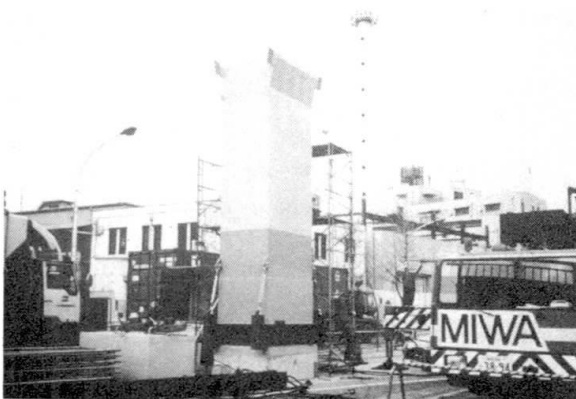
Photo. 2 Stabilizer System

The steel piers were unstable on the soft seismic isolation bearings until they formed a three-dimension rigid frame. In the field work, a stabilizer system were invented as shown in photograph 2. This system was introduced to stabilize the columns before the erection of girder and deck, and it could save the accuracy of piers and bearings also. The stabilizer was designed to have a temporary horizontal bearing capacity against 0.15G.

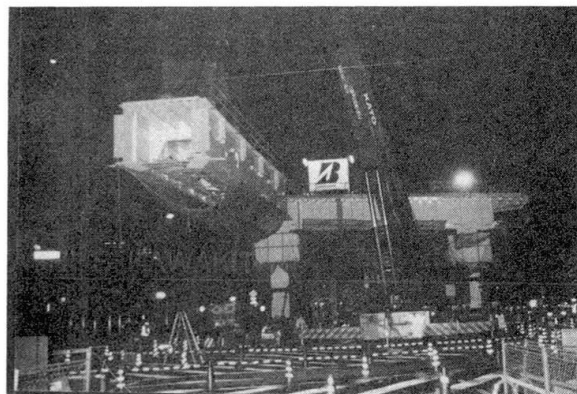
Photo. 3 Erection of Girder and Deck

The length of Benten Viaduct is as much as 686m, which causes  $\pm 28\text{mm}$ 's expansions at both ends from the difference of temperature of  $\pm 10$  degrees centigrade. To keep an adequate accuracy of erection, columns and cross beams were built up first. After that, plate girders with steel deck were erected measuring and correcting the errors at each pier points. The accuracy of erection was finally found to be less than 5 mm at the isolators point.
