**Zeitschrift:** IABSE reports = Rapports AIPC = IVBH Berichte  
**Band:** 79 (1998)

**Artikel:** Reconstruction of the Benten Viaduct after the 1995 earthquake  
**Autor:** Hayashida, Mitsuhiro / Hayashi, Hidenao / Kawakita, Shiro  
**DOI:** <https://doi.org/10.5169/seals-59867>

## Reconstruction of the Benten Viaduct after the 1995 Earthquake

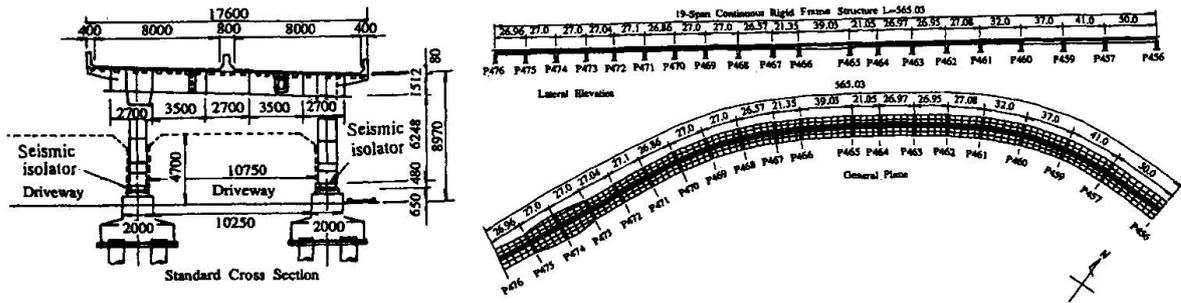
Fig. 2 General View of Benten Viaduct

The Hanshin/Awaji Earthquake occurred on January 17, 1995, caused tremendous damage on the Hanshin Expressway Kobe Route, especially at Benten section (referred in Figure 1). The reconstructed bridge, “Benten Viaduct”, was determined to be the 19-span continuous rigid frame with steel deck along with the installation of seismic isolator. The general view of structure is shown in Figure 2.

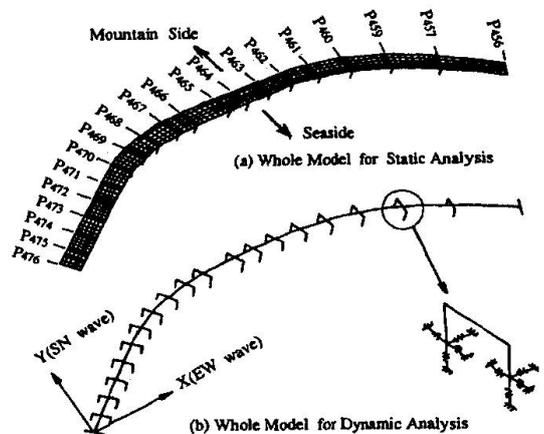
Fig. 3 Entire Models for Analysis

In static analysis model (a) in the Figure 3 was used. The superstructure consisted of main girders, beams, and piers which was supported by the two way horizontal spring as well as perpendicular and rotational ones. The characteristic of isolator is expressed in natural period (T) and the ratio of yield point load (Qd/Wu)[2]. In order to give an appreciate initial coefficient of bearing reaction for the static analysis model, the period and the ratio of yield point load were decided by applying a representative bridge pier that would satisfy the following three design objects.

According to the strategy above, it was decided to adopt a continuous rigid frame. It was supposed that the additional piling reinforcement was needed for rigid connection or for hinge connection and finally it was concluded to adopt the structure of installing seismic isolation bearing on the foundation (referred in Table 1). Since the Benten Viaduct is warped to the seaside and the overhang length of cross beams differs slightly, analysis was made on the entire structural model of the two types shown on Figure 3.

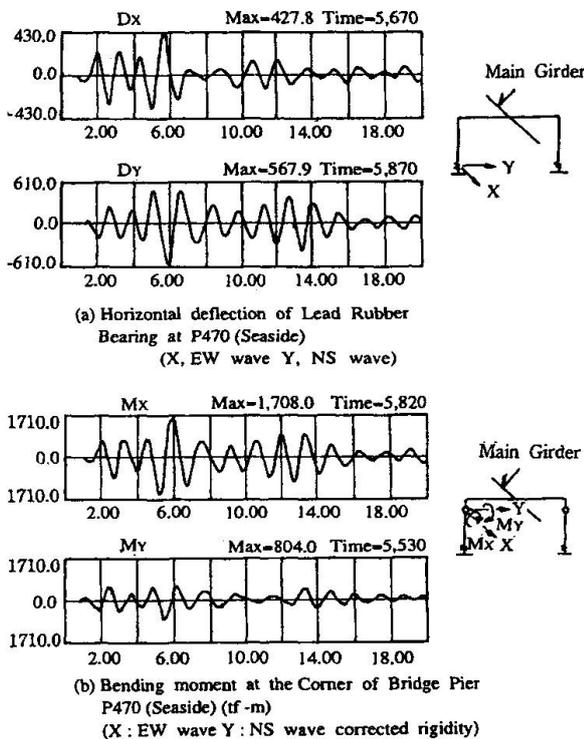
Fig. 4 An Example of Response Analysis  
On Time History

The time histories were exemplified in the Figure 4 for the response in the horizontal deflection of the seismic isolator and the bending moment at the beam joint at P470. Maximum deflections were 428mm in the longitudinal direction of bridge and 568mm in the transverse direction, which were observed after 6 seconds from the beginning of earthquake.

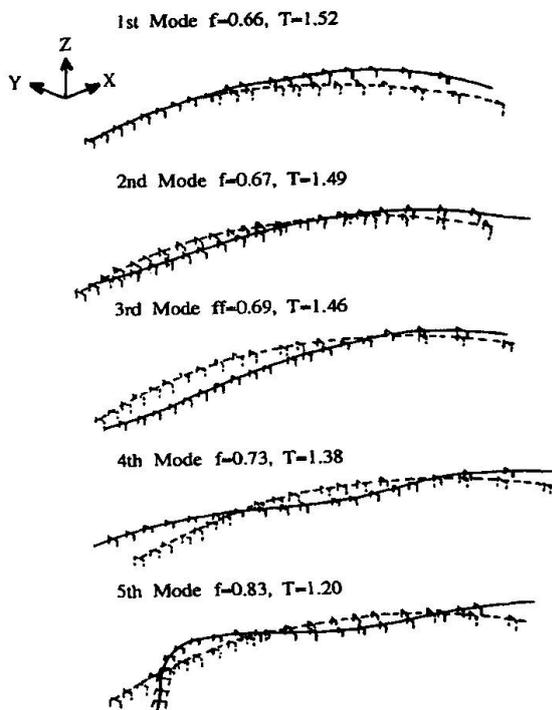
Fig. 5 Results of  
Natural Vibration Analysis

The results of natural vibration analysis on the entire model is shown on Figure 5 and all up to 5th modes shows inherent mode of horizontal direction. From the result of natural vibration analysis applied on a plane model, the mode for horizontal move at the bearing position is so remarkable that the similar tendency may be seen in a three dimensional model.

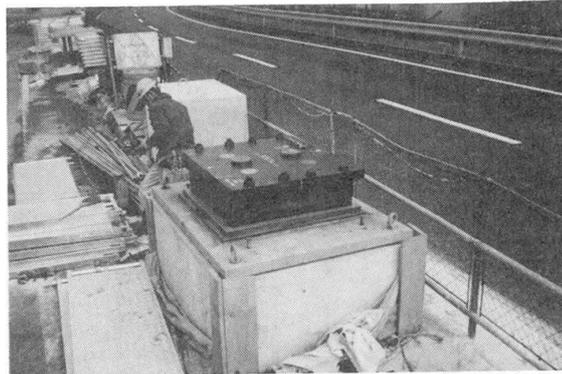
Photo. 1 Seismic Isolation Bearing

Seismic isolation bearing was designed referring to the “Manual of Isolation Design for Highway Bridge.” There are two types of seismic isolator, LRB (Lead Rubber Bearing) and HDR (High Dumping Rubber). LRB is a laminated-rubber bearing concluding lead plugs inside to give bi-linear deformation characteristic, while HDR is made of laminated super elastic gum.

Benten Viaduct has so much dimension of statically indeterminate that LRB was supposed to be more effective than HDR, because it is softer on various temperature range and harder under strong earthquake force. Each LRB bearings was designed in the same height nevertheless the difference of their design load in order to make the deformation characteristics regular. The appearance of seismic isolation bearing is shown in Photograph 1.

- T (natural period of whole superstructure) = 1.45 sec
- h (dumping constant of isolator when horizontal displacement=100mm) = 22 %
- shear deflection of isolator (when  $K_h=0.23$ ) = 50% (design capacity=150%)
- shear deflection of isolator (when  $K_h=0.68$ ) = 196% (design capacity=250%)
- shear deflection of isolator (dynamic analysis) = 357% (design capacity=400%)

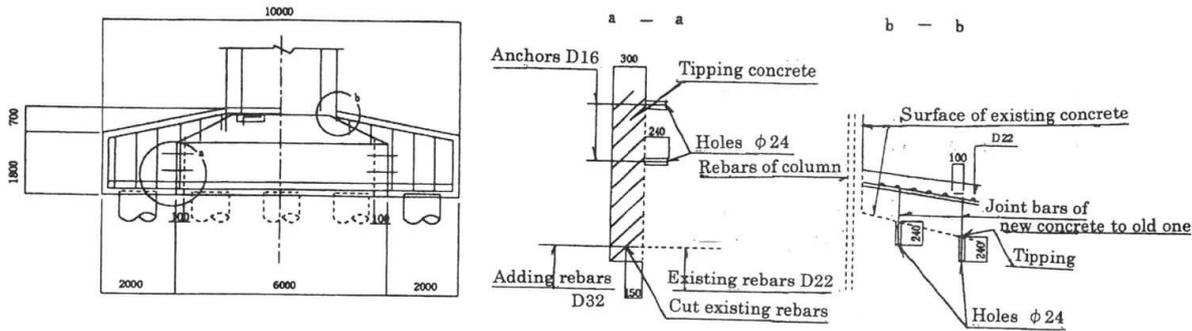
Fig 6 Reinforcement of Pile and Footing

Before the reconstruction project, bearing capacity (qd) of existing pile foundation was researched by means of cone penetrating test. Bearing capacity of 300 to 600  $\text{tf}/\text{m}^2$  was confirmed in most part, however, there still found some foundations which had only 150  $\text{tf}/\text{m}^2$  of qd. Therefore, these foundations had to be reinforced with adding piles, and the number of them were fourteen, which was 30% of the foundations among Benten section.

Also, the reinforced bars were jointed to the existing ones by means of enclosed arc welding. Details of reinforcement of footing are shown in figure 6.

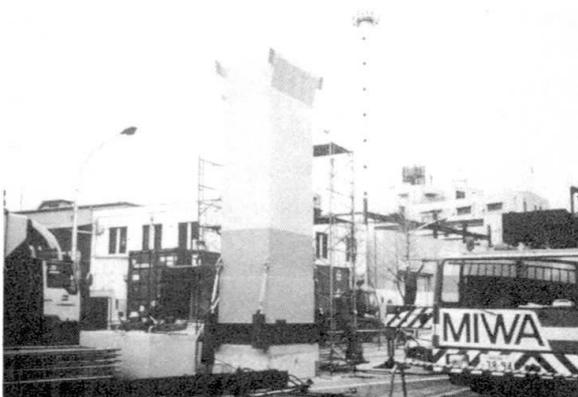
Photo. 2 Stabilizer System

The steel piers were unstable on the soft seismic isolation bearings until they formed a three-dimension rigid frame. In the field work, a stabilizer system were invented as shown in photograph 2. This system was introduced to stabilize the columns before the erection of girder and deck, and it could save the accuracy of piers and bearings also. The stabilizer was designed to have a temporary horizontal bearing capacity against 0.15G.

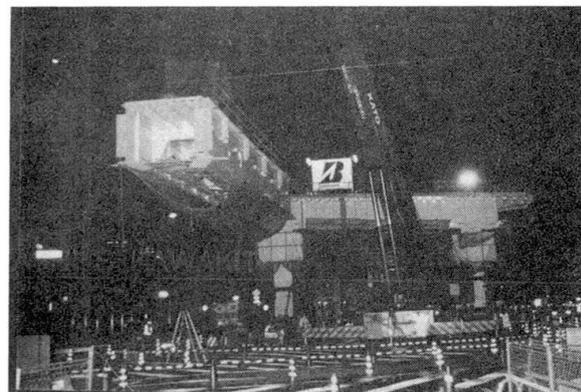
Photo. 3 Erection of Girder and Deck

The length of Benten Viaduct is as much as 686m, which causes  $\pm 28\text{mm}$ 's expansions at both ends from the difference of temperature of  $\pm 10$  degrees centigrade. To keep an adequate accuracy of erection, columns and cross beams were built up first. After that, plate girders with steel deck were erected measuring and correcting the errors at each pier points. The accuracy of erection was finally found to be less than 5 mm at the isolators point.
