**Artikel:** Estimation of the remaining fatigue life of a railway bridge

## Estimation of the Remaining Fatigue Life of a Railway Bridge

The *Dangsan* steel railway bridge was located in Seoul, Korea, crossing the famous Han river for subway traffics (The old bridge was disassembled and a new bridge is under construction at the same location). Upon requests, the bridge had undergone many inspections near the end of its service life since it was reported that there were several fatigue cracks found, and the city authority considered deeply about the safety of the bridge. The remaining life of the bridge had been estimated through the field measurements and the corresponding fatigue test conducted. The results are briefly presented herein.

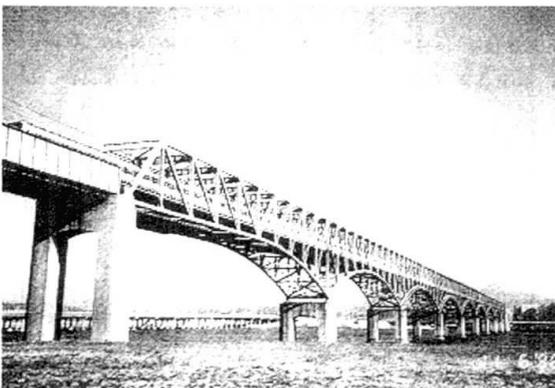
Fig. 1 The Dangsan bridge

The bridge consisted of three units of three-span-continuous steel Pratt truss with length 90-90-90m for its main spans in the middle and plate girder bridges on both ends. The picture, profile and corresponding FEM model are depicted in Fig. 1, 2, and 3, respectively. The bridge was made to serve the subway traffics only, and was experiencing about 510 trains daily in two way system.

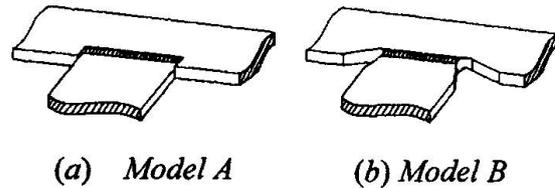
Fig. 4 Fatigue Model

Some upper chords connected with bracings were found to have peculiar details at the connections of gusset plates due to the bad manufacture (See Fig. 4a). About 2cm of flange edges were cut off, and then the gusset plates were attached. Fatigue tests were carried out to identify the fatigue strength of these particular details. Based on visual inspections, experimental fatigue models were made to simulate the actual welding and manufacturing conditions by applying the improper cutting and welding to the flange edges. Repairing method was proposed by finishing the rectangular corner at the welding parts in the round shape according to AASHTO, which may improve the fatigue strength of the detail. Two models were prepared: with actual condition (model A); with proposed condition (model B) shown in Fig. 4a, b, respectively. In addition, the experimental models with typical details were also prepared for fatigue test to compare the results with those of other two models. Upon the test results, the Fatigue strengths for each model were measured and plotted on the AASHTO's S-N curves (Fig. 5). Fig. 5a is the result of the model A which simulates the actual detail condition, and Fig. 5b is the result of model B with the repaired detail. The model A shows that the fatigue strength is a little lower than Category E due to the improper details, but clearly higher than Category E'. The model B shows an apparent improvement.
