Retrofit of Corroded Splice Plates Using Epoxy Glued Escort Plates

Isao SUGIE
Civil Eng.
Hanshin Expressway Public Corp.
Osaka, Japan

Summary

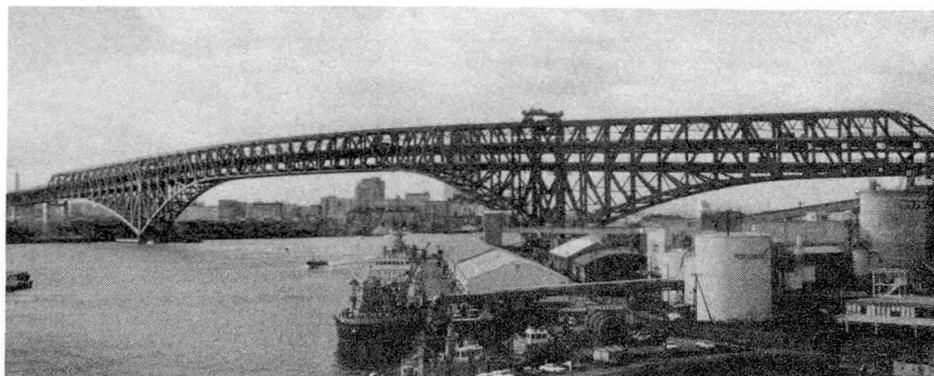
The Port Bridge is the third longest Gerber truss bridge in the world. It was constructed in 1975 and connected the reclaimed lands of Osaka Bay area with a 450 metre centre span as shown in fig.1.

Fig.1 Overall-view of the Port Bridge

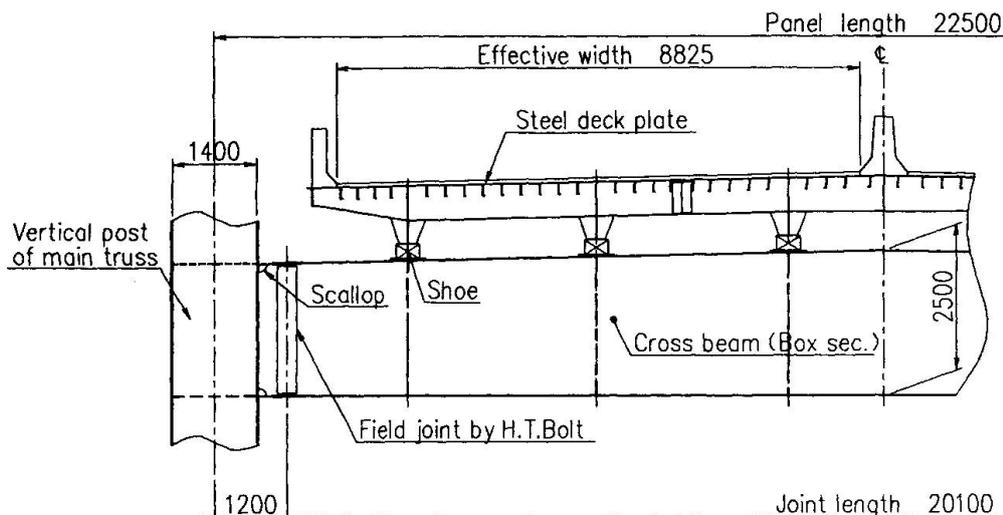
As shown in fig.2, rain water entered from the scallops of the web plate of cross beam welded to the main truss members. There are no drainage holes around them, and the box beams have collected water inside them. As a result, corrosion has been advanced at the lower flange joints of the cross beams. This created two structural problems. One is the reduction of axle force of the high tension bolts. The maximum rate of measured reduction was 30 %, which is bigger than that due to relaxation (approximately 10 to 15%). Another is the reduction of thickness of the splice plates. The most corroded one was 5 mm thinner than the original. Finally, the stress limitation can not be guaranteed at the joints.

Fig. 2
General view
around corroded
joint

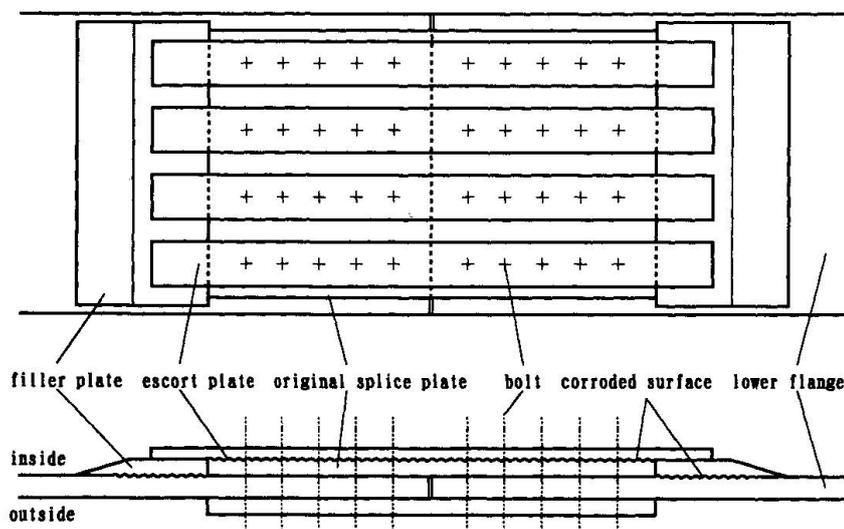
Fig.3 shows the retrofit using epoxy glued escort plates. In this method, the original splice plate can remain and only a row of bolts can be removed. These are replaced with new ones at the same time for fitting a long rectangular escort plate. The bolts should be replaced from the centre to the corners of the flange, so that re-distribution of the stress flow can be improved. Filler plates should be also fitted to make up for the lack of thickness of the corroded flange plates. Other methods for retrofit have been considered such as replacement of the whole splice plates or reinforcing them with additional plates fixed by welding. They, however, were rejected for the following reasons.

Fig. 3
Retrofit of
corroded splice
plates using
epoxy glued
escort plate

(1) The working stresses due to dead loads are too large to remove the whole splice plate and all bolts from the lower flange at the same time.

(2) The influence of welding would be great, because high tension steel (HT70, HT80) was used. Finally, using epoxy glued escort plates resulted in the most effective and practical method.

Laboratory tests have been done to examine the effectiveness of this method. The two bolts model test indicated that there were no remarkable difference between the sound specimen and the corroded ones reinforced by the escort plate.
