Retrofit of Corroded Splice Plates Using Epoxy Glued Escort Plates

Isao SUGIE

Civil Eng.
Hanshin Expressway Public Corp.
Osaka, Japan

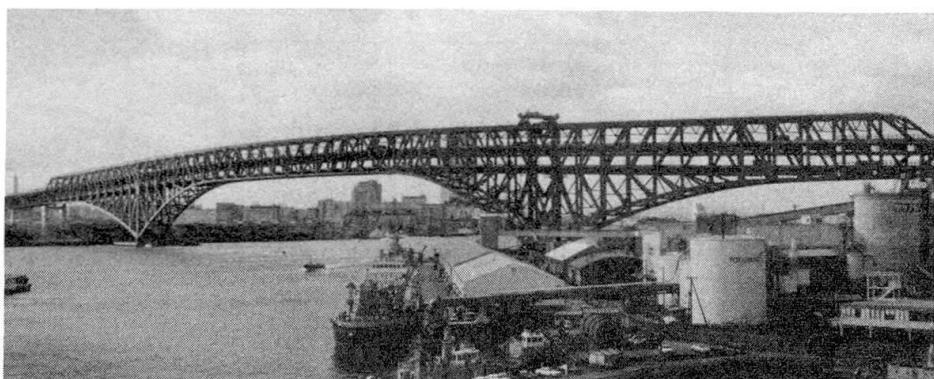
Fig. 1 Overall-view of the Port Bridge

The Port Bridge is the third longest Gerber truss bridge in the world. It was constructed in 1975 and connected the reclaimed lands of Osaka Bay area with a 450 metre centre span as shown in fig.1.

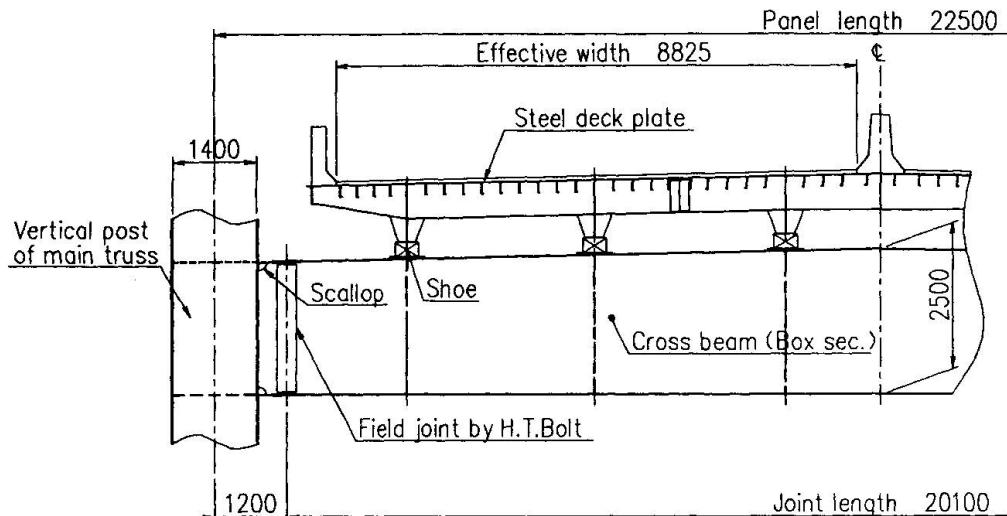
Fig. 2
General view
around corroded
joint

As shown in fig.2, rain water entered from the scallops of the web plate of cross beam welded to the main truss members. There are no drainage holes around them, and the box beams have collected water inside them. As a result, corrosion has been advanced at the lower flange joints of the cross beams. This created two structural problems. One is the reduction of axle force of the high tension bolts. The maximum rate of measured reduction was 30 %, which is bigger than that due to relaxation (approximately 10 to 15%). Another is the reduction of thickness of the splice plates. The most corroded one was 5 mm thinner than the original. Finally, the stress limitation can not be guaranteed at the joints.
