**Zeitschrift:** IABSE reports = Rapports AIPC = IVBH Berichte  
**Band:** 79 (1998)

**Artikel:** Cable supported bridge under movement of foundation due to earthquake  
**Autor:** Yamasaki, Yasutsugu / Ikeda, Torahiko  
**DOI:** <https://doi.org/10.5169/seals-59901>

## Cable Supported Bridge under Movement of Foundation due to Earthquake

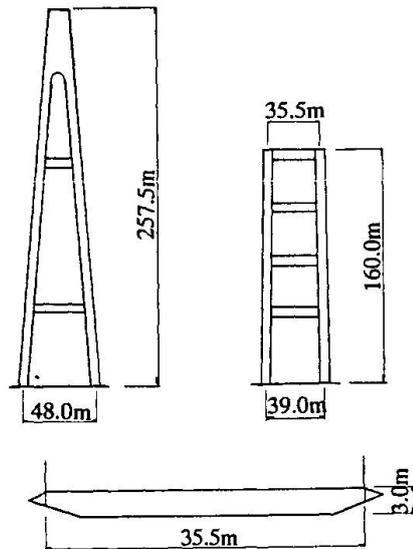
Table 1. Characteristics of bridge elements

Suspension bridge	
Girder	A=1.378 m <sup>2</sup> I <sub>z</sub> = 2.43 m <sup>4</sup> I <sub>y</sub> =162.24 m <sup>4</sup>
Tower	A=2.362 m <sup>2</sup> I <sub>z</sub> = 21.97 m <sup>4</sup> I <sub>y</sub> =12.18 m <sup>4</sup>
Cable	A=0.195 m <sup>2</sup>
Cable stayed bridge	
Girder	A=1.567 m <sup>2</sup> I <sub>z</sub> =2.58 m <sup>4</sup> I <sub>y</sub> =172.76 m <sup>4</sup>
Tower	A=2.362 m <sup>2</sup> I <sub>z</sub> = 21.97 m <sup>4</sup> I <sub>y</sub> =12.18 m <sup>4</sup>
Cable	A=0.009~0.015 m <sup>2</sup>

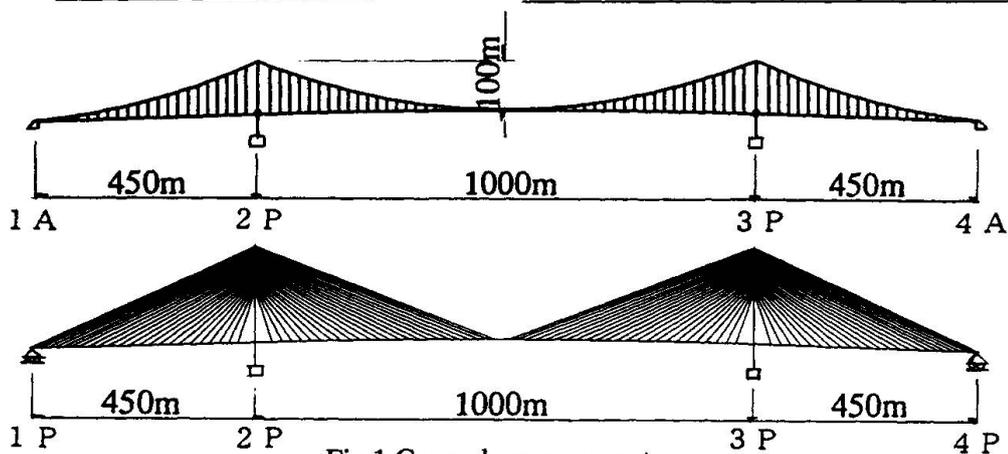
Fig 1 General arrangement

In this circumference, we have computed the behavior of suspension bridge and cable stayed bridge after the completion under the similar scale of movements of the foundations. The bridges for computation are suspension bridge with a main span of 1,000m having un-continuous suspended girder vertically supported by links and transversely supported by wind shoes at the towers and the anchorages, and cable stayed bridge with a main span of 1,000m having continuous suspended girder vertically supported by bearings and links, transversely supported by wind shoes at the towers and the anchorages, and longitudinally supported by spring from the towers. The general arrangements of the bridges are shown in Fig 1. and the characteristics of bridge elements are shown in Table 1.

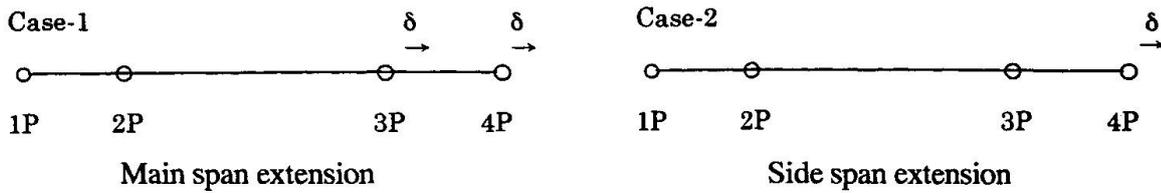
Fig 2. Longitudinal movement

We assumed two cases. One is a tower foundation and an anchorage (or a pier) in the same side move longitudinally outward by the same distance (main span extension), which simulates that fault located in the main span slides, and the other is only an anchorage (or a pier) moves longitudinally outward (side span extension), which simulates that fault located in the side span slides, as shown in Fig 2.

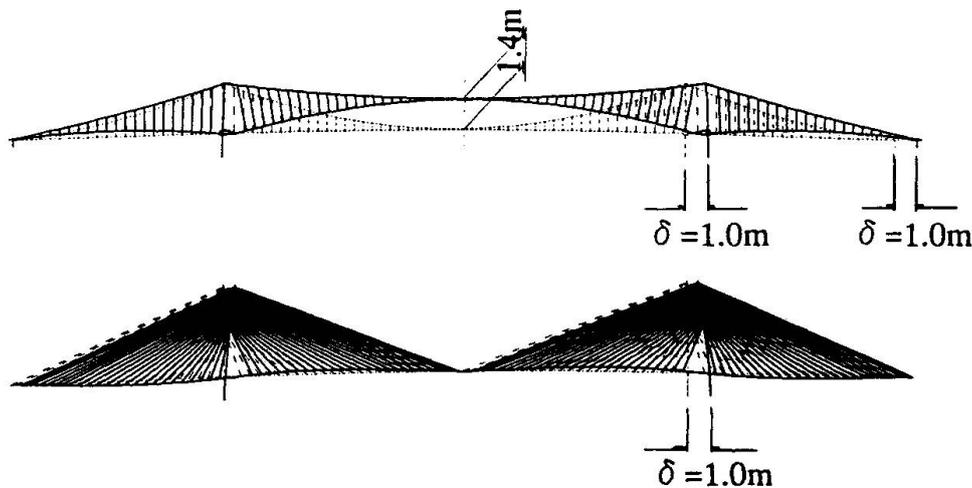
Fig 3. Bridge deformation

Fig 3. shows the deformation of two bridges for the main span extension of 1.0m, and Fig 4. & 5 show the extra stresses occur in the tower and in the cable of the two bridges by the main span extension ranging from 0.5m to 1.0m . Suspension bridge is able to absorb a extension of main span easily by a change of cable sag (1.4m for extension of 1.0m), which doesn't make tower top displacement much (0.09m each) to balance cable forces of main span and side span at tower top and increase a stress of main cable (13Mpa). By this behavior, suspension bridge is not much overstressed by main span extension. While, cable stayed bridge absorbs a extension of main span by displacement of tower tops (0.52m each for extension 1.0m) inward pulled straight by stay cables. By this behavior, cable stayed bridge is much stressed by main span extension, and the extra stress occurs at the tower base comes up to 17% of its allowable stress by a extension of 1.0m.

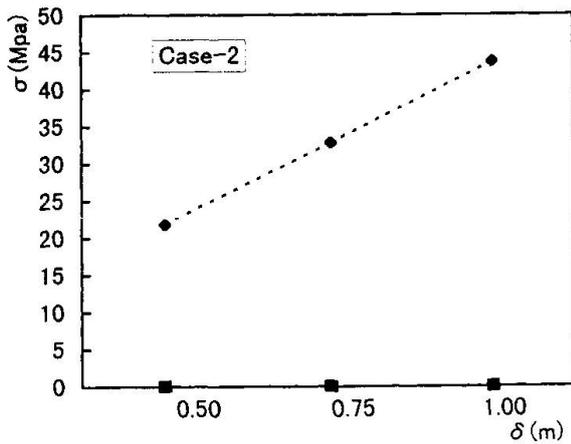
Fig 6. Extra stress at 3P tower base

Fig 6. and 7. show the extra stresses occur in the tower and in the cable of the suspension bridge by the side span extension ranging from 0.5m to 1.0m. Suspension bridge is much effected by a extension of side span. The tower top moves by nearly the same scale as that of the movement of anchorage (0.86m for extension of 1.0m), which doesn't produce much extra stress in main cable (16Mpa), but produces, depend on the stiffness of tower, some stress at the tower base. Cable stayed bridge is not effected by a extension of side span, because a damage of bearing at the end pier absorbs most of such extension.

It is also founded that a increase of span length doesn't reduce the extra stress of suspension bridge much. The extra stress occurs at the tower base of the suspension bridge of 900-2000-900 for the side span extension of 1.0m is 41 Mpa for 44Mpa of the suspension bridge of 450-1000-450.

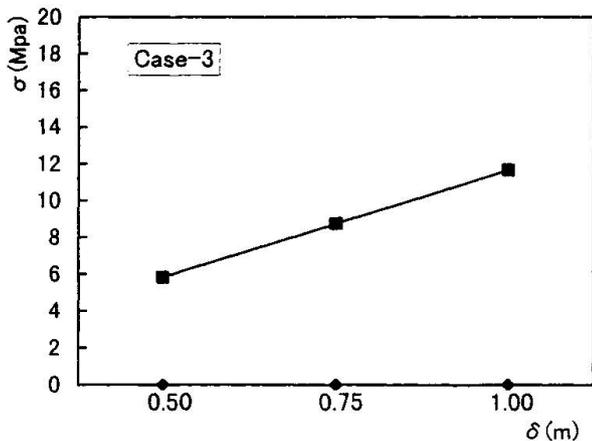
Fig 9. Extra stress in the suspended girder

Fig 9. and 10. show the extra stresses occur in the suspended girder and in the tower of the two bridges for the transverse shift in main span ranging from 0.5m to 1.0m. The governing factor to produce the extra stresses in the suspended girder is a continuity of the suspended girder. Suspension bridge with un-continues girder, which is normally applied to Japanese suspension bridges, is not effected by transverse movement of foundation. The tower tops of suspension bridge move

transversely much (0.39m each for shift of 1.0m) because a big force is applied at the tower top by the main cable. While, cable stayed bridge, for which continuous girder is necessarily applied, is much effected by transverse movement of foundation, and the extra stress occurs in the suspended girder at the tower comes up to 6% of its allowable stress. The tower tops of cable stayed bridge moves transversely, but not much (0.27m for shift of 1.0m).

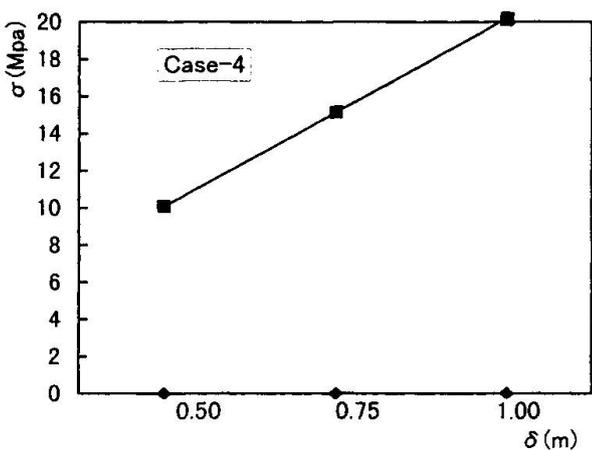
Fig 11. Extra stress in the suspended girder

Fig 11 and 12. show the extra stresses occur in the suspended girder and in the tower of the two bridges for the transverse shift in side span ranging from 0.5m to 1.0m. Cable stayed bridge is much more stressed by the transverse shift in side span than by the transverse shift in main span. The extra stress occurs in the suspended girder at the tower is 10% of its allowable stress. The top of 3P tower moves transversely by 0.54m, but doesn't produce much extra stresses at the tower base because A-shape tower change the in-plane bending moment due to the tower top displacement to the axial forces in the tower section. Suspension bridge with un-continuous girder is not effected by transverse movement of foundation.
