Cable supported bridge under movement of foundation due to earthquake

Zeitschrift: **IABSE reports = Rapports AIPC = IVBH Berichte**

Band (Jahr): **79 (1998)**

Cable Supported Bridge under Movement of Foundation due to Earthquake

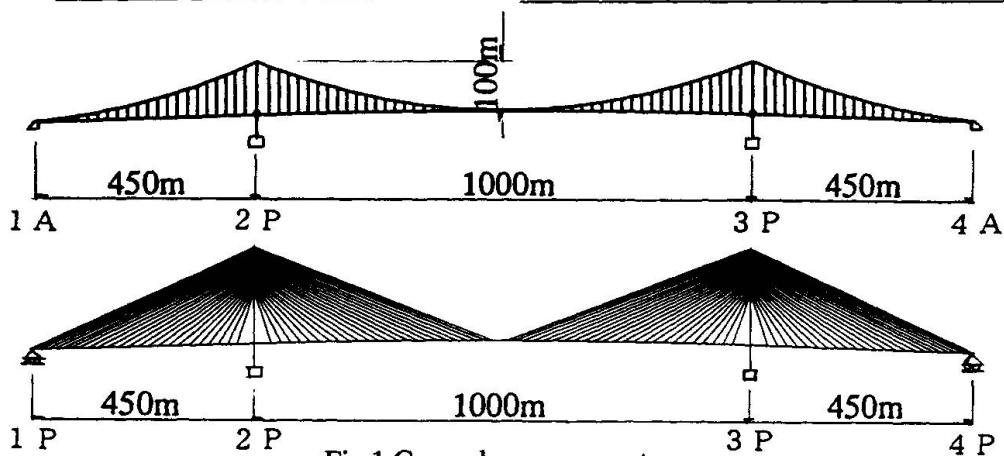
Fig 1 General arrangement

In this circumference, we have computed the behavior of suspension bridge and cable stayed bridge after the completion under the similar scale of movements of the foundations. The bridges for computation are suspension bridge with a main span of 1,000m having un-continuous suspended girder vertically supported by links and transversely supported by wind shoes at the towers and the anchorages, and cable stayed bridge with a main span of 1,000m having continuous suspended girder vertically supported by bearings and links, transversely supported by wind shoes at the towers and the anchorages, and longitudinally supported by spring from the towers. The general arrangements of the bridges are shown in Fig 1. and the characteristics of bridge elements are shown in Table 1.

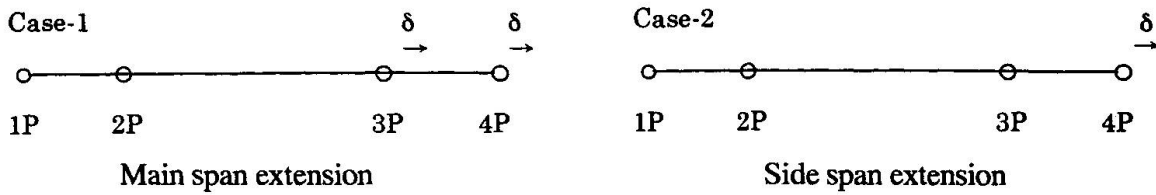
Fig 2. Longitudinal movement

We assumed two cases. One is a tower foundation and an anchorage (or a pier) in the same side move longitudinally outward by the same distance (main span extension), which simulates that fault located in the main span slides, and the other is only an anchorage (or a pier) moves longitudinally outward (side span extension), which simulates that fault located in the side span slides, as shown in Fig 2.

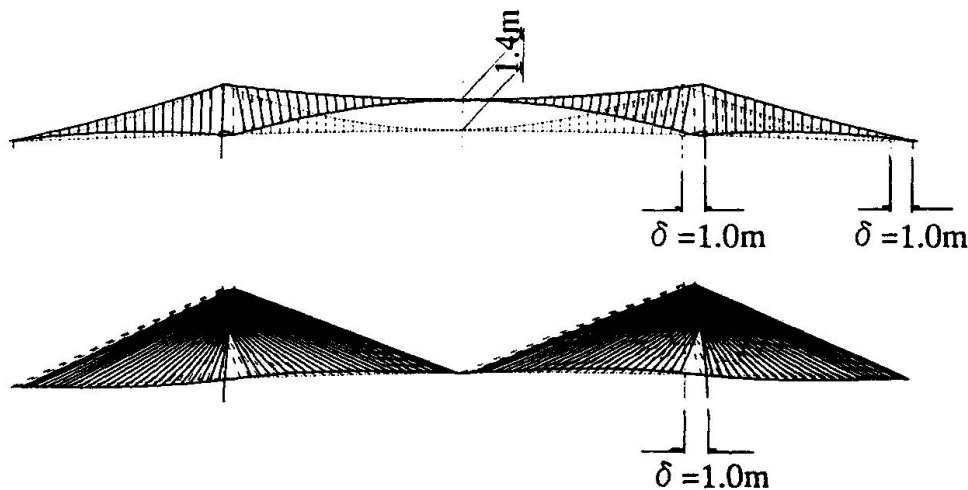
Fig 3. Bridge deformation

Fig 3. shows the deformation of two bridges for the main span extension of 1.0m, and Fig 4. & 5 show the extra stresses occur in the tower and in the cable of the two bridges by the main span extension ranging from 0.5m to 1.0m . Suspension bridge is able to absorb a extension of main span easily by a change of cable sag (1.4m for extension of 1.0m), which doesn't make tower top displacement much (0.09m each) to balance cable forces of main span and side span at tower top and increase a stress of main cable (13Mpa). By this behavior, suspension bridge is not much overstressed by main span extension. While, cable stayed bridge absorbs a extension of main span by displacement of tower tops (0.52m each for extension 1.0m) inward pulled straight by stay cables. By this behavior, cable stayed bridge is much stressed by main span extension, and the extra stress occurs at the tower base comes up to 17% of its allowable stress by a extension of 1.0m.

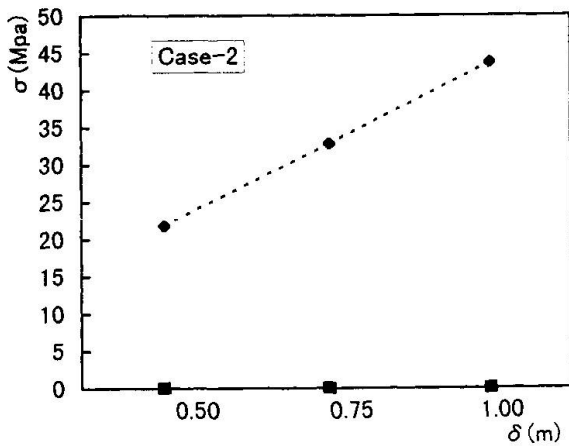
Fig 6. Extra stress at 3P tower base

Fig 6. and 7. show the extra stresses occur in the tower and in the cable of the suspension bridge by the side span extension ranging from 0.5m to 1.0m. Suspension bridge is much effected by a extension of side span. The tower top moves by nearly the same scale as that of the movement of anchorage (0.86m for extension of 1.0m), which doesn't produce much extra stress in main cable (16Mpa), but produces, depend on the stiffness of tower, some stress at the tower base. Cable stayed bridge is not effected by a extension of side span, because a damage of bearing at the end pier absorbs most of such extension.

It is also founded that a increase of span length doesn't reduce the extra stress of suspension bridge much. The extra stress occurs at the tower base of the suspension bridge of 900-2000-900 for the side span extension of 1.0m is 41 Mpa for 44Mpa of the suspension bridge of 450-1000-450.

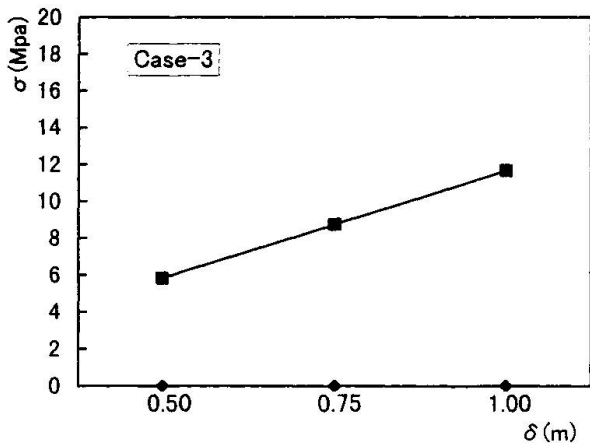
Fig 9. Extra stress in the suspended girder

Fig 9. and 10. show the extra stresses occur in the suspended girder and in the tower of the two bridges for the transverse shift in main span ranging from 0.5m to 1.0m. The governing factor to produce the extra stresses in the suspended girder is a continuity of the suspended girder. Suspension bridge with un-continues girder, which is normally applied to Japanese suspension bridges, is not effected by transverse movement of foundation. The tower tops of suspension bridge move

transversely much (0.39m each for shift of 1.0m) because a big force is applied at the tower top by the main cable. While, cable stayed bridge, for which continuous girder is necessarily applied, is much effected by transverse movement of foundation, and the extra stress occurs in the suspended girder at the tower comes up to 6% of its allowable stress. The tower tops of cable stayed bridge moves transversely, but not much (0.27m for shift of 1.0m).

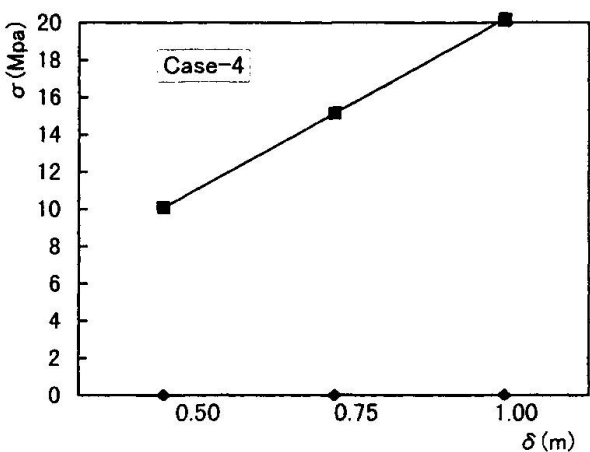
Fig 11. Extra stress in the suspended girder

Fig 11 and 12. show the extra stresses occur in the suspended girder and in the tower of the two bridges for the transverse shift in side span ranging from 0.5m to 1.0m. Cable stayed bridge is much more stressed by the transverse shift in side span than by the transverse shift in main span. The extra stress occurs in the suspended girder at the tower is 10% of its allowable stress. The top of 3P tower moves transversely by 0.54m, but doesn't produce much extra stresses at the tower base because A-shape tower change the in-plane bending moment due to the tower top displacement to the axial forces in the tower section. Suspension bridge with un-continuous girder is not effected by transverse movement of foundation.
