Artikel: Structural design of large-span single layer latticed dome
Autor: Sahashi, N. / Hangai, Y. / Hisatoku, T.
DOI: <https://doi.org/10.5169/seals-59968>

Structural Design of Large-Span Single Layer Latticed Dome

This report describes the types and effects of imperfections which will affect the strength of a large-scale steel single-layer latticed dome, by taking the case of designing and constructing a single-layer latticed dome as large as approx. 190 m in plane diameter.

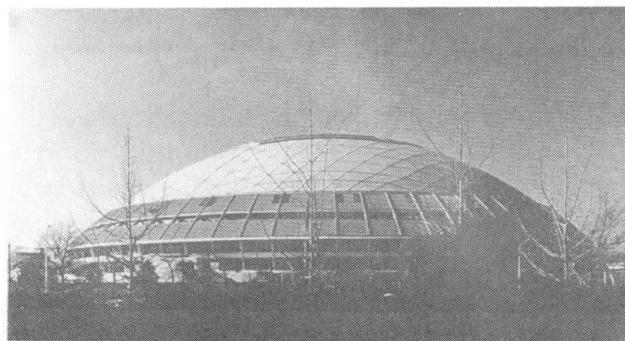
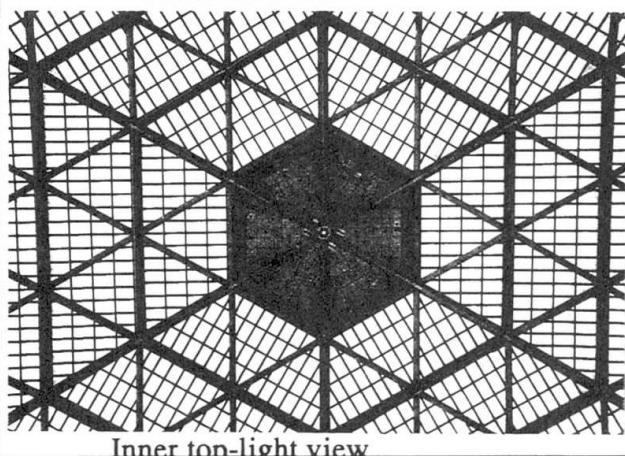
Photo 1-1 Panoramic view of Nagoya Dome

Panoramic view

Inner top-light view

The building dealt with in this report is "Nagoya Dome" constructed in Nagoya City, Japan. This building is a multi-purpose stadium with steel roof, mainly used for baseball games. The construction of the building was commenced in August, 1994 and completed in March, 1997. (Photo 1-1)

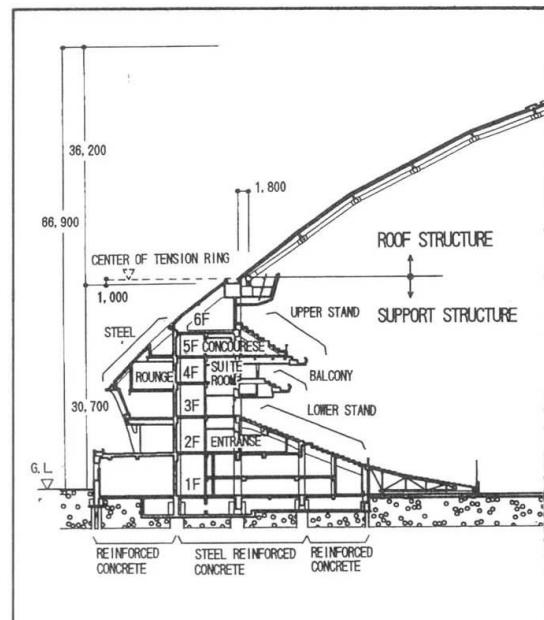
Fig. 1-1 Section of the building frame

The structural type of the roof is a steel single-layer latticed dome, 187.2 m in plane diameter and 32.95 m in height, which is one of the largest single-layer latticed dome structures in the world. (Fig. 1-1)

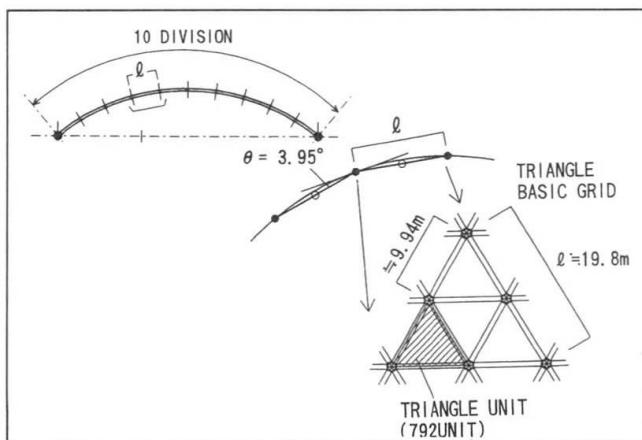
Fig. 1-2 The lattice division pattern

The under-roof structure is a steel framed reinforced concrete structure, which is 36 m high. The diameter on centers of columns along the outermost circumference is 229.6 m, and the diameter on column centers of the top floor is 187.2 m. The tension rings for the roof are located on the girders, each of which over-hangs 1.8 m inward from the center of column on the top floor of the under-roof structure because applied was the lift-up method in which the roof was built on the ground and hung up for the purpose of rationalizing the construction method. Therefore, the roof's plane diameter on centers of the tension ring members is 183.6 m, and the roof height on centers of the members is 32.95 m. Thus the rise-to-span ratio (H/L) is 0.179. (Fig. 1-2)

Each lattice component of the roof consists of 4 triangles approx. 10 m per side each, produced by splitting a triangular plane approx. 20 m per side. Those triangles are rigidly jointed to each other by welding them at the points of contact.

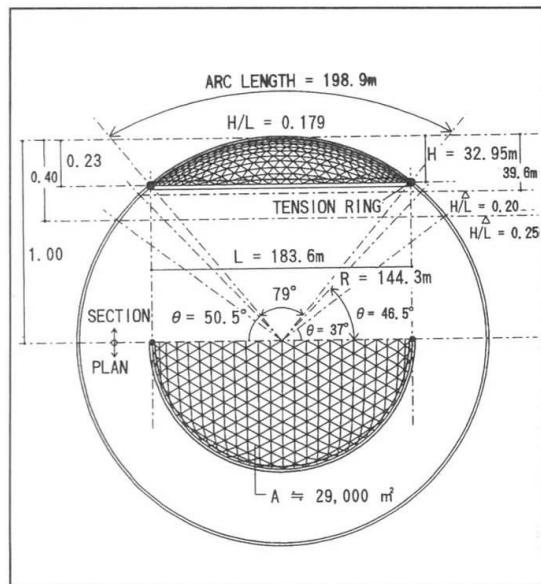
Fig 1-3 The roof Structure section

The lattice is made of steel pipes, 650 mm in diameter, the thickness of which is gradually increased from 19 mm at the roof center to 28 mm along the outer circumference. For the tension rings, steel pipes 950 mm in diameter and 50 mm in thickness are used. (Fig. 1-3)

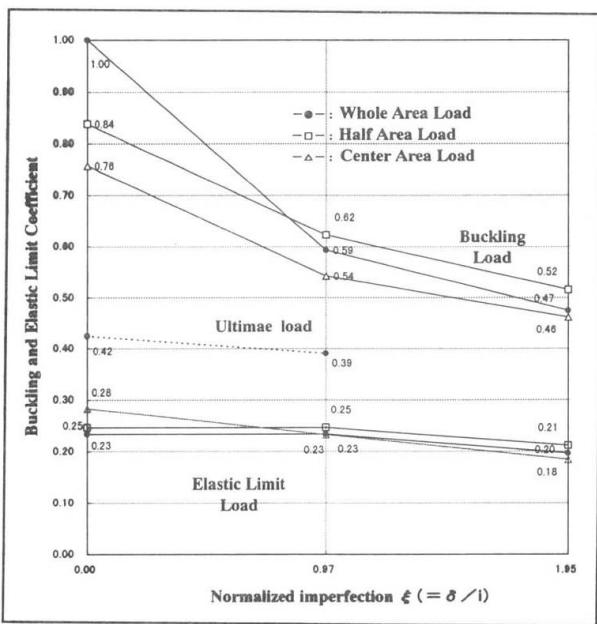
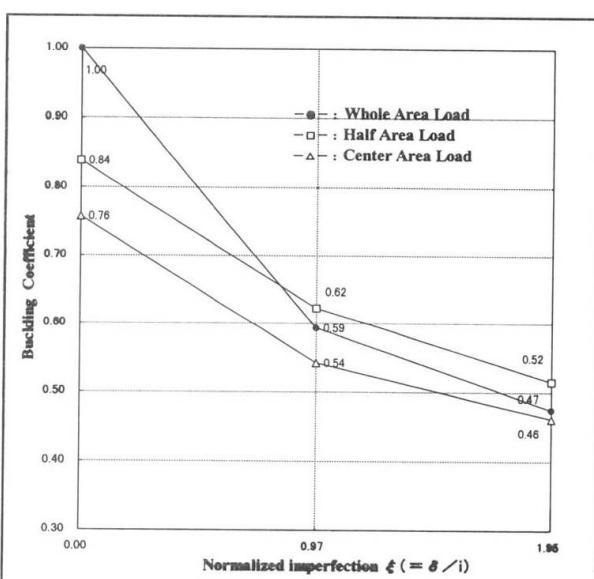
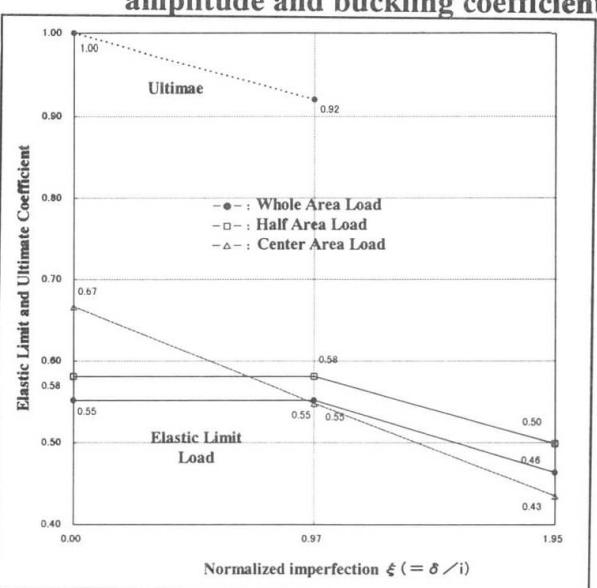
Fig. 2-1 Normalized imperfection amplitude and buckling coefficient

Fig. 2-2 Normalized buckling coefficient

Fig. 2-3 Elastic limit strength coefficient

This chapter describes the result of comparative study on how the amplitudes of geometrical imperfections affect the elastic limit strength and buckling strength of the steel single-layer lattices under the different load conditions. We evaluate buckling strengths and elastic-plastic strengths in consideration of various imperfections; The analysis model was a three-dimensional model with 577 nodal points and each nodal point was provided with 6 degrees of freedom. Non-linear incremental analysis was applied for any analyses by considering the characteristics of a single-layer latticed structure, except for seismic time history response analysis. The main frame under the roof was replaced by equivalent springs in the model. The analytical results are shown in Figs. 2-1 to 2-3.

- 1) The elastic limit loads were approx. 1/3 to 1/2 of the global buckling loads, and the ultimate loads were approx. 1/2. Therefore, the member yield precedes the global buckling on such a scale as the single-layer latticed dome used in analyses.

- 2) The effects that geometrical imperfections exercised on buckling loads were the largest during the full load application: the strength accounted for approx. 60 % at the imperfection $\xi \approx 1.0$ and reduced to approx. 47% at the imperfection $\xi \approx 2.0$.

- 3) The perfect system buckling load with the partial load considered at the center of the roof was the smallest: 76% of that during the full load application. The effects of the imperfections were relatively small. Near the imperfection $\xi \approx 2.0$ in any load distribution, the buckling strength was approx. 1/2 of that during the full load application.

- 4) The effects that imperfections exercised on the ultimate strength were relatively small: approx. 92 % at the imperfection $\xi \approx 1.0$.
- 5) The effects that imperfections exercised on the elastic limit strength at the imperfection $\xi \approx 2.0$ varied to 85% ~ 65% of the perfect system, which shows the result of the effects exercised by the combination of load distribution and imperfection distribution.

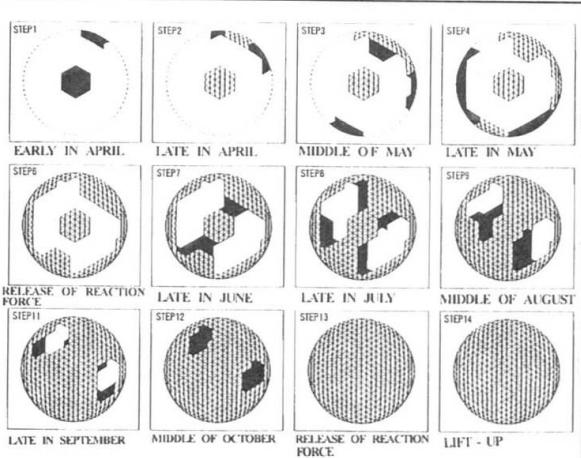
Fig. 3-1 Analytical models corresponding to construction steps

Specifically, the typical under-construction configurations during the roof fabrication were set in the analytical models. The analysis in consideration of the above conditions 1) to 3) was conducted on each of the set models, the results of which were calculated in the addition, and thus the predicted effects of the construction were grasped.

The imperfections accompanying the construction are shown by the differences between the member stresses / contact deformations calculated in the above method and the results obtained in the method (perfect system analysis) where all the loads were applied together to the perfect system model usually used for the structural analysis. Photo 3-1 shows the construction in progress, and Fig. 3-1 shows the sketch of the analytical models.

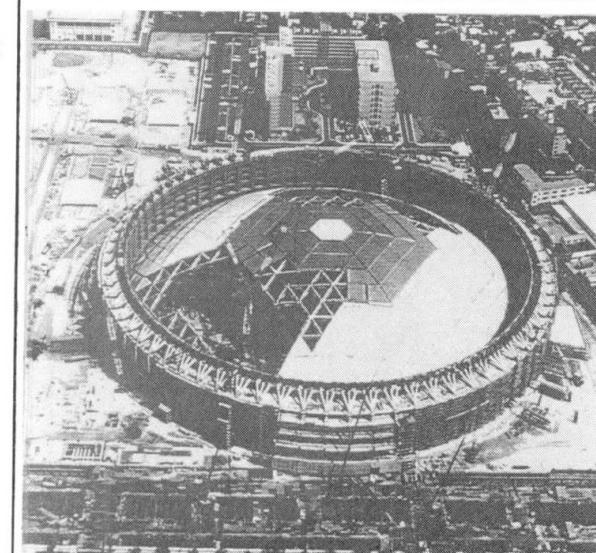
Photo. 3-1 Over view of construction state

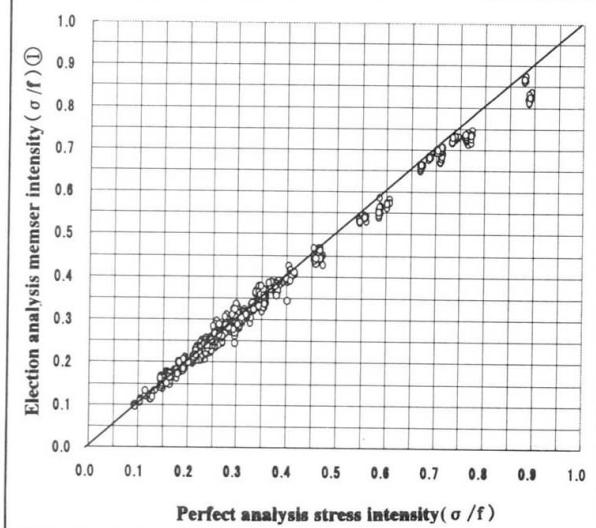
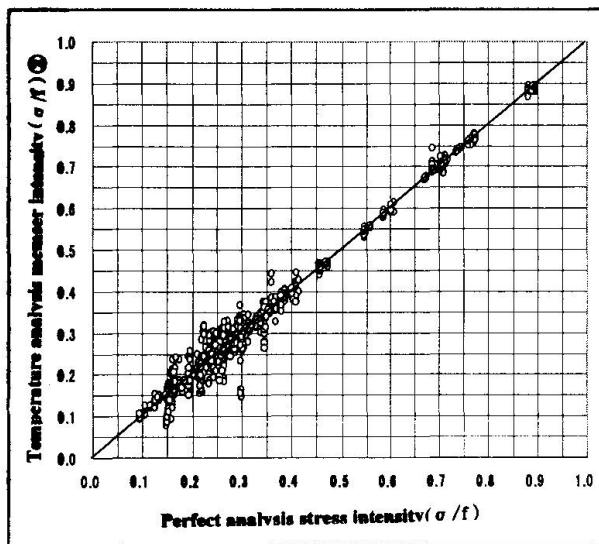
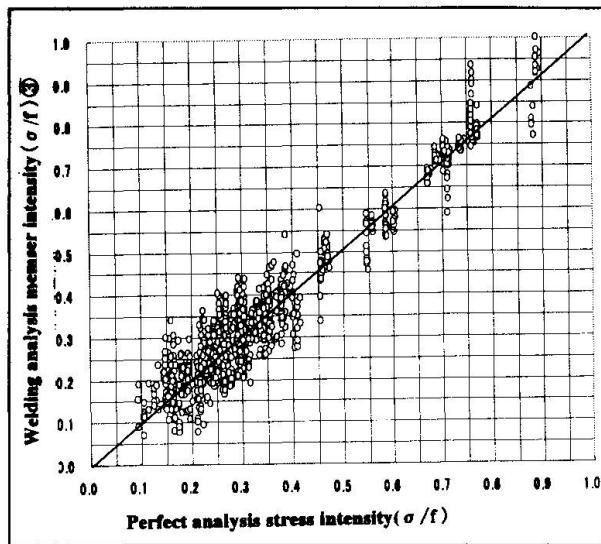
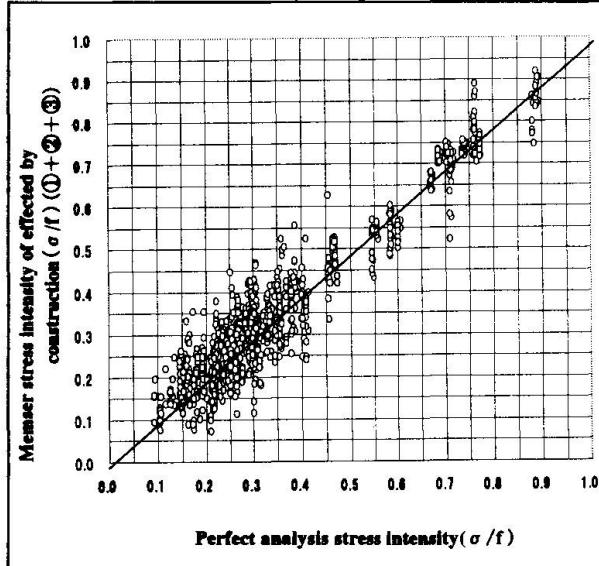
Fig. 3-2 Member stress intensity correlation (Erection analysis)

Fig. 3-3 Member stress intensity correlation (Temperature analysis)

Fig. 3-4 Member stress intensity correlation (Welding analysis)

Fig. 3-5 Stress intensity correlation total (under-construction)

The results of expressing the effects of the construction in the variation correlative distributions of the member stress ratios are shown in Figs. 3-2 to 3-5.

The abscissa indicates the perfect-system analytical results, and the ordinate indicates the under-construction imperfection analytical results.

- 1) Most of the imperfections which occur under on-site erection are caused by welding.
- 2) The effects of the whole construction result in the member stress ratio of approx. ± 0.2 .
- 3) The effects on the member stresses under the different analytical conditions vary from one another in amplitude and affected member. Therefore, the effects of the whole construction are smaller than the result of the simple accumulation of the analytical results.
- 4) The geometrical imperfections under construction are as small as approx. $0.15 i$ (i = radius of gyration of the member) in case of the nondimensionalized imperfections.

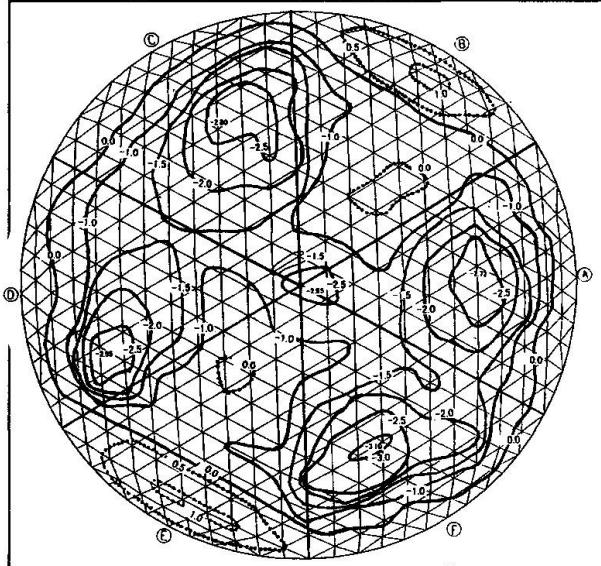
Fig. 3-6 Geometrical imperfections(cm) (plane distribution)

Figs. 3-6 and 3-7 show the distributions of the vertical imperfections at the points of contact. Fig. 3-6 shows the plane distribution of geometrical imperfections, while Fig. 3-7 shows the imperfections graphed by nondimensionalizing the geometrical imperfections at the radius of gyration of the members and splitting them into 6 between the center and the outer circumference of the roof.

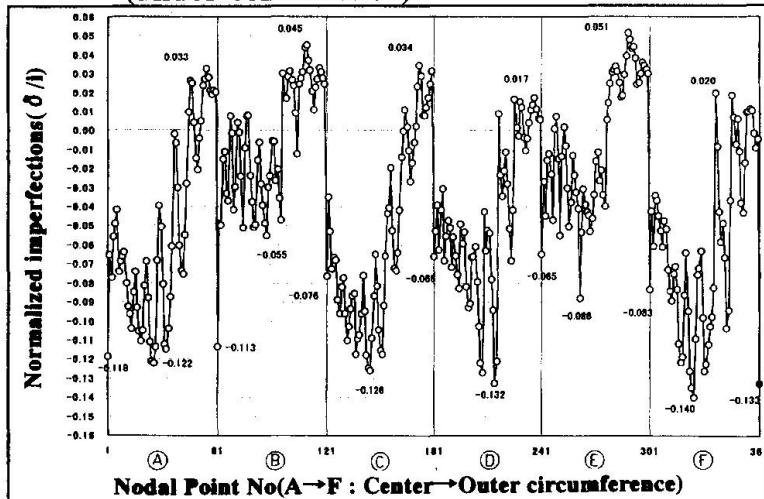
Fig.3-7 Normalized imperfections graph of each nodal point
