Zeitschrift: IABSE reports = Rapports AIPC = IVBH Berichte
Band: 80 (1999)

Artikel: Evaluation of cracked soft rock on in-situ test results
Autor: Shimamine, Tetsuo / Watanabe, Akiyuki / Sonoda, Kosei
DOI: <https://doi.org/10.5169/seals-60738>

Evaluation of Cracked Soft Rock on In-Situ Test Results

The base rock expected to be used for the foundation of a railway arch bridge (180m span) currently in the planning stage is heavily-cracked auto-brecciated andesite (rock grade about C_M - C_L -Rock classification of dam foundation in Japan). There was a need to accurately evaluate the bearing capacity, since a load amounting to as much as about 2.1kN (normal condition) would be applied to the base rock at each bridge pier. Since being an arch bridge, there was a desire to restrain support point displacement of the foundation to the utmost, and since it was also necessary to take into consideration the reduction in bearing capacity due to the effect of slopes due to the fact that the foundation would be constructed on slopes facing the river. We thus conducted block shear tests as a way of improving the accuracy of the shear constant. We evaluated bearing capacity of the base rock an

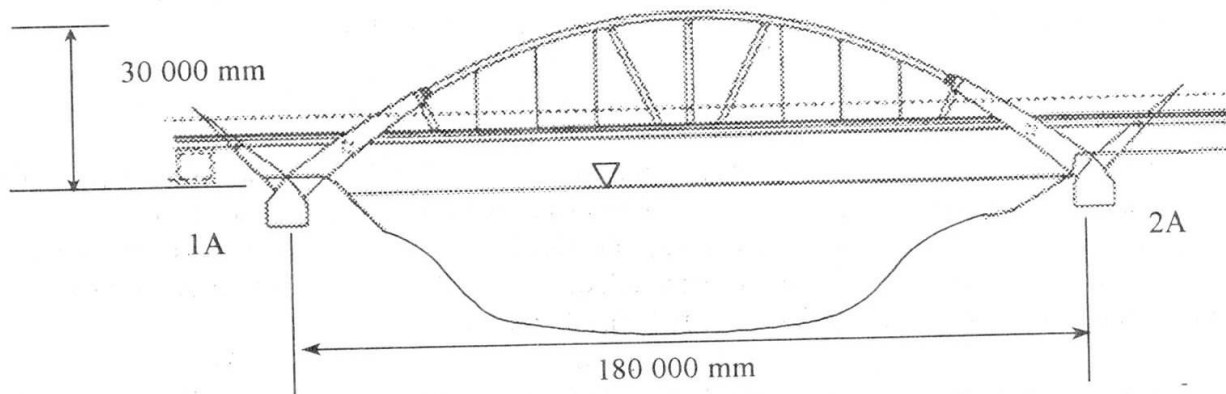
Fig.1 Outline view of the bridge

We will next give an explanation of the strata composition in the vicinity of the foundation. Side 2A is characterized by surface deposits (fill, old surface soil) with an N-value of about 5 to a depth of GL-4m, and terraced deposits (sand and gravel mixed with cobblestone) at a depth of GL-7-9m with soft stone tuff-breccia with heavily-cracked auto-brecciated andesite intrusions) at depths greater than GL-9m (refer to Fig.1 and Table 1).

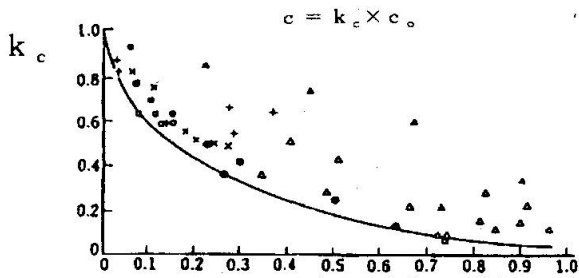
Fig. 2 Relationship of C_r and k_c

In addition, Figs. 2 & 3 indicate data compiled by the Japan Roadway Public Corporation relating to the relationship between the cracking index and the reduction index of cohesion strength and the angle of internal friction. This data included the test data of the Railway Technical Research Institute of the National Railway. It is possible to estimate the values of c and ϕ by means of a curve that takes the lower limits of variation indicated in Fig. 2 & 3. In other words:

Material values for the bedrock of side 2A determined from the above are shown in Table 4. According to this method, it is necessary to carry out a reduction of about 80% for cohesion strength and about 40% for the angle of internal friction relative to the results of triaxial compression tests. However, it is possible that shear constants c and ϕ are underestimated with this method, since there are various reasons, such as the fact that basically the minimum values are used for the reduction index and the impossibility of differentiating quantitatively between open and closed cracks because of the use of elastic waves.

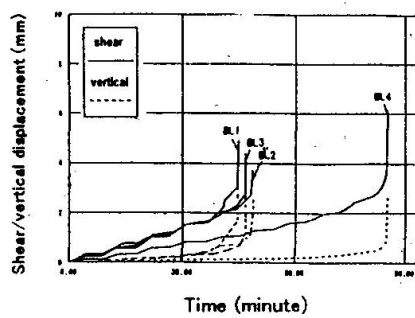
Fig. 7 Relationship between time and shear/vertical displacement (average)

Failure took 2-3 times longer with BL4 than with BL1-3.

The conditions of failure of the shear plane of the blocks are indicated in Fig.6. The relationship between time and shear/vertical displacement (average) is indicated in Fig.7. The relationship between shear stress and displacement velocity is indicated in Fig.8. The relationship between shear stress and the amount of shear displacement is indicated in Fig.9. And the relationship between shear stress and shear/vertical displacement (average) is indicated in Fig.10.

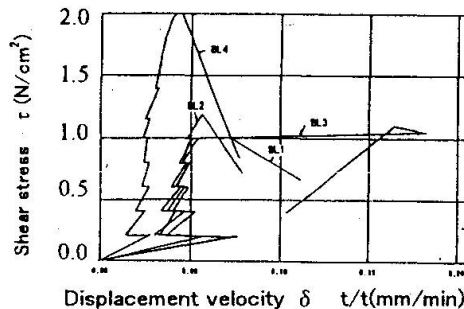
Fig. 8 Relationship between shear stress and displacement velocity

The displacement velocity of BL4 was about 1/2 that of BL1-3 and the progress of the displacement was slow.

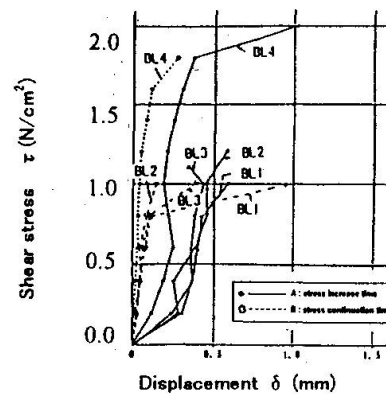
Fig. 9 Relationship between shear stress and the amount of shear displacement

The amount of shear displacement was about 1/2 that of BL1-3 for both stress increase time and continuation time. This would indicate that the base rock of BL4 is hard and that fractures are closed.

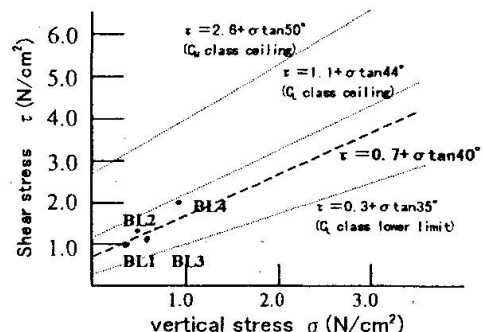
Fig. 11 Test results and volcanic rock shear strength properties

In addition, if we plot the values obtained in the tests in the shear strength properties of the volcanic rock shown in Fig. 11, we could see that the test values for BL1-3 would be average values for C_L grade rock and that the test values of BL4 would be at the upper limit for C_L grade rock. Based on this, we can state that appropriate values were obtained in the tests corresponding to the rock type and grade.

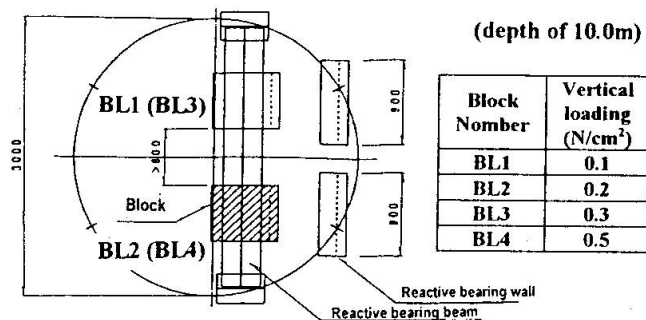
Fig.4 Plane view of the conditions of block shear tests [depth of 8.5m]

Deep foundation holes with a diameter of 3m were excavated in the vicinity of the foundation on side 2A and the tests were conducted using 2 blocks each at a depth of 8.5m (block numbers BL 1 & 2) and a depth of 10.0m (block numbers BL 3 & 4) from G.L. A plane view of the test conditions is shown in Fig.4 and an inclined view is shown in Fig.5.

The shear plane was 60cm × 60cm in size and, since load strength was conjectured to be in the range of 0.4N/cm² under normal loading conditions at the bottom of the foundation, vertical loading was carried out in the stages of 0.1, 0.2, 0.3 and 0.5N/cm². The loading velocity was set at 2.5×10^{-2} N/cm²/min with a stationary period of 5 minutes at each stage. In addition, horizontal shear loading was carried out at a velocity of 5.0×10^{-2} N/cm²/min with a stationary period of 5 minutes after each 0.2N/cm² loading and the load was increased until shear failure occurred. The blocks were set up so that they would shear in the direction of the river.

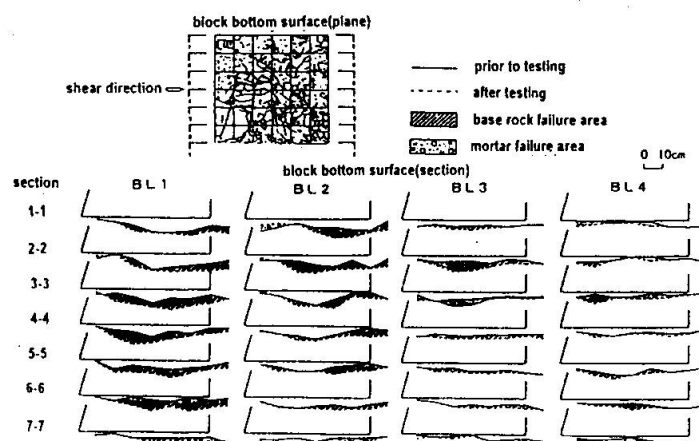
Fig.6 Conditions of failure of the shear plane of the block

Observation of the conditions of the shear plane indicated that the failure of blocks BL1-3 was deeper than in block BL4 and there was also a tendency in all of the blocks to form a slope inclining generally toward the front. In regard to the shear plane conditions, blocks BL1-3 sheared in the direction of the joint of the breccia contained in the auto-brecciated andesite. However, block BL4 sheared with a number of cracks appearing in the base rock itself in the direction of the shear and in the perpendicular direction as shear loading was applied.
